## 激光薄膜元件内微缺陷的表征分析

**摘要** 激光系统用薄膜元件既要有优异的光学性能, 又要有高的激光诱导损伤阈值 (LIDT)。薄膜元件的基底表面上交替沉积有高低折射率材料, 通过膜厚、折射率等参数的优化可实现所需的光学性能, 但元件中存在的微缺陷 (如膜料喷溅缺陷、基底缺陷等) 是导致 LIDT 降低的重要原因。通过精准定位切割、三维重构的方法, 表征膜料喷溅和基底抛光产生的微缺陷的形貌结构, 并对其激光辐照前后的元素分布进行了分析。研究结果为镀制工艺、基底加工工艺的改进提供了参考。

# Characterization Analysis of Micro-defects in Thin-Film Components for Laser Systems

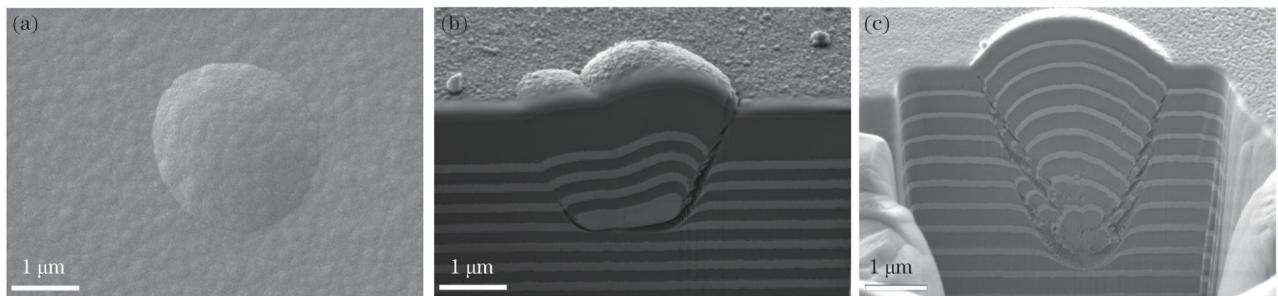
图 2 膜料喷溅产生的微米量级节瘤缺陷的 SEM 图。(a) 薄膜表面典型节瘤形貌; (b) 节瘤内  $\text{HfO}_2$  种子; (c) 节瘤内  $\text{SiO}_2$  种子  
Fig. 2 SEM images of micron-scale nodule defects produced by film material ejection. (a) Typical nodule morphology on film surface; (b)  $\text{HfO}_2$  seed in nodule; (c)  $\text{SiO}_2$  seed in nodule

镀膜元件表面由于膜料喷溅形成的典型节瘤缺陷如图 2 所示,微米量级的节瘤缺陷的球冠尺寸较大,如图 2(a)所示,种子源也较大,如图 2(b)、(c)所示,截面图中亮色区域为  $\text{HfO}_2$ ,暗色区域为  $\text{SiO}_2$ ,表明节瘤种子既有  $\text{HfO}_2$  也有  $\text{SiO}_2$ 。

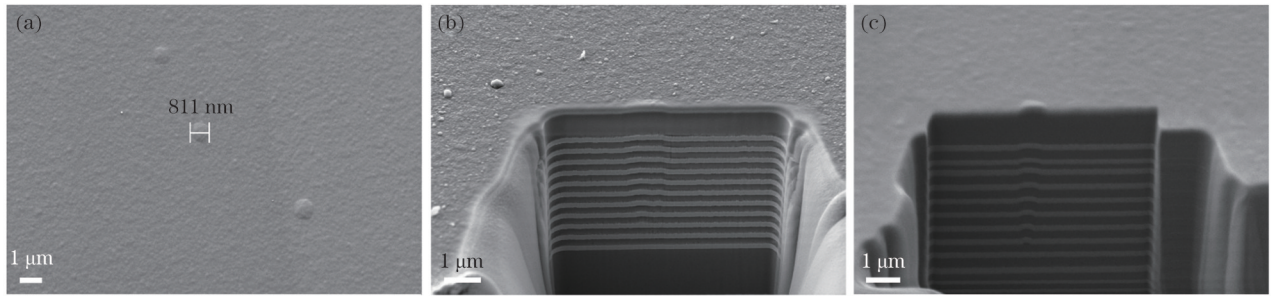
亚微米量级节瘤缺陷在薄膜表面上的尺寸较小,如图 3(a)所示,球冠直径近 800 nm,其种子源更小,且没有明显的结构性边界,很难再用聚焦离子束(FIB)切割的方式确定种子源的位置和成分,如图 3(b)、(c)所示。

图 3 膜料喷溅产生的亚微米量级节瘤缺陷的 SEM 图。(a) 薄膜表面典型节瘤形貌；(b) 一个节瘤缺陷的截面；(c) 另一个节瘤缺陷的截面

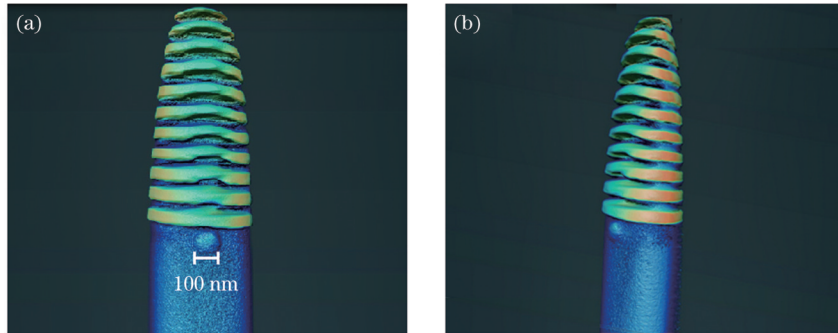
因此,以亚微米量级节瘤为中心,将缺陷切成类圆柱体,采用 TEM 三维重构的方式,对亚微米量级节瘤进行分析,最终发现其种子源尺寸为 100 nm,如图 4 所示。图 4(a)、(b)分别为三维重构的正面图和侧面图。

图 4 亚微米量级节瘤缺陷的 TEM 三维重构图。(a) 正视；(b) 侧视

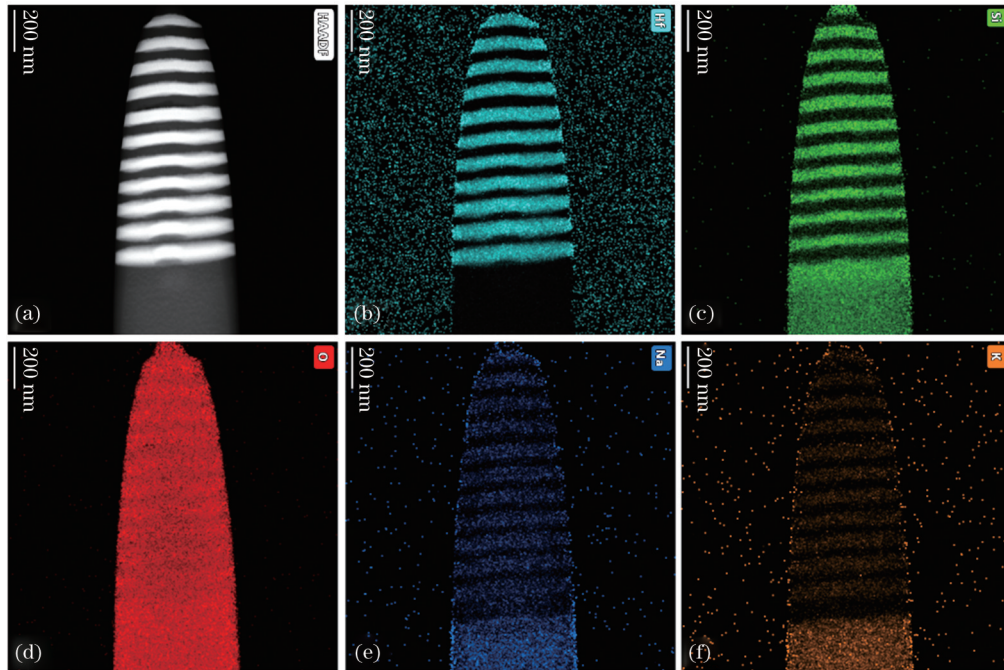
用 TEM 对圆柱体进行 HAADF 成像,如图 5(a)所示。用 EDS 对圆柱体进行与 HAADF 像对应的成分分析,测得种子源位置处的成分为 Si 和 O,如图 5(b)~(d)所示,证实其种子源为喷溅的  $\text{SiO}_2$ ,位于  $xL$  打底层中。除膜层中的 Hf、Si、O 元素外,在基底和  $\text{HfO}_2$  层中发现了 Na、K 离子的富集,如图 5(e)、(f)所示。这是由于 BK7 基底含有少量 Na、K 离子,在镀膜过程中,加温和真空的共同作用使得来自基底的 Na、K 离子扩散并聚集在高折射率膜层中<sup>[25-26]</sup>。

图 5 TEM-EDS 测得的亚微米量级节瘤缺陷中的元素分布。(a) HAADF 像；(b) Hf；(c) Si；(d) O；(e) Na；(f) K

表征分析了基底及 355 nm 和 532 nm 高反膜元件表面的微缺陷来源及其损伤特征。通过对亚微米级缺陷点的三维重构,证明了其种子源为百纳米的喷溅  $\text{SiO}_2$  膜料。镀膜的真空中加温过程会导致基底中 Na、K 离子的扩散并聚集于高折射率膜层;微米级膜料喷溅缺陷被激光辐照后生成的损伤坑边缘呈熔融状,邻近损伤坑边缘的  $\text{HfO}_2$  层呈明显多孔柱状结构,O 和 Hf 的原子数分数比低于 2:1;基底内的杂质缺陷被激光辐照后产生等离子体喷发的温度高于  $\text{HfO}_2$  气化温度,导致  $\text{HfO}_2$  气化进入基底裂纹。分析结果表明,为了提高激光损伤阈值,应进一步优化  $\text{SiO}_2$  预熔和沉积过程,避免百纳米的  $\text{SiO}_2$  缺陷;采用高纯度石英基底进行薄膜镀制;可采用离子束抛光技术去除传统抛光工艺带来的基底表面缺陷。

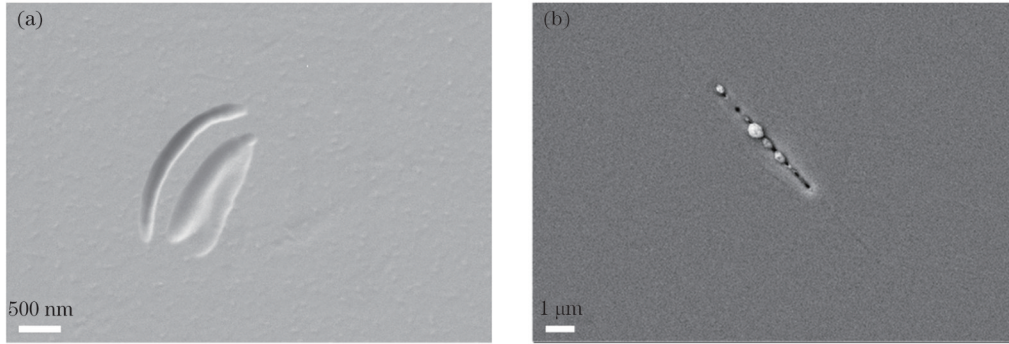
对传统抛光基底表面进行形貌观察,发现了基底抛光过程中产生的坑点和微裂纹,如图 6 所示;对基底进行 200 °C 退火后基底微裂纹处析出浅色类球状杂质,如图 6(b) 所示。在这样的抛光基底上镀

图 6 基底缺陷的 SEM 形貌图。(a)坑点;(b)高温退火后的基底裂纹

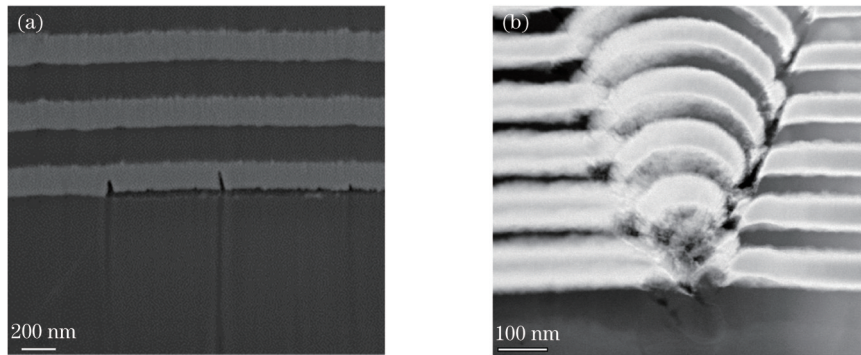
膜,并在基底缺陷对应位置上对镀制的薄膜进行 FIB 切割,在截面上可以看到基底缺陷导致的膜层剥离和孔隙,如图 7(a) 所示;较大的基底杂质也会导致类节瘤缺陷结构,如图 7(b) 所示。这是由于镀膜过程中的温度为 200 °C,且处于真空环境,因此镀膜

过程中基底缺陷的放气和杂质析出对膜层产生影响。对图 7(b)中的基底杂质进行元素分布分析,发现基底杂质的成分主要为 Al 和 O,如图 8 所示,这应该

图 7 基底缺陷引起的膜层缺陷。(a)薄膜底层剥离和孔隙的 SEM 图;(b)膜层内的类节瘤缺陷结构的 TEM 图

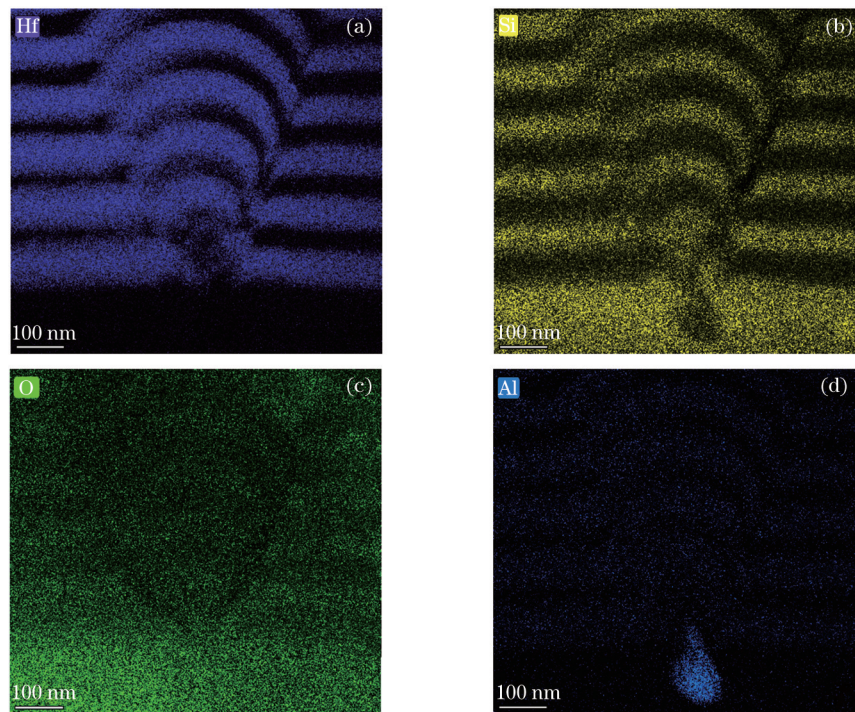
是基底抛光过程中使用的  $\text{Al}_2\text{O}_3$  抛光粉残留在基底表面坑点中导致的,杂质在镀膜后析出,成为缺陷种子源。

图 8 TEM-EDS 测得的图 7(b)中基底杂质的元素分布。(a)Hf;(b)Si;(c)O;(d)Al

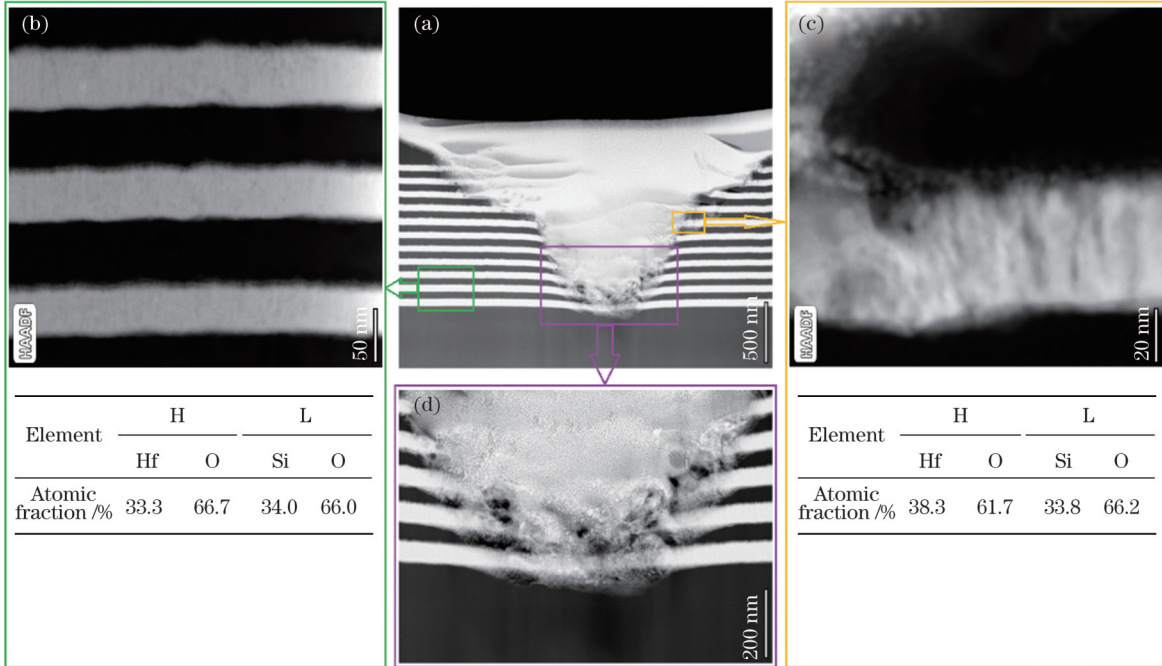
355 nm 高反射膜内的节瘤缺陷在激光辐照后产生的喷发损伤坑如图 9(a)所示,该点处的激光辐照能量密度为  $24.9 \text{ J/cm}^2$ 。对损伤坑进行局部放大,发现远离损伤坑的膜层致密,元素含量接近正常化学计量比,如图 9(b)所示;邻近损伤坑边缘的 H 层呈现明显的多孔

柱状结构, O 与 Hf 的原子数分数比明显低于 2:1,如图 9(c)所示;损伤坑底部和侧壁呈现熔融态,如图 9(d)所示,说明损伤区域的温升达到  $\text{HfO}_2$  和  $\text{SiO}_2$  的熔点。

图 9 激光辐照后膜层内节瘤缺陷导致的喷发损伤坑的 TEM-EDS 分析。(a) 损伤坑全貌; (b) 远离损伤坑的膜层形貌及元素含量; (c) 损伤坑边缘形貌及元素含量; (d) 损伤坑底部形貌

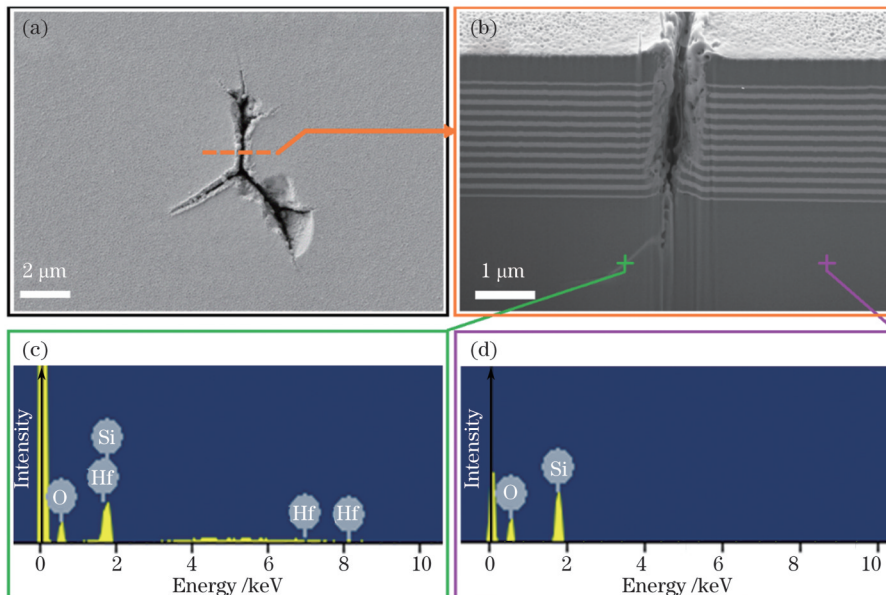
532 nm 高反射膜在激光辐照后的裂纹状损伤坑如图 10(a)所示,该点处的激光辐照能量密度为  $82.7 \text{ J/cm}^2$ 。对损伤坑进行截面观察,发现损伤裂纹

图 10 裂纹状损伤坑的 SEM-EDS 分析。(a) 裂纹状损伤; (b) 裂纹状损伤的截面形貌; (c) 基底白色区域的元素; (d) 基底非损伤区域的元素

延伸至基底较深处,且基底裂纹内有明显白色物质,如图 10(b)所示。对基底裂纹内的白色物质进行成分分析,并取同一水平位置处的非损伤区域作对比,测试结果如图 11(c)、(d)所示,白色区域含 Hf、Si 和 O 元素,非损伤区域仅含 Si 和 O 元素,而基底的主要成分为 Si 和 O。结果表明,缺陷在激光辐照后产生等离子体喷发的温度高于  $\text{HfO}_2$  气化温度 ( $5400\text{ }^\circ\text{C}$ ),导致  $\text{HfO}_2$  气化进入基底裂纹中。
