0.532- μm laser conditioning of $\text{HfO}_2/\text{SiO}_2$ third harmonic separator fabricated by electron-beam evaporation

The 0.532- μm laser conditioning of $\text{HfO}_2/\text{SiO}_2$ third harmonic separator fabricated by electron-beam evaporation (EBE) was studied. The laser induced damage threshold (LIDT) of the separator determined by 1-on-1 test is 9.1 J/cm² and it is 15.2 J/cm² after laser conditioning determined by raster scanning. Two kinds of damage morphologies, taper pits and flat bottom pits, are found on the sample surface and they show different damage behaviors. The damage onset of taper pits does not change obviously and the laser conditioning effect is contributed to the flat bottom pits, which limits the application of laser conditioning.

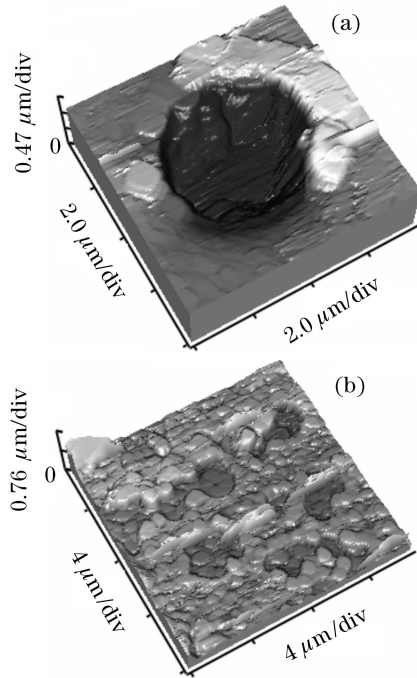
There were two damage morphologies found on the sample surface after damage test and raster scanning. Atomic force microscopy (AFM) images are shown in Fig. 3. One of them was taper pit as Fig. 3(a) with about 5- μm diameter at the sample surface and depth varying from 0.4 to 1.1 μm . The other one was flat bottom pit

Fig. 3. AFM micrographs of damage morphologies. (a) Taper pits; (b) flat bottom pits.

as shown in Fig. 3(b). They had a typical cylindrical shape with diameter about $3\ \mu\text{m}$ and depth about $0.2\ \mu\text{m}$. Generally there were several such pits linked together. In a lot of cases, a small melted zone was obvious at the center of the damage.

The formation of taper pits was studied and it was thought to be caused by nodular defects^[13–15]. The nodular defects formed during film deposition were unstable and during laser pulse irradiation they were heated until ejection and taper pits were formed finally. From the experiments, the results show that the pulse energy density is $15.2\ \text{J}/\text{cm}^2$ for both the 1-on-1 test and raster scanning when taper pits emerges, so the damage onset of the nodular defects does not change obviously after raster scanning. As to the flat bottom pits, Dijon^[16] thought that they were initiated by some invisible absorbing centers and he proposed four steps leading to the flat bottom pits:

In 1-on-1 test the flat bottom pits appeared when the pulse energy density was $9.1\ \text{J}/\text{cm}^2$. But during raster scanning we found them only when the pulse energy density was more than $16.0\ \text{J}/\text{cm}^2$. This suggests that raster scanning enhances the laser resistance capability of this kind of defect.
