Analysis and control of abnormal phenomena in HgCdTe surface treatment

LIU Yan-Zhen, LI Shu-Jie, ZHANG Ying-Xu, XIN Yong-Gang, LI Zhi-Hua, LIN Yang, LI Xiong-Jun,
QIN Qiang, JIANG Jun, GUO Jian-Hua*

(Kunming Institute of Physics, Kunming 650223, China)

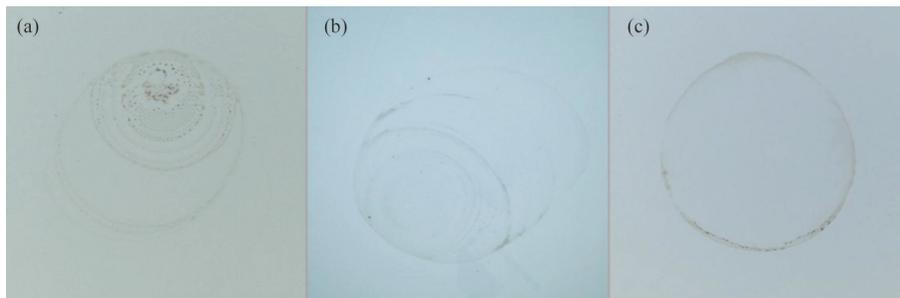
due to its lower value change in the free energy. Additionally, the etching rates of the three components of HgCdTe are $\text{Cd} > \text{Hg} > \text{Te}$. The free energy of Te^{2-} oxidized to soluble cations is relatively high, which can only be oxidized to Te^0 by Br_2 . The slower etching rate of Te will lead to the HgCdTe surface rich in elemental tellurium^[11-13]. During the cleaning process, water droplets are easily formed on the surface of HgCdTe owing to the Te^0 -rich surface is hydrophobic, which will induce poor drying and form water mark defects in the N_2 purge process, as shown in Fig. 1. Water mark defects could compromise adhesion to passivation film, weakening the passivation effects.

Based on the above experimental results, it is easy to form water mark defects on the surface of HgCdTe when the N_2 flow is unstable and the purging time is longer in the atmosphere containing oxygen. The fluctuation of N_2 pressure on the surface of the HgCdTe resulting from unstable N_2 flow tends to induce the formation of water droplets. If the water droplets cannot be blown dry in time, they are inclined to form water trace defects in the process of slow evaporation^[15]. However, water is often used as the cleaning agent after wet etching of HgCdTe, and no obvious oxidation reaction occur when HgCdTe samples are immersed in water in air. Therefore, the formation mechanism of water mark defects should be oxygen absorption corrosion. In the process of oxygen absorption corrosion, the oxygen transport rate has a great influence on the reaction. At the edge of the water droplet, that is, at the solid-gas-liquid three-phase interface of air on the surface of water HgCdTe, the water content is less, and the dissolved oxygen concentration is higher. The water layer in the center of the water drop is the thickest. In the process of reaction, oxygen in the air is added more slowly by dissolution and diffusion than at

the edge of the water drop, which will cause the difference in the concentration of dissolved oxygen between the center and the edge of the water drop, thus forming the concentration difference corrosion battery. The cathodic reaction is $O_2+2H_2O+4e^-=4OH^-$, which is mainly concentrated in the edge region of oxygen-rich water droplets. Oxygen can be quickly replenished from the air, and the generated OH^- reacts with Te^0 in this area as follows: $3Te+6OH^-=2Te^{2-}+TeO_3^{2-}+3H_2O$, and the generated Te^{2-} and TeO_3^{2-} can further combine with Cd^{2+} and Hg^{2+} to form corresponding compounds. The excess OH^- can also combine with Cd^{2+} and Hg^{2+} to form insoluble hydroxides or oxide precipitation ($Cd^{2+}+2OH^-=Cd(OH)_2\downarrow$, $Hg^{2+}+2OH^-=Hg(OH)_2=HgO\downarrow+H_2O$). The anodic reaction is $2H_2O+Te-4e^-=TeO_2+4H^+$, which mainly occurs in the central area of water droplets. With the evaporation of water, the reaction products in water droplets precipitate on the surface of HgCdTe, and obvious water trace rings appear on the edge of water droplets. Therefore, in the surface treatment process, the simplest method to inhibit the formation of water mark defects is to use steady N_2 flow to quickly dry the HgCdTe surface before the O_2 dissolved into the water droplets.

Fig. 1 Three typical microscopic images of water mark defects
图1 三种典型的水痕缺陷

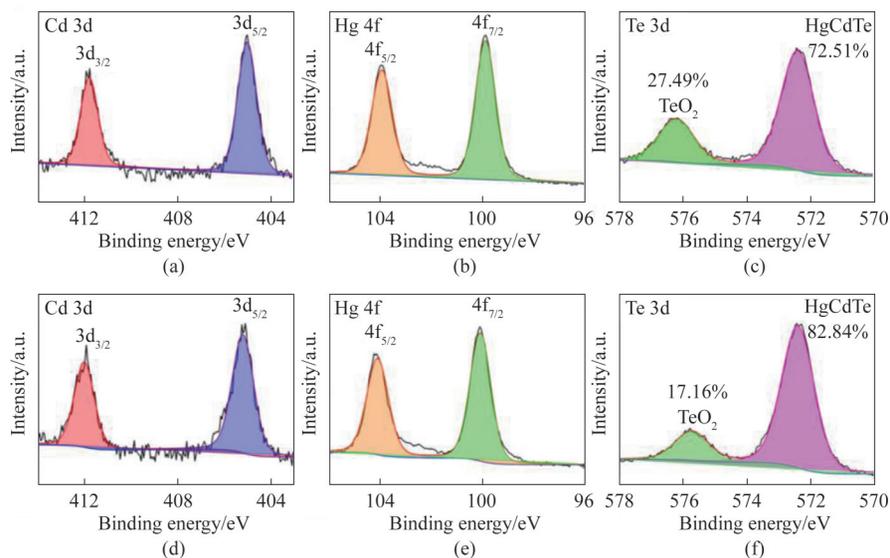
Fig. 2 High-resolution XPS spectra of elements with water mark defect (a), (b), (c), and normal area (d), (e), (f)
图2 水痕缺陷(a),(b),(c)和正常区域(d),(e),(f)组成元素的XPS高分辨谱

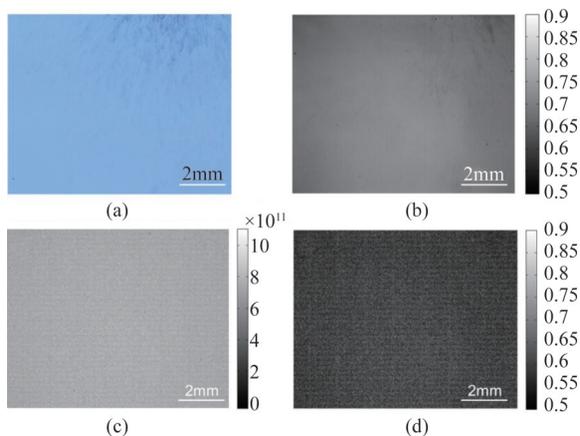
ished by $\text{Br}_2\text{-CH}_3\text{OH}$ solution, the abnormal phenomenon of some areas staining, commonly known as corrosion patchy, would occasionally occur. Figure 3 (a) shows a typical staining phenomenon. These stained films have a direct impact on the pixel response signal in this area, resulting in the “reappear” of irregular imprints in the response diagram (Fig. 3(b)). XPS detection method was used to analyze the element composition of the irregular imprint area, and the test results showed that in addition to Hg, Cd, and Te elements, Br element was also examined, as shown in Fig. 4. According to the XPS high resolution spectrum of C element, the proportion of each oxidation state of carbon element detected in the sample is similar to the conductive adhesive background, so the carbon element detected in the sample may only come from the conductive adhesive. Therefore, the formation of the staining phenomenon should be caused by the uneven etching of different parts by Br_2 in the wet etching process. According to Fig. 3(b), the pixel response signal in staining area is ~ 632 mV, while the pixel response signal in normal area is ~ 694 mV, demonstrating that the former is 62 mV smaller than the latter. Additionally, it can be found that there is no significant difference between the areas with and without staining both in the spectral detectivity (D^*) diagram (Fig. 3(c)) and the noise diagram (Fig. 3(d)), indicating that the staining phenomenon has little effect on the dark current of the device. Thus, the reason for the difference in response between the areas with and without staining is the difference in quantum efficiency of pixels caused by the staining. There are more impurities on the HgCdTe surface of the area with the staining than the other area, which will make the reflection coefficient of the light incident on the lower surface different after passing through the absorption layer, thus affecting the absorption of optical signals by pixels in this area, resulting in low quantum efficiency of pixels.

Fig. 3 (a) Typical microscopic images of staining, (b) the response diagram, (c) the D^* diagram, and (d) the noise diagram
图3 (a)典型染色现象的显微镜照片,(b)器件的响应图,(c) D^* 图,(d)噪声图

non exhibits a higher probability if the speed of methanol washing on the surface was slower or the surface washing agent was not uniform. In these two cases, the residual corrosion solution on the surface of HgCdTe is not uniformly diluted, which will lead to the change of the concentration gradient of etch agent in different areas, resulting in the difference of etching rates. Additionally, it was found that staining tends to form under the condition of $\text{Br}_2\text{-CH}_3\text{OH}$ solution contaminated by water. Theoretically, the process of wet etching of HgCdTe by $\text{Br}_2\text{-CH}_3\text{OH}$ is chemical corrosion, and Br_2 molecules directly collide with the surface of HgCdTe to generate corrosion products. However, when there are impurities such as water in the solution, these impurities act as the electrolyte of ionic conductor, and the electrochemical reaction preferably proceed between HgCdTe and the corrosion solution. At this time, the electrochemical inhomogeneity on the surface of the HgCdTe, including surface chemical

composition nonuniformity, the crystal structure inhomogeneity (such as grain and grain boundary), as well as the inhomogeneity of physical state (such as stress distribution, deformation, etc.), can result in the surface with different potential in some micro areas, inducing electrochemical corrosion. For example, the atomic energy of the defect site on the HgCdTe surface is higher than that of the non-defect site, and the defect site is preferentially corroded as an anode, resulting in the difference in the thickness of the corroded film between the defect area and the non-defect area, and showing different interference colors. Therefore, in order to reduce the probability of staining, it is necessary to avoid the uneven corrosion on different parts of the HgCdTe. Additionally, in the etching process, water contamination should be avoided strictly. When the etch process is completed, the entire HgCdTe surface needs to be washed quickly with a large amount of methanol.

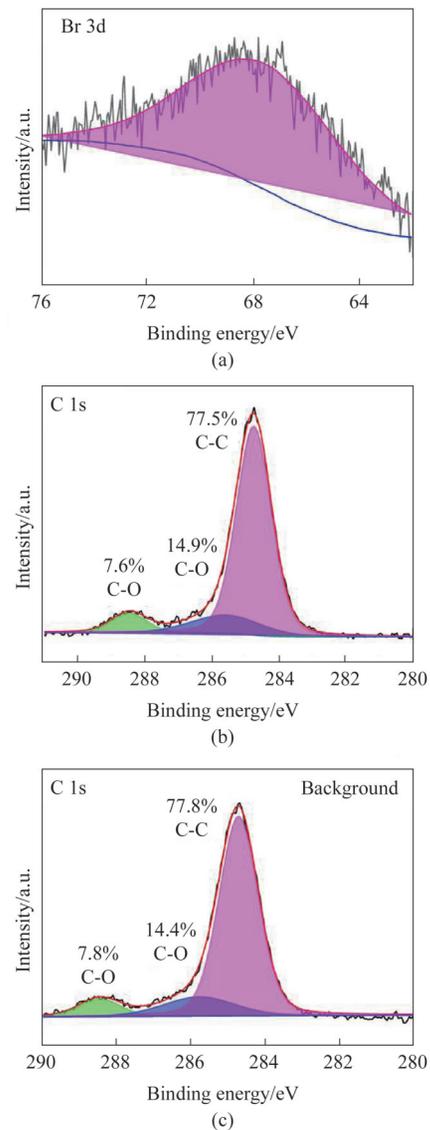
Fig. 4 XPS high-resolution spectrum of Br 3d (a), C 1s (b), and C 1s (conductive adhesive) (c)

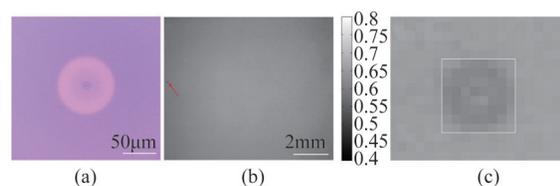
After the passivation film layer is prepared, round spots can be observed on the surface of some HgCdTe samples, and most of these spots are centered on a defect, which generally leads to circular dark spots in the response diagram of the device (a back-illuminated device with the scale of 640×512 pixels and the pixel center distance is $15 \mu\text{m}$ as an example), as shown in Fig. 5. The diameter of the round spot is about $90 \mu\text{m}$, and the size of the central material defect is about $6 \mu\text{m}$. This material defect does not cause dead pixels, as exhibited in Fig. 5(c), resulting in a smaller response signal of about 8×8 pixels (the round spot area is $\sim 59 \text{ mV}$ smaller than the normal area).

Fig. 5 (a) Typical microscopic images of round spot, (b) the response diagram, and (c) the number of pixels contained in the circular dark spot (a small square represents a pixel)

The CH_3OH molecule has strong polarity and is easily adsorbed at the defect by electrostatic interaction. It was found that after washing the surface of HgCdTe with methanol, soaking the HgCdTe sample with isopropanol, which is less volatile and less polar than methanol, for several minutes, and then drying, could significantly reduce the probability of round spot.

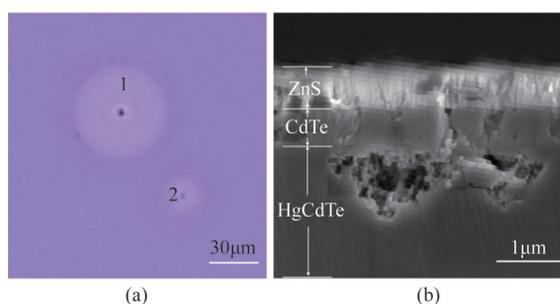
To explore the cause of the round spot, after the ZnS and CdTe passivation films were removed by dry etching, the element composition at the round spot was tested by XPS technology (the test point is one $10 \mu\text{m} \times 10 \mu\text{m}$ area in the round spot that avoids the central material defect, Mark 1 in Fig. 6(a), another HgCdTe sample), and Hg, Cd, Te, Br, C, and O elements were detected. Figure 6(b) shows the SEM image of the section structure of the defect in the center of the round spot marked 2 in Fig. 6(a), illustrating that the defect originates from the HgCdTe film. Figure 7 shows the XPS high resolution spectrum of Br and C elements. By comparing Fig. 7(b) and Fig. 4(c), it can be found that the C=O and C-O contents of the sample accounted for 11.3% and 30.7%, respectively, which were significantly higher than that of the conductive adhesive (7.8% and 14.4%). The difference of test results indicate that the carbon element detected in the sample comes from both the sample and the conductive adhesive, demonstrating that the C element was contained in the round spot, which can be attributed to the adsorption residue of organic liquid at the defect in the wet process. In addition, according to the process carried out, it can be inferred that Br element originates from Br_2 residue during $\text{Br}_2\text{-CH}_3\text{OH}$ etching process. Therefore, it can be concluded that the round spot originates from the defect tending to adsorb wet agent. In the process of wet treatment, some

wet agent will adsorb and remain in the defects due to the large number of tiny pores in the defects. When passivation film deposition, the residual wet agent gradually volatilizes to the defects around forming round spot owing to the temperature increase.

Fig. 6 Typical microscopic images of round spot (a) and the SEM image of material defect (b)

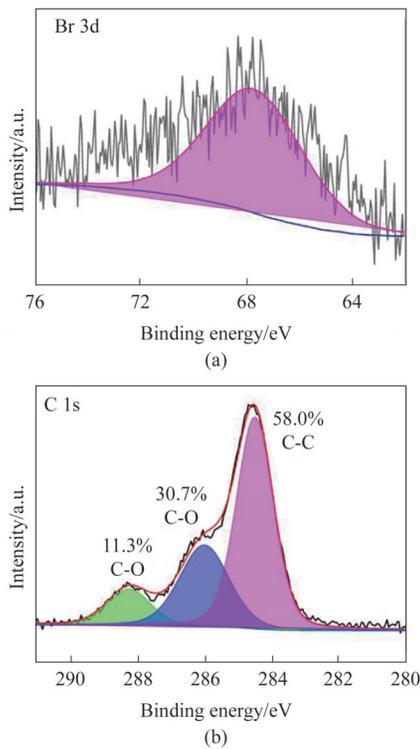
Fig. 7 XPS high-resolution spectrum of Br 3d (a) and C 1s (b)
图7 Br 3d(a)和C 1s(b)的XPS高分辨谱

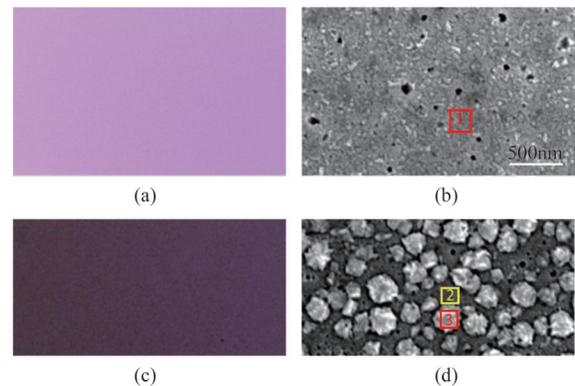
After the passivation film was prepared, another common problem is that the roughness of some areas of some HgCdTe samples is too high, which is manifested as the color is obviously dark (Fig. 8(c)). After the ZnS film removed by hydrochloric acid, the surface morphology of the over-roughness and the normal area was investigated by SEM technology, and the results are shown in Fig. 8. The surface roughness of the normal area is relatively lower, while the surface of the rough area shows obvious large particles. Table 2 presents the results of energy dispersive spectrum (EDS) in normal area (Mark 1 in Fig. 8(b)), non-particle area (Mark 2 in Fig. 8(d)) and particles (Mark 3 in Fig. 8(d)) in over-rough area, respectively. The results demonstrate that the components of these three areas are basically the same. Then, the CdTe film was removed by acid potassium dichromate solution and the morphology was investigated by SEM. The SEM image of normal area is relatively flat, while the surface of the over-rough area has obvious particles

Fig. 8 Typical microscopic images and SEM images of normal area (a), (b), and over-roughness area (c), (d)
图8 正常区域(a), (b)和过粗糙区域(c), (d)显微镜及SEM下观察的表面状态图

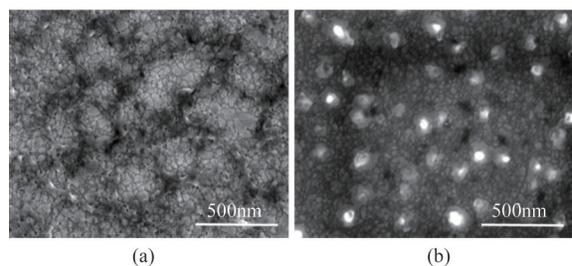
(as shown in Fig. 9). In general, the grains of the passivation film deposited on the surface with small roughness are uniform and compact with lower internal defects. While, the passivation film deposited on the surface with high roughness is porous and loose, showing a higher defect density. During the process of passivation film preparation, on the rough surface of HgCdTe sample, the adsorption energy of adsorbed atom varies greatly, so nuclei are tend to form at the positions with higher adsorption energies, inducing the formation of large particles. For the surface with small roughness, the distribution adsorption position is relatively uniform due to the smaller difference degree of adsorption energy, resulting in the passivation film structure more uniform and compact. Therefore, the phenomenon of over-roughness of passivation film can be ascribed to the larger surface roughness of HgCdTe in this area.

Fig. 9 SEM images of samples after CdTe film removed for normal area (a) and over-roughness area (b)
图9 HgCdTe 晶片正常区域(a)和过粗糙区域(b), CdTe 钝化膜去除后的表面状态图

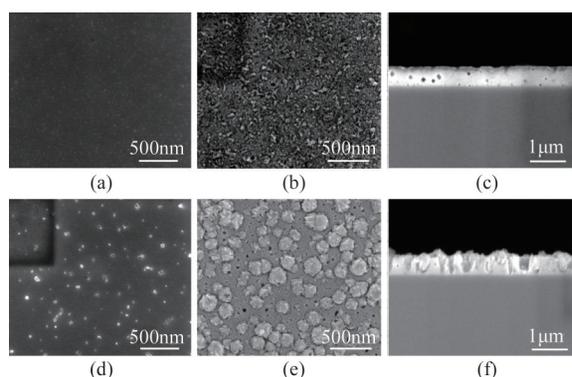
It was observed that the surface roughness of HgCdTe increased significantly when it was immersed in toluene for several hours. For comparison, one HgCdTe sample with uniform surface was evenly divided into two halves and one half was soaked in toluene. Figure 10 shows the SEM images of HgCdTe samples without and with toluene immersion. The surface roughness of the HgCdTe sample without toluene immersion is small, while the sample after toluene immersion shows many large particles, which is consistent with the results in Fig. 9(b). Subsequently, CdTe film and ZnS film were deposited on two samples by conventional process, and ZnS film was removed by hydrochloric acid. Then, the morphology of the as-prepared HgCdTe samples was in-

vestigated by SEM, and the results were shown in Fig. 10 (b) and (e). The surface of sample without toluene immersion is relatively flat and the particle size is small. Additionally, it can be seen from the cross section that there are a few holes in the CdTe film (Fig. 10(c)). While, there are obviously a large number of bigger particles on the surface of sample soaked in toluene (Fig. 10(e)), and these particles are embedded in the CdTe film (Fig. 10(f)), which is similar to the over-roughness phenomenon. It can be concluded that the surface roughness of HgCdTe immersed in toluene increases, which may be caused by a certain interaction between toluene and HgCdTe.

Fig. 10 SEM images of the sample without toluene immersion (a) the surface of HgCdTe, (b) the surface of CdTe, (c) the section structure of CdTe/HgCdTe, and the sample with toluene immersion (d) the surface of HgCdTe, (e) the surface of CdTe, (f) the section structure of CdTe/HgCdTe
图10 HgCdTe 晶片不同条件下的表面状态图, 未浸泡甲苯(a) HgCdTe 表面, (b) CdTe 表面, (c) CdTe/HgCdTe, 截面 SEM 图; 浸泡甲苯: (d) HgCdTe 表面, (e) CdTe 表面, (f) CdTe/HgCdTe 截面 SEM 图

During the preparation of HgCdTe IR detector chip, some organic impurities on the initial surface of HgCdTe should be cleaned by organic reagents, including toluene, acetone and ethanol, before surface polishing. Thus, the over-roughness problem may be due to the direct contact of toluene with the HgCdTe surface. Through the experiment, it was found that by shortening the soaking time of toluene or using trichloroethylene instead of toluene, the over-roughness problem was obviously controlled. However, the interaction mechanism between toluene and HgCdTe still needs to be further studied.
