1064 nm 纳秒激光辐照下 $\text{HfO}_2/\text{SiO}_2$ 增透膜损伤的动态过程研究

Dynamic Damage Process of $\text{HfO}_2/\text{SiO}_2$ Anti-Reflection Coatings Under 1064 nm Nanosecond Laser Irradiation

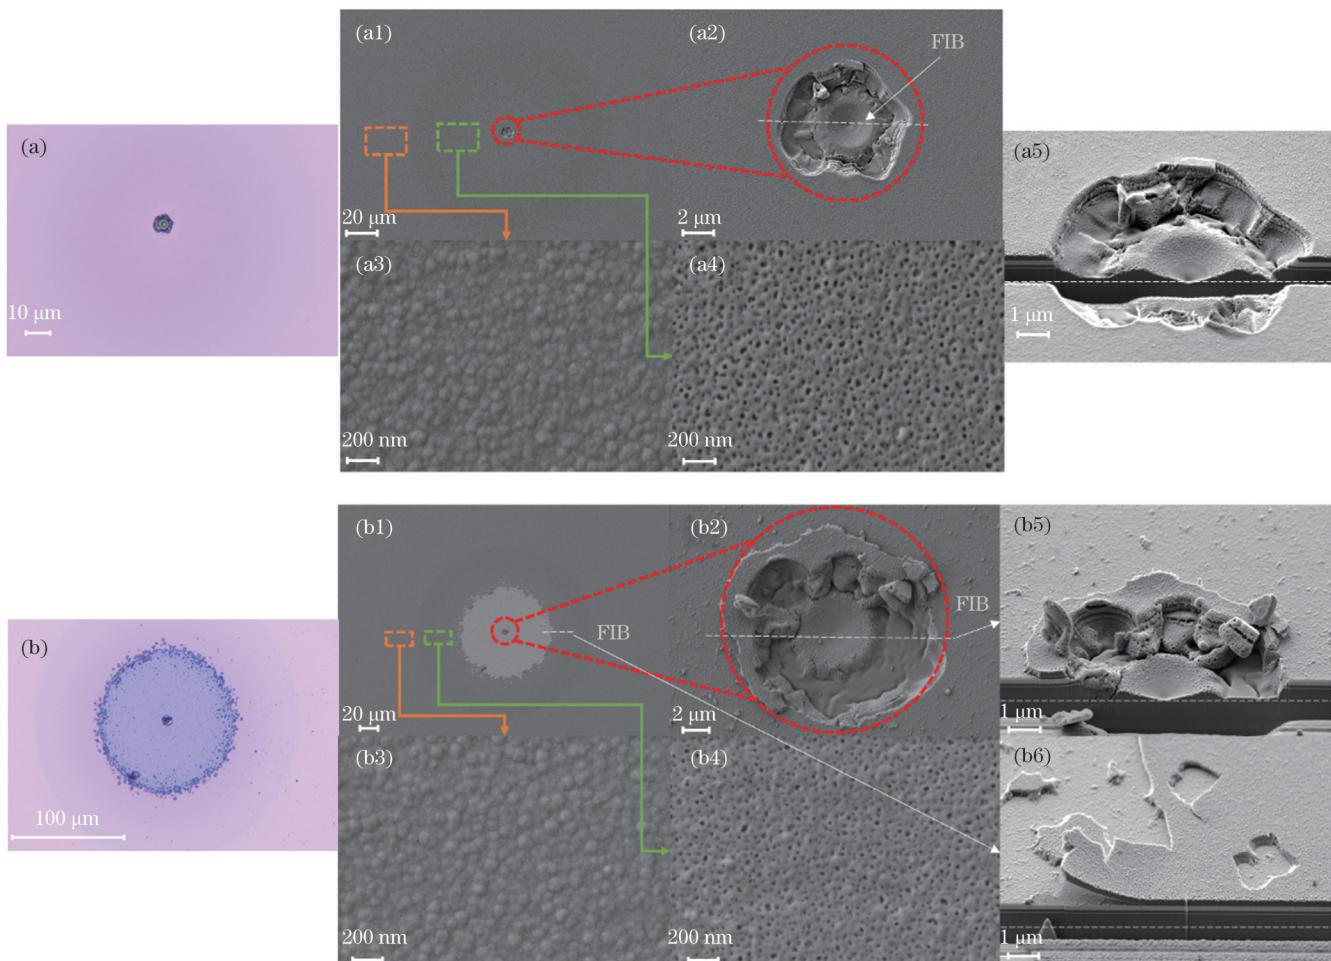
正向过程中的典型损伤形貌主要有两类: 周围无膜层剥落的小坑和周围伴随层剥落的微尺度小坑, 如图 4(a)、(b) 所示。图 4(a) 所示小坑周围有轻微颜色变化区域, 如图 4(a1) 所示, 变色区直径在百微米左右; 图 4(b) 所示小坑首先是直径可达 $\sim 100 \mu\text{m}$ 的圆形膜层剥落区, 剥落区外围还有明显的环形颜色变化区域, 如图 4(b1) 所示。两类损伤的小坑尺寸大小基本为 $7 \sim 10 \mu\text{m}$, 小坑底部中心均有一个圆滑、规整的球冠状凹坑, 呈现明显的熔融、气化特征, 而小坑周围膜层断裂位置粗糙且不规则, 表现出应力破坏特征, 如图 4(a2) 和图 4(b2) 所示。相比于图 4(a3) 和图 4(b3) 所示的未损伤区域, 两类损伤中的颜色变化区

出现许多纳米级的孔洞, 这与等离子体烧蚀密切相关^[27], 如图 4(a4) 和图 4(b4) 所示。利用 FIB 获得上述两损伤小坑的剖面, 如图 4(a5)、(b5)、(b6) 所示, 白色虚线位置处为基底-膜界面, 增透膜膜厚为 837 nm, 可见两类损伤小坑的形成源头均位于膜层与基底界面附近处, 无膜剥落的小坑周围膜层结构完整, 而伴随膜层剥落的小坑, 剥落的只是最表面的 SiO_2 层。

图4 正向过程中的损伤形貌。(a)无膜层剥落的小坑;(b)伴随膜层剥落的小坑;(a1)与(b1)分别为图4(a)和图4(b)的SEM图;(a2)与(b2)分别为图4(a1)和图4(b1)中小坑的放大图;(a3)与(b3)分别为图4(a1)和图4(b1)中虚线框所示未损伤区域的SEM图;(a4)与(b4)分别为图4(a1)和图4(b1)中虚线框所示颜色变化区域的SEM图;(a5)与(b5)分别为图4(a)和图4(b)中的小坑剖面图;(b6)为图4(b1)中白色虚线所示膜层剥落边界的剖面图

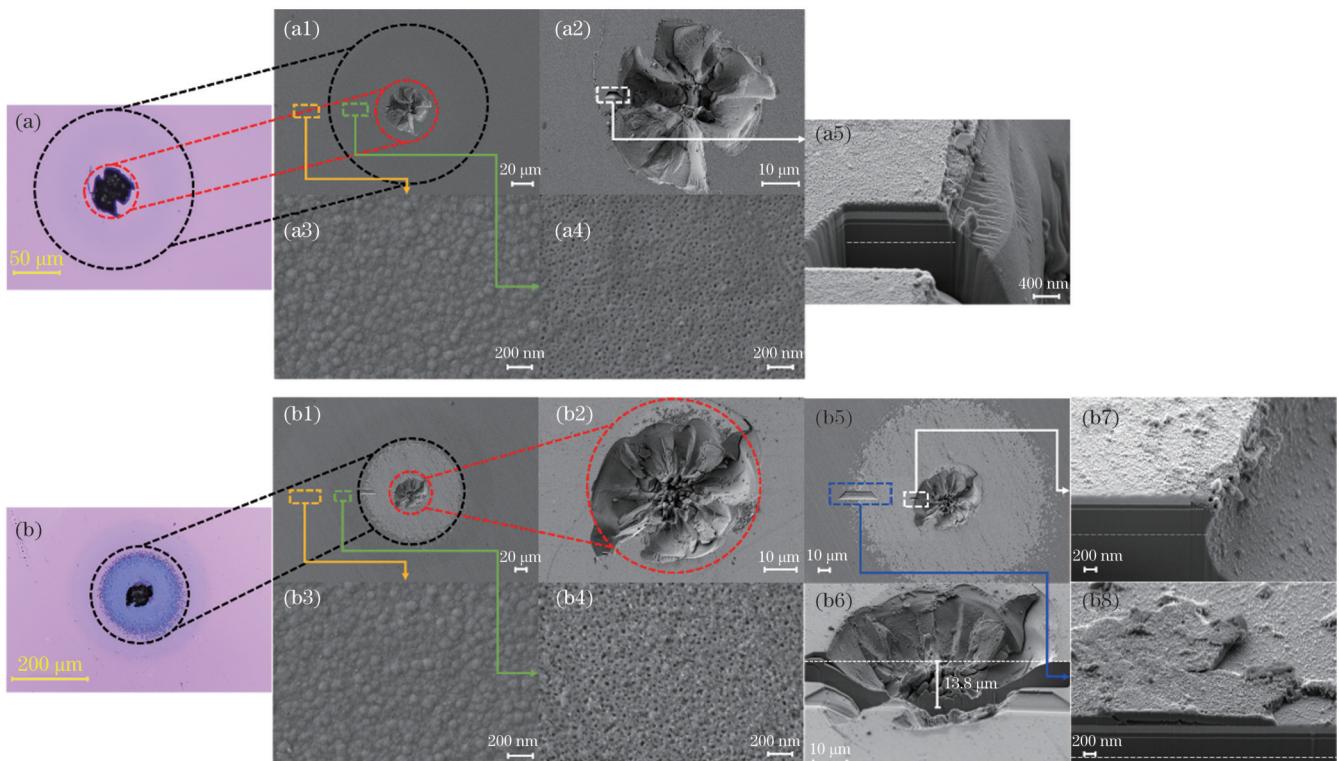
在光学显微镜观察下, 反向过程中的损伤形貌与正向过程类似, 中心位置均有小坑, 损伤程度较轻的周围只是发生轻微颜色变化, 而较为严重的区域出现了膜层剥落, 如图 5(a) 和图 5(b) 所示。利用 SEM 进行进一步分析, 两类损伤的凹坑尺寸都为 $40 \sim 80 \mu\text{m}$, 相较于正向过程中的小坑尺寸明显增大; 此外小坑底部没有类似的球冠状凹坑, 整个结构均表现出力学破坏特征, 并且中心区域都深入基底, 这与熔石英出射面的损伤形貌基本一致^[28], 如图 5(a2) 和图 5(b2) 所示。相比于图 5(a3) 和图 5(b3) 中的未损伤区域, 两类损伤中的颜色变化区域也是等离子体烧蚀的孔洞, 如图 5(a4) 和图 5(b4) 所示。利用 FIB 获得上述两损伤小坑的剖面, 如图 5(a5)、(b6)、(b7)、(b8) 所示, 两类损伤凹坑中心深度为 $\sim 15 \mu\text{m}$, 比正向过程中的小坑深

度大得多,对于伴随膜层剥落的坑,也是表面的 SiO_2 层发生脱落。

图 5 反向过程中的损伤形貌。(a)无膜层剥落的小坑;(b)伴随膜层剥落的小坑;(a1)与(b1)分别为图 5(a)和图 5(b)的 SEM 图;(a2)与(b2)分别为图 5(a1)和图 5(b1)中小坑的放大图;(a3)与(b3)分别为图 5(a1)和图 5(b1)中虚线框所示未损伤区域的 SEM 图;(a4)与(b4)分别为图 5(a1)和图 5(b1)中虚线框所示颜色变化区域的 SEM 图;(a5)为图 5(a2)中白色虚线框所示小坑边界的剖面图;(b5)为(b1)中层剥落小坑局部 FIB 后的表面 SEM 图;(b6)为图 5(b2)中小坑的剖面图;(b7)为图 5(b5)中白色虚线框所示小坑边界的剖面图;(b8)为图 5(b5)中虚线框所示层剥落边界的剖面图

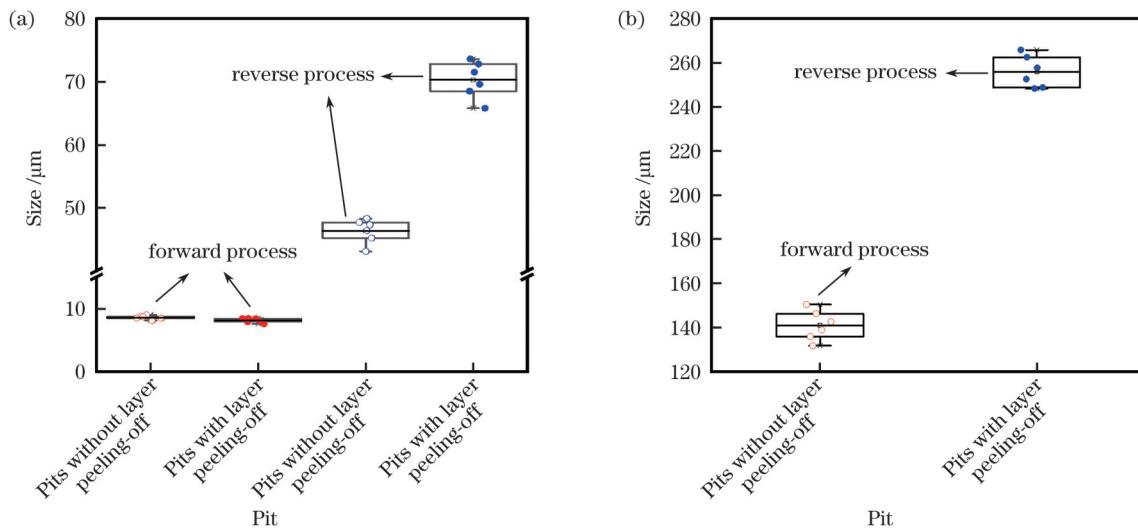
基于以上对损伤形貌的分析,统计了各类损伤小坑以及剥落膜层的尺寸大小,如图6所示。在正向过程中,无论是否有膜层剥落,中心小坑尺寸都为7~10 μm ;而在反向过程中,中心小坑尺寸为40~80 μm ,明显大于正向过程中的小坑,其中伴随膜层剥落的小坑尺寸稍大于无膜层剥落的小坑尺寸,如图6(a)所示。对于膜层剥落尺寸的大小,正向过程中膜层剥落的尺寸为150~160 μm ,而反向过程中膜层剥落的尺寸比正向过程的大,尺寸为240~280 μm ,如图6(b)所示。

图 6 各类损伤小坑以及剥落膜层的尺寸大小统计。(a)损伤中心小坑;(b)剥落膜层

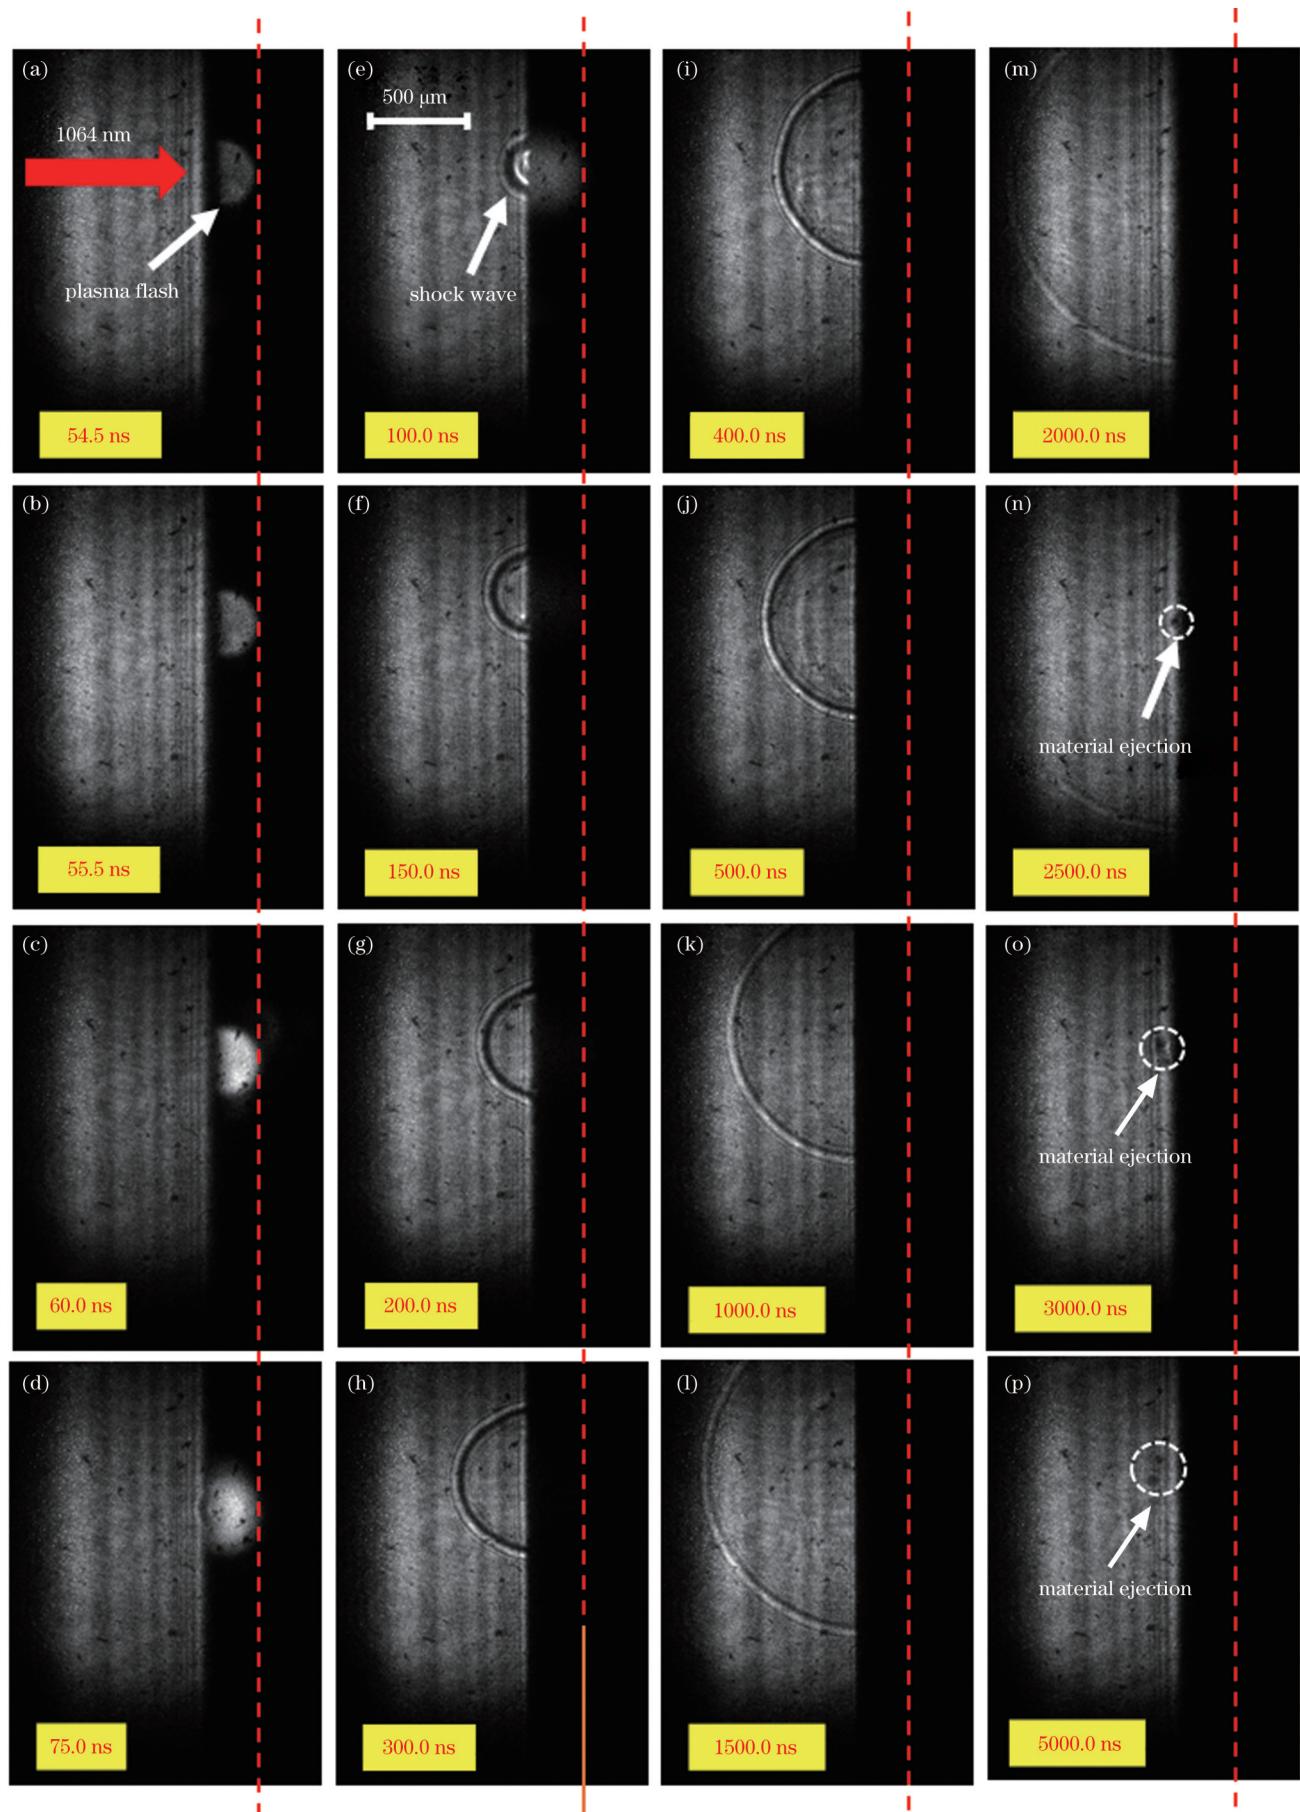
对于正向过程,伴随膜层剥落的小坑的损伤动态过程如图7所示。由于探测光的相干性,探测光经过样品边缘处形成衍射区域,图7中的虚线对应于样品表面。当ICCD快门触发信号与泵浦激光触发信号之间的延时为54.5~100.0 ns时,可以观察到等离子体闪光,等离子体闪光呈半圆形,直径为300~400 μm ;等离子体闪光在延时为~60.0 ns时达到最强并在延时为100.0 ns时消失,其持续时间比激光脉冲长,在这个过程中等离子体逐渐远离膜层,这与激光诱导等离子体逆着激光入射方向发展的表现是一致的^[29]。延时

图 7 正向过程中伴随膜层剥落的小坑的损伤动态过程
Fig. 7 Damage dynamic process of pits with layer peeling-off in forward process

75.0 ns 后可看到冲击波开始形成并以球状在空气中扩展，一直持续到超出拍摄视场范围，延时达到 2500.0 ns 时发现有材料开始喷射，喷射的持续时间可能较长，在 5000.0 ns 时依然可以拍摄到。

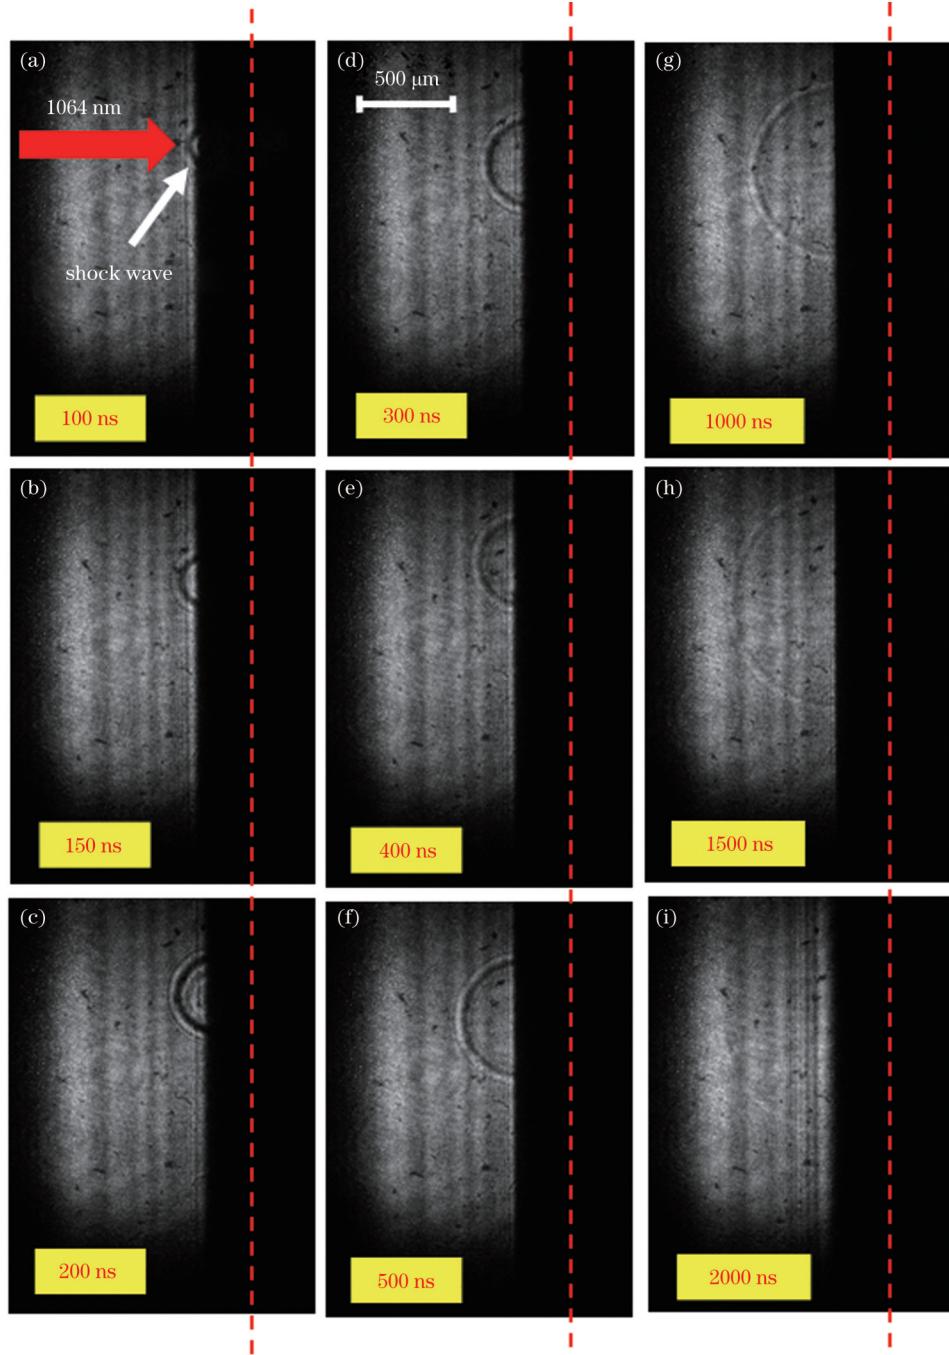
正向过程中无膜层剥落的小坑的损伤动态过程如图 8 所示。相比于有膜层剥落的损伤形貌，在该类损

伤形成过程中没有观察到等离子体闪光，并且冲击波出现在延时 100.0 ns 后，比有膜层剥落时的晚了约 25.0 ns。另一个明显的区别是冲击波传播速度，同一延时下拍摄到的该形貌对应的冲击波半径尺寸较小，同时随着时间的推移，冲击波强度迅速衰减。此外，在该损伤过程中未观察到材料喷射。

图 8 正向过程中无膜层剥落的小坑的损伤动态过程

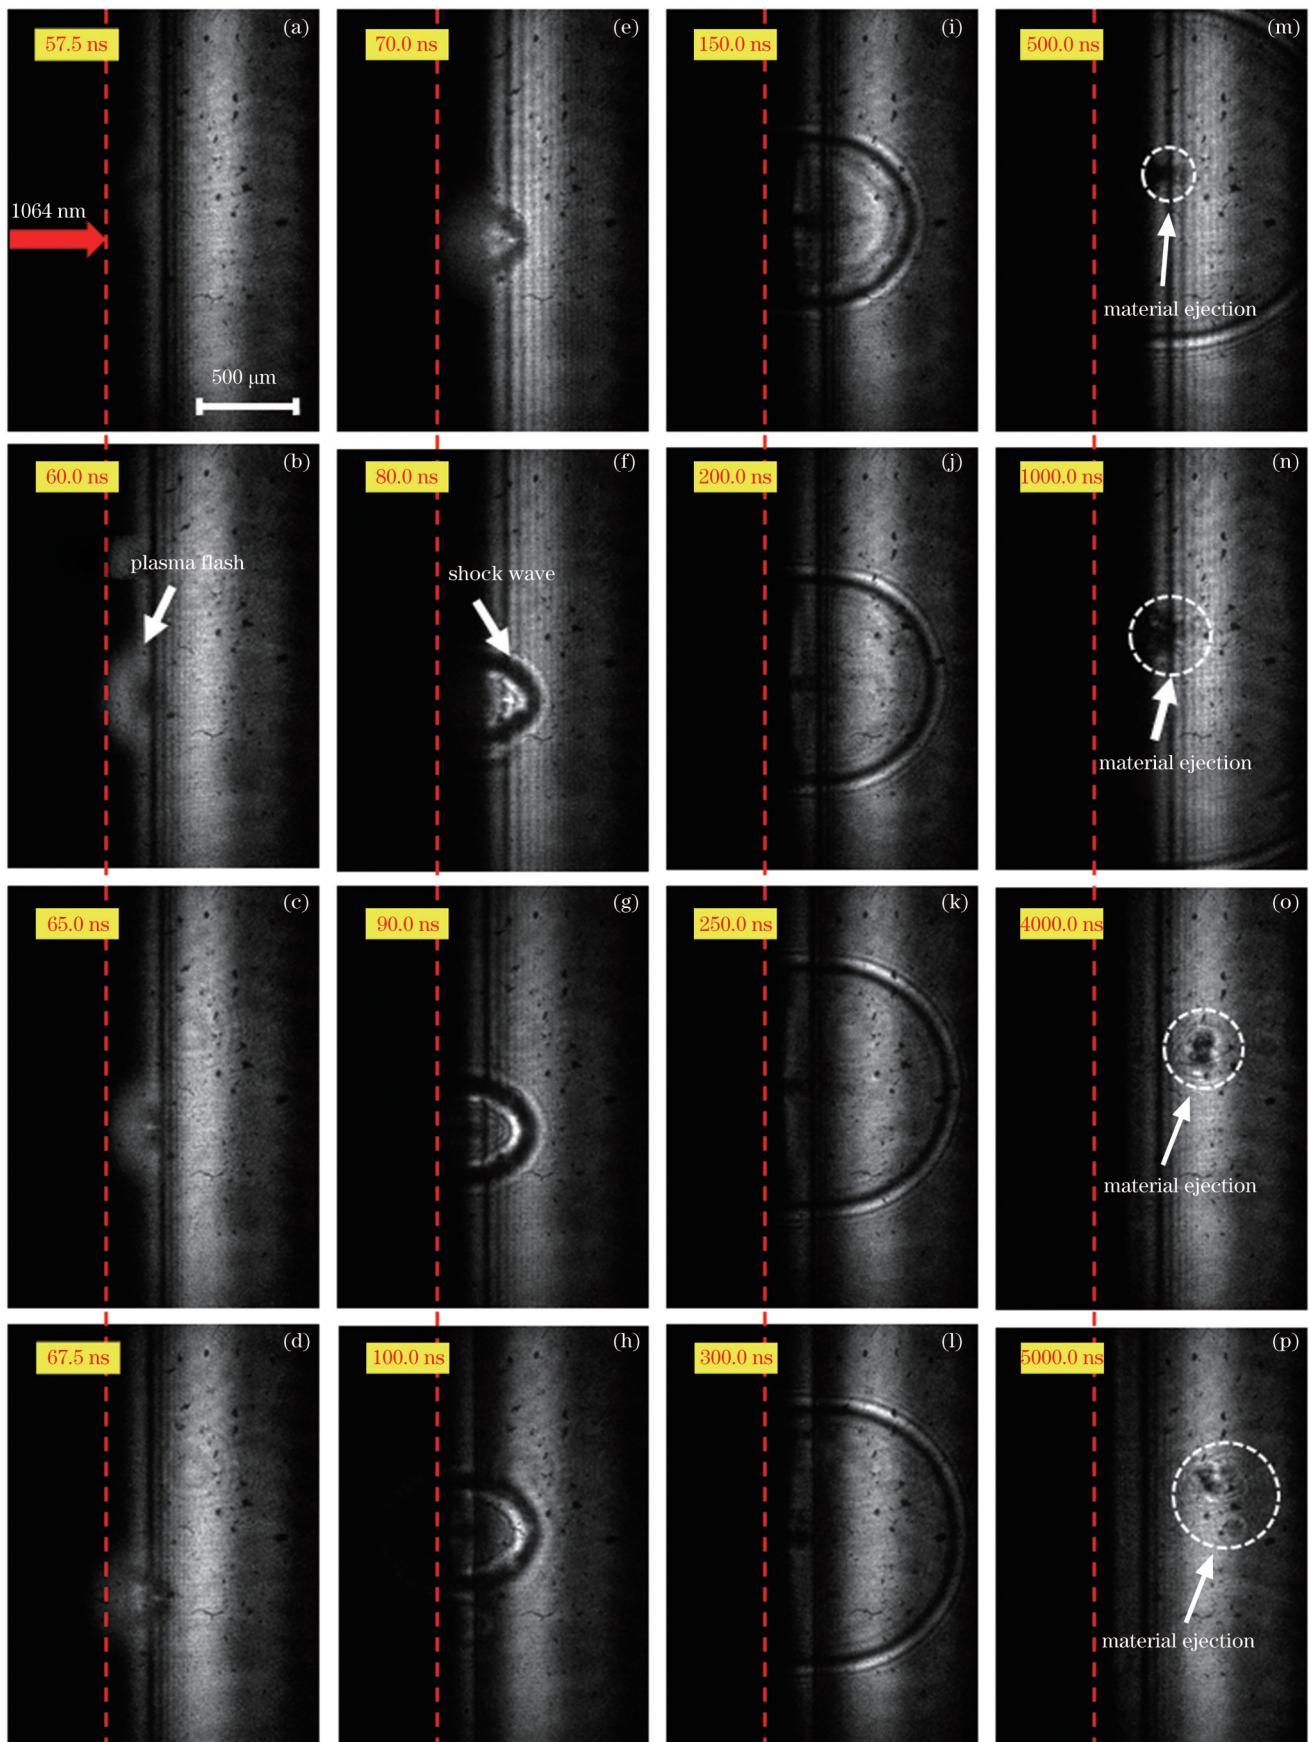
反向过程所对应的两类不同损伤形貌的动态过程分别如图 9 和图 10 所示。伴随有膜层剥落的小坑的损伤动态过程如图 9 所示。在 60.0~67.5 ns 延时范围内有着明显的等离子体闪光现象，直径为 300~400 μm 。但是与膜层位于激光入射面时相比，等离子体闪光出

现得较晚、强度较弱并且持续时间较短。在延时为 70.0 ns 时开始出现冲击波，致密不透明等离子体在损伤中心处出现喷射，随后这些喷射的不透明等离子体与冲击波分离，并在等离子体羽流内部迅速消失。在延时 500.0 ns 之后，开始出现材料喷射，整个喷射过程

图 9 反向过程中伴随膜层剥落的小坑的损伤动态过程
Fig. 9 Dynamic damage process of pits with layer peeling-off in reverse process

持续数十微秒,大量的材料以喷射方式脱离样品表面。

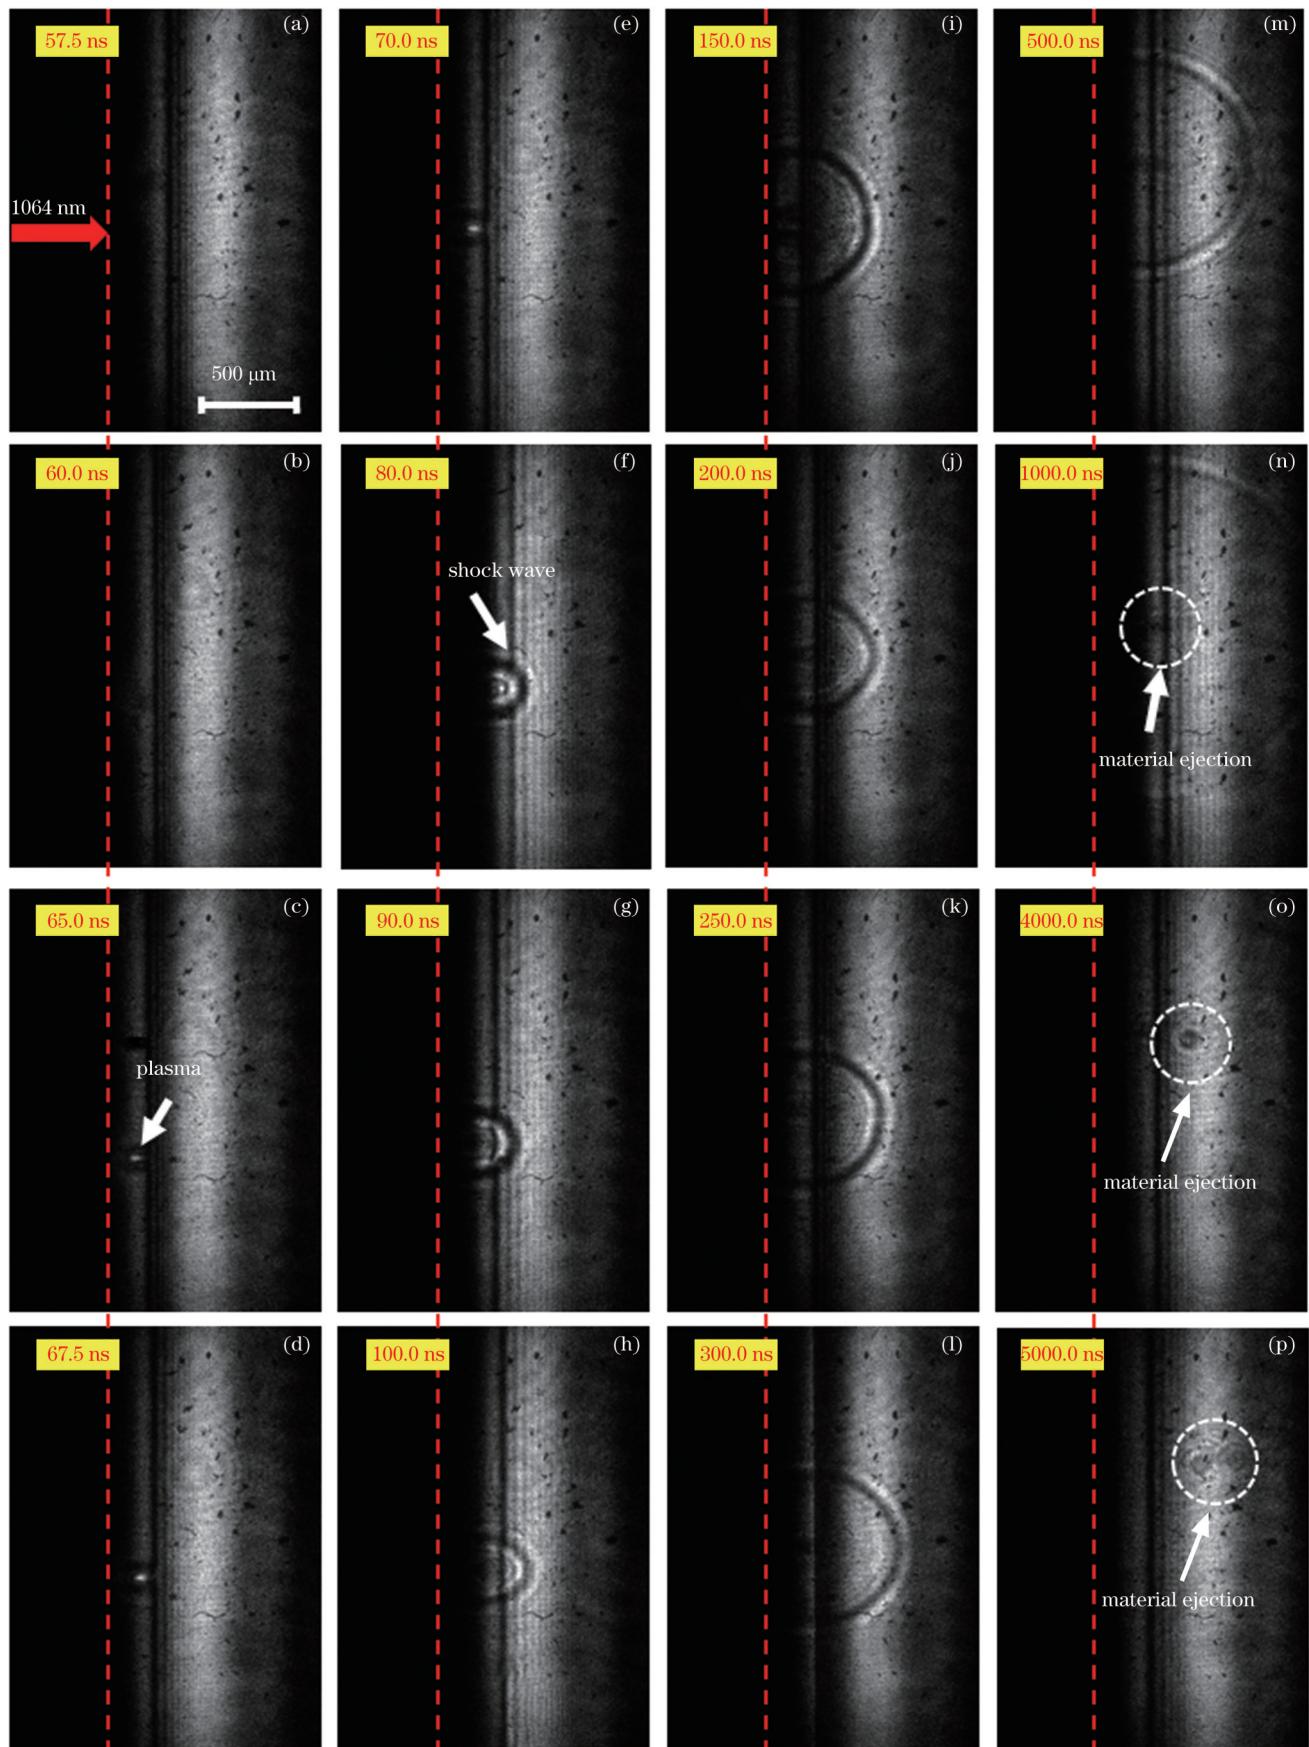
图 10 反向过程中无膜层剥落的小坑的损伤动态过程

无膜层剥落的小坑的损伤动态过程如图 10 所示,在整个过程中都未观察到大尺寸的等离子体闪光,在延时为 65.0 ns 时出现点状闪光并逐渐远离膜面,延时为 80.0 ns 时形成冲击波,延时达到 100.0 ns 时等离子体闪光消失,随后出现材料的喷射现象,但与有膜层剥落的小坑相比,其冲击波传播较缓慢。

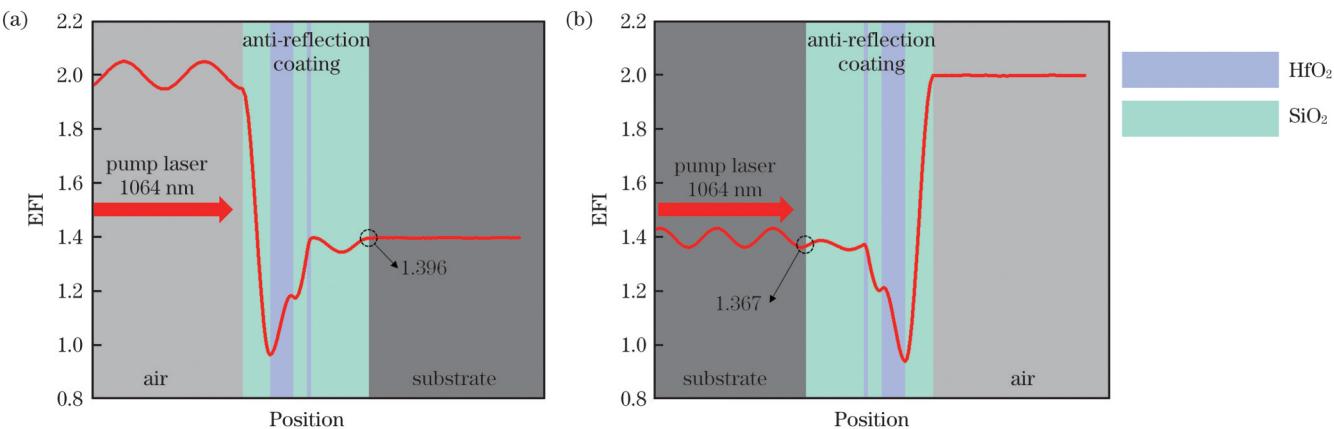
实验中使用的辐照激光的脉冲能量密度一致,并且膜层在辐照激光波段高透,脉冲能量大部分能够穿过膜层,但反向过程中的损伤更明显、损伤尺寸更大。我们利用有限元分析方法仿真了两种激光入射方式下的电场分布,如图 11 所示。其中:图 11(a)为正向过程中的场强分布,基底-膜层界面处的场强(EFI)为 1.396;图 11(b)为反向过程中的场强分布,可以看到基底-膜界面处的相对场强为 1.367。这里为了便于比较,对电场强度作了归一化处理。由电场仿真结果可以看出,膜层位于入射面与出射面时的电场强度差别较小,不足以形成损伤形貌差异。

图 11 增透膜正向和反向过程电场仿真。(a)正向过程;(b)反向过程

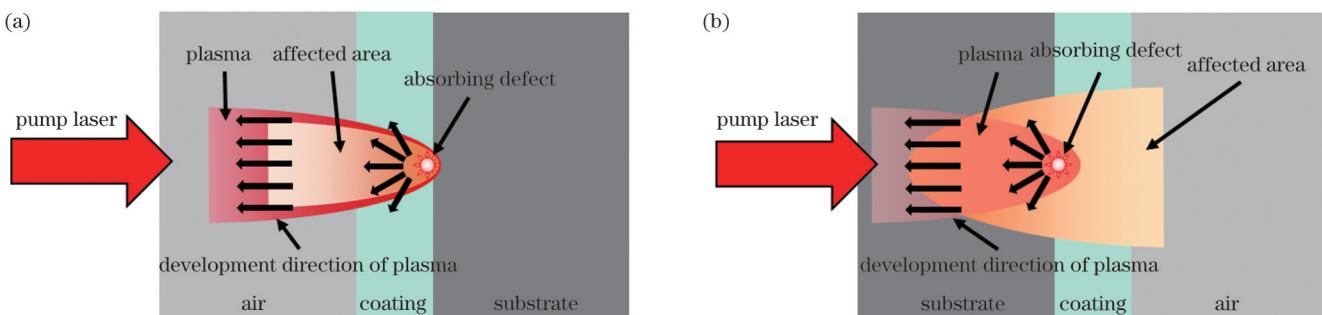
由获得的损伤动态过程可知,在伴随层剥落的动态过程中都能观察到等离子体闪光现象,反向过程中等离子体闪光的强度较弱,如图 7(a)~(e)和图 9(b)~(e)所示。此外,反向过程中发现有大量致密不透明等离子体喷射并且迅速消失,如图 9(e)~(i)和图 10(f)~(k)所示。相比于正向过程,反向过程中还有着大量的粒子喷射,如图 9(m)~(p)和图 10(n)~(p)所示。当激光脉冲辐照时,膜层与基底界面处的杂质或缺陷吸收能量形成相变,并可能进一步吸收能量形成等离子体,这些通常在脉冲辐照后的前几个纳秒时间内完成。等离子体内部具有密度极高的自由电子及正离子,对辐照光束具有较强的吸收作用,又因为等离子体会逆着激光入射方向发展,这样正向过程中的等离子体阻挡了脉冲后续能量的传递,膜层及基底只吸收了激光脉冲的一部分能量,只有面对激光的部分等离子体才能吸收能量以维持等离子态,因此等离子体闪光也较强,而接近样品表面的部分逐渐湮灭,这使得等离子体远离膜面,如图 12(a)所示,在一定程度上降低了正向过程中的损伤程度。

对于将膜面置于激光出射面的反向过程,激光脉冲自基底向薄膜辐照,也同样由于等离子体逆着激光入射方向向基底发展,等离子体吸收的激光能量将在基底内部大量沉积,该过程中的热力耦合以及击穿效应使得周围更多的材料离化喷出,从而形成更大、更深的损伤区域,如图 12(b)所示。因此,两种辐照条件下损伤形貌差异较大的主要原因是激光诱导薄膜损伤过程中形成的等离子体会逆着激光入射方向发展,正向过程中等离子体阻挡激光后续能量传递至薄膜表面,而反向过程中等离子体阻挡激光后续能量在材料内部大量沉积,从而造成两个过程中材料沉积的能量差异较大,因此两种辐照条件下薄膜损伤形貌的差异较大。

图 12 等离子体对激光脉冲的屏蔽作用。(a)正向过程;(b)反向过程

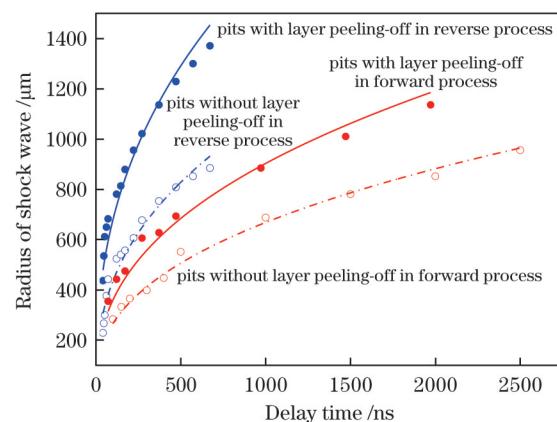
式中: Φ 是常数, 约等于 1; E_s 是冲击波的能量; ρ 是空气密度, 约等于 1.2 kg/m^3 ; t 是冲击波传播的时间; β 是冲击波传播的维度, 球面传播的 $\beta = 3$ 。基于 3.2 节中的损伤过程, 通过解析记录图片, 统计不同辐照方式、不同损伤形貌下的冲击波传播时间与距离, 结果如图 13 所示。随着等离子体的膨胀, 由于受到空气的阻力, 冲击波半径 R 的增长速度放缓, 冲击波的波前速度逐渐减小。将图 13 获得的数据代入式(1), 计算相应的爆炸能量, 结果如表 1 所示。该计算结果表明, 无论是正向过程还是反向过程, 有膜层剥落时损伤吸收的能量都大于无剥落时, 正向过程中有膜层剥落时损伤吸收的能量是无膜层剥落时的 4 倍, 反向过程中有膜层剥落时损伤吸收的能量是无膜层剥落时的 9.12 倍, 多吸收的能量用于激发更强的等离子体并促成膜层剥落。激光辐照方式的影响更加明显, 同样是无膜层剥落的损伤过程, 反向过程吸收的能量是正向过程的 10.5 倍, 而对于有膜层剥落的损伤过程, 这个比例提升至

23.93。由此可见激光入射方向对损伤过程的影响, 多吸收的这部分能量促使更多的材料熔化气化甚至击穿形成等离子体完成质量迁移, 由此导致更大尺寸的损伤区域。

图 13 不同损伤形貌对应的冲击波半径随时间变化的曲线(点和圈表示数据, 线表示拟合线)
