Laser Repair of Steam Turbine Blades

(Invited Paper)

M. Brandt¹ S. Sun^{1,2} A. Bishop²

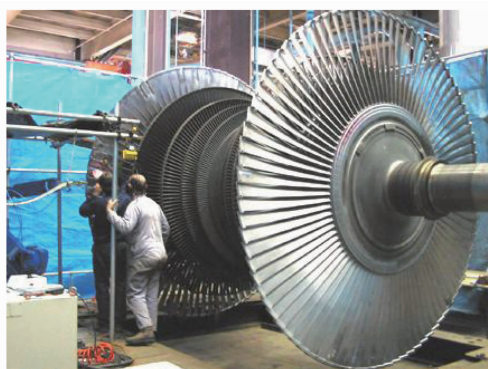
Fig. 1 Typical low pressure stage from a 200-MW turbine showing the blades

Researchers have investigated the potential of repairing erosion damaged turbine blades by laser cladding^[1~4]. We have achieved this, however, with the increased complexity of cladding blades while they are still attached to the low pressure rotor (total mass 27 tonnes) and located at the power station (that is, in-situ). A 3-kW fibre delivered Laserline diode laser, a Sulzer Metco powder feeder, and a Motoman robot integrated to apply the laser clad to the laser pressure (LP) turbine rotor suspended in a cradle, is shown in Fig. 1. The arrangement of the largest (last row) blades demonstrates the near vertical surfaces and restricted space in which the clad is applied.

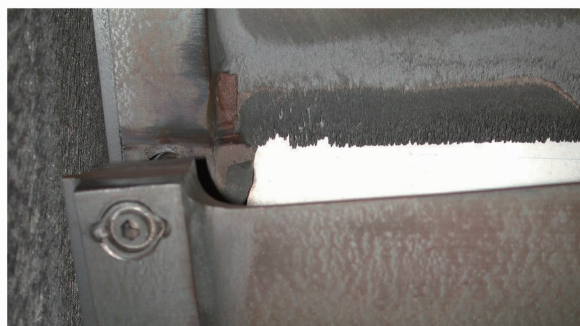
Fig. 2 Erosion of the blade after some eight to ten years of operation

Water droplet erosion has been known for some time, and one of the methods for the manufacturers to overcome is to add a shield to the blades in the area where there is erosion. Of those materials tried as a shield, Stellite 6 has proved to be successful. Stellite 6 is a cobalt based material with nominally 28% Cr, 4.5% W, 1.2% C, 1% Mn, 3% Ni, and 3% Fe. It is often used as pressed and sintered part and is attached to the blade using a silver brazing alloy. This has proven to extend the life of the blades considerably, but over time the shield also erodes, as shown in Fig. 2. Consequently, blades need to be completely replaced or new shields need to be fitted. In either event, the blades have to be removed from the shaft.

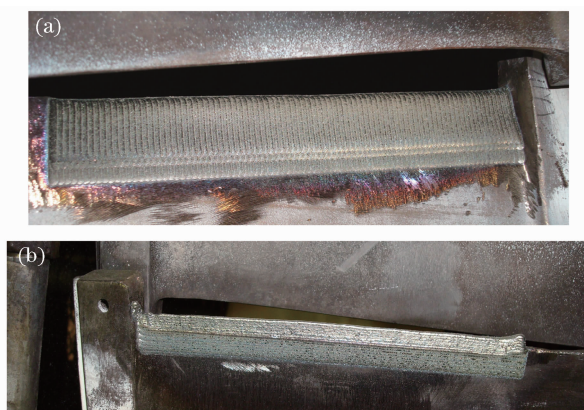
Fig. 4 Laser clad blades with (a) front view and (b) rear view before processing to original profile

The blades were cladded on the rear (trailing) surface near leading edge. The front surface and the top or leading edge after the original worn edge shields were removed. The sequence and direction of cladding used facilitated minimal distortion while providing a wide enough build up to facilitate the reconstruction of the leading edge. Finally, the ground and the original profile of the blade restored. Figures 4(a) and (b) show the blades after cladding.
