Experimental study on characteristics of nanosecond laser-induced damage on optical elements

To study how laser pulse wavelength will affect the damage characteristics of optical elements with different degrees of contamination, we compare the extent of damage on optical glass between nanosecond pulsed laser of 1064 and 355 nm wavelength, respectively, and reach the following conclusions: the surface quality of clean optical elements determines its own anti-laser damage capability; the damage probability of optical sample caused by ultraviolet radiation-induced organic contamination is much higher than the infrared radiation-induced one; and contaminated metal particles can lower damage threshold of optical elements by 2–3 times.

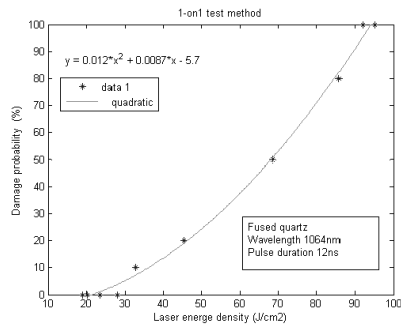
Fig. 2. Fitting curve of damage threshold and probability of fused silica by 1064 nm laser pulse in vacuum.

We used lasers of 1064 and 355 nm wavelengths on fused silica glass samples to determine its “zero chance of damage thresholds.” Measurement method is the one-on-one method, corresponding to each of the laser energy, 10 points of the same optical sample were irradiated, a total of 10 kinds of energy result in a total of 100 measurement points. Then we observed these damage points under microscope. The results are shown in Figs. 2 and 3.

Figure 2 shows the result of a 1064 nm wavelength laser. The solution to the fitting curve equation leads to the “zero chance of damage threshold” of fused silica with energy density $E_{th} = 22 \text{ J/cm}^2$.

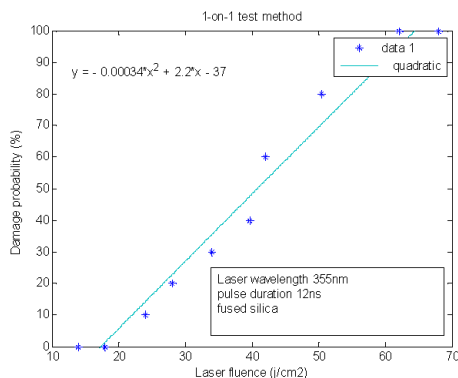
Fig. 3. Fitting curve of damage threshold and probability of fused silica by 355 nm laser pulse in vacuum.

Figure 3 shows the result of a 355 nm wavelength laser. Solution to the equation leads to 18 J/cm^2 for the “zero chance of damage threshold” of fused silica. Analyzing from the thermal injury mechanism, the reason for a lower damage threshold of fused silica with 355 nm wavelength laser irradiation than with 1064 nm wavelength laser irradiation is that fused silica’s absorption rate of 355 nm laser is nearly 6–7 times greater than that of 1064 nm laser^[13].

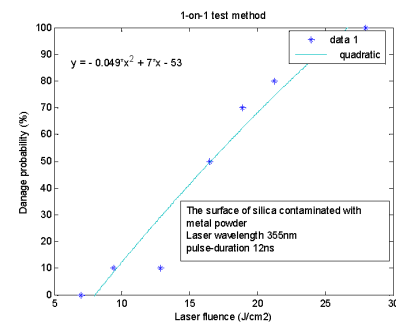
Fig. 6. Damage probability of metal particle contaminated fused silica sample

Except different laser wavelengths, we used same conditions as above. We used one-on-one method to test the damage probability of quartz sample with metal contamination. Compared with above experiment, the damage threshold induced by two kinds of wavelength is similar, as shown in Fig. 6.

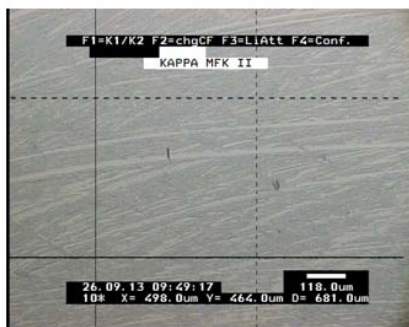
Fig. 9. Fomblin vacuum grease-coated optical sample surface.

Sample C: Surface coated with a layer of Fomblin vacuum grease, see Fig. 9.

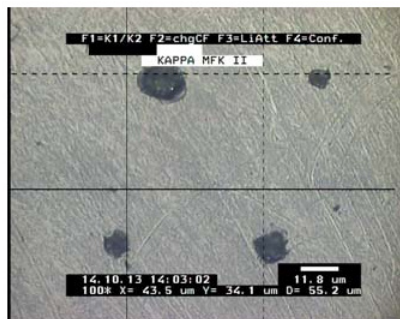
Fig. 10. UV radiation-induced damage of fused silica samples with vacuum grease contamination (one-on-one testing method).

Damaged sample is shown Fig. 10
