## 2.79 $\mu\text{m}$ 中红外激光对 CMOS 图像传感器的辐照效应研究

## Irradiation effect of 2.79 $\mu\text{m}$ mid-infrared laser on CMOS image sensor

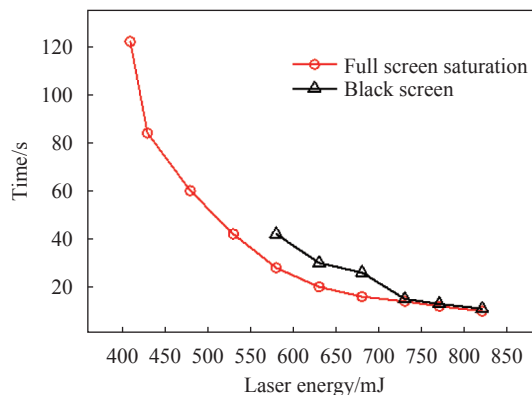
激光能量不经聚焦直接辐照到 CMOS 图像传感器上,传感器处光斑直径为 8 mm。在激光重频 5 Hz 辐照下,随着激光能量的提高,图像传感器出现了激光干扰:饱和现象和过饱和现象,两种激光干扰现象出现的时间随入射能量的变化情况如图 3 所示。当激光能量为 390 mJ 时,对应的激光能量密度为 0.76 J/cm<sup>2</sup>,经过 122 s 的辐照,传感器出现全屏饱和现象,即全屏白色。当激光能量提高到 580 mJ 时,对应的能量密度为 1.15 J/cm<sup>2</sup>,经过 30 s 的辐照出现饱和现象,42 s

图 3 干扰现象随激光能量的变化情况 (重频 5 Hz)

Fig.3 Time of irradiation effect vs laser energy (Repetition frequency 5 Hz)

**Results and Discussions** The experimental results of laser interference show that saturation and oversaturation appears on the CMOS image sensor with the increase of laser energy (Fig.3). After stopping laser irradiation for a period of time, CMOS can automatically return to the normal working state. The experimental results show that with the increase of the repetition frequency, CMOS image sensor needs less laser energy and less time to achieve
