## Experiment into Nondestructive Testing of Rail Foot Cracks Using Infrared Thermal Waves

**Abstract:** At present, ultrasonic testing is widely used in rail crack detection. However, in the process of rail crack detection, there is a certain blind spot in this method, and cracks on both sides of the rail foot are not detected. Aiming at these shortcomings, an infrared thermal wave nondestructive testing platform for detecting cracks on the rail foot is proposed in this paper. Infrared thermal wave nondestructive testing for rail cracks is a new research area in the field of infrared nondestructive testing, and the establishment of the experimental platform mainly includes three parts: the selection of the thermal excitation source, the construction of the experimental platform, and the extraction of the infrared images. The technology is used to heat the surface of the rail foot through a thermal excitation source. According to the wave theory of the heat transfer from the surface to the inside of the rail foot, the transfer process can be affected by the rail's physical characteristics and internal structure. If there are defects inside the rail, the distribution of the tempera

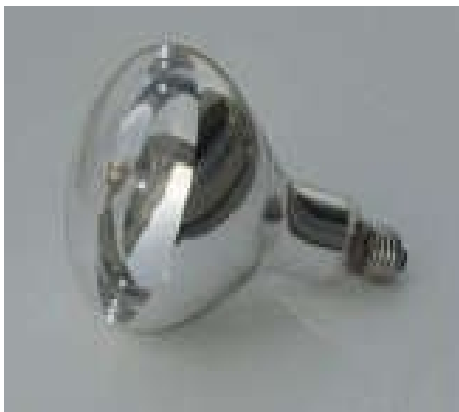
Fig. 1 Halogen lamp

are selected to heat the rail bottom surface, and an infrared thermal imager is used to collect the thermal wave signal from it. According to the temperature distribution of the rail bottom surface, an appropriate thermal excitation source is selected. Traditional thermal excitation sources include high-energy flash lamps, U-type xenon flash lamps, lasers, halogen lamps, and hot air. A halogen lamp is shown in Figure 1, and a U-type xenon flash lamp is shown in Figure 2.

By comparing and analyzing the heating effect of the two kinds of thermal excitation source, such as the heating time required for the rail foot surface to reach the same temperature and the temperature achieved at the rail foot surface with the same time, it can be shown that the requirements for infrared thermal wave non-destructive testing of active rail bottom cracks can be met using the halogen lamp as the thermal excitation source. Compared with the U-type xenon flash lamp, it can operate at a higher temperature, and the efficiency in

heating the rail foot surface as a thermal excitation source is higher. A halogen lamp only transforms 6% to 10% of electrical energy into light energy, and the remaining part is converted into heat energy. Moreover, a halogen lamp has the advantages of low cost, long service life, good seismic resistance, and easy heat control, which is more suitable for the infrared thermal wave detection system of rail bottom cracks. The halogen lamp can transfer different heat energies according to the length of the heating time. The maximum energy of the halogen lamp is 4500 J, and the minimum energy is 700 J<sup>[5]</sup>.

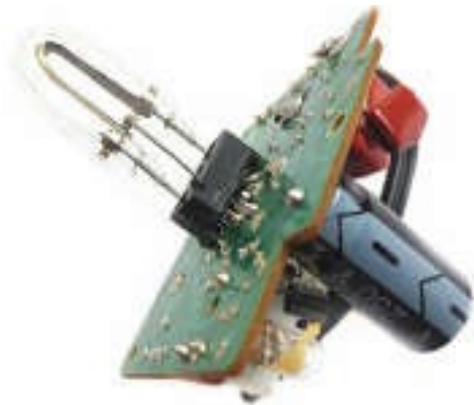
Fig. 2 U-type xenon flash lamp

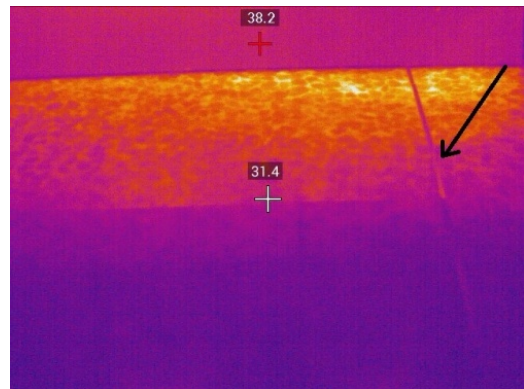
Fig. 3 Infrared image of halogen lamp heating

The infrared image obtained by heating with the halogen lamp is shown in Figure 3, and that obtained by heating with the U-type xenon flash is shown in Figure 4. The crack center temperature can reach 25.9 °C using a U-type xenon flash lamp as the thermal excitation source, and 38.2 °C using a halogen lamp.

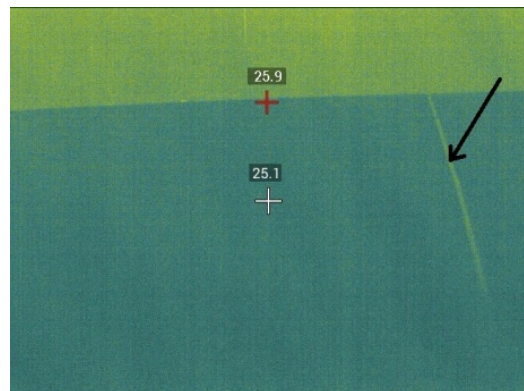
Fig.4 Infrared image heated by U-type xenon flash

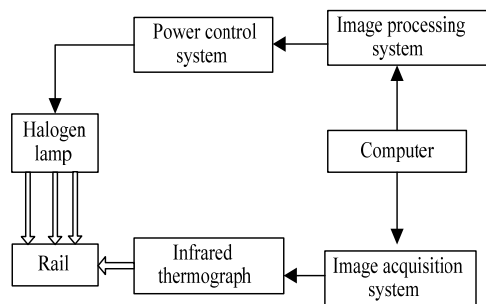
Fig.5 Block diagram of infrared thermal wave nondestructive testing of rail foot crack in active rail

The experimental block diagram is shown in Figure 5. The detection process of the system uses a 1000 W halogen lamp for actively heating the rail foot surface, and the heat flow transfers from the surface to the rail interior. After heating is completed, an infrared thermal image of the rail foot surface is collected by the infrared thermal imager. The infrared thermal image of the rail foot crack collected by the online infrared image analysis software in the computer is processed according to the temperature in the thermal image and is used to determine whether there are defects in the rail foot.

As shown in Figure 5, an experimental platform for non-destructive infrared thermal wave detection of rail foot cracks in active rails has been built, and the procedural steps for the experimental platform are as follows:

- Installation of halogen lamps. Hang two 1000 W halogen lamps on the lamp cylinder pole, erect a tripod at each end of the lamp cylinder pole and fix the lamp cylinder pole across it. Adjust the height of the tripods and the angle of the halogen lamps to aim the halogen lamps at the surface of the rail foot, at the crack.

- Set-up of the infrared thermal imager. The cracks are detected by an ordinary lens and two macro lenses (50 and 100 mm). The quality of the image acquisition is closely related to the location of the infrared thermal imager and the selection of the lens.

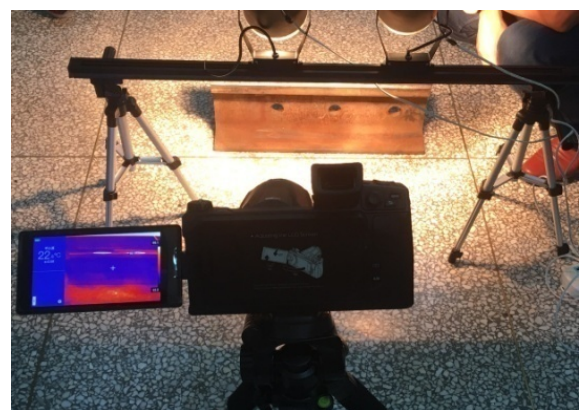
Fig.6 Experimental photo of infrared thermal wave nondestructive testing of rail foot cracks

After the set-up of the infrared thermal wave nondestructive testing system for rail bottom cracks, the system needs to be debugged. First, turn on the thermal imager and start the on-line infrared thermal image analysis software on the computer. When the thermal imager is in a stable working mode, observe whether the thermal image displayed by the computer in real-time meets the requirements of the rail bottom crack detection experiment. According to the different detection methods used, the infrared thermal wave nondestructive testing experiment for rail bottom cracks can be split into single-sided and double-sided detection methods. The single-sided detection method has the thermal excitation source and the infrared thermal imager on the same side of the rail. The double-sided detection method has the thermal excitation source and the infrared thermal imager on opposite sides of the rail. However, due to the real-time requirements of rail bottom crack detection, the thermal imager and the thermal excitation source must be on the same side. In this paper, the single-sided detection method is used to collect the infrared thermal images of rail bottom cracks. The experimental platform for infrared thermal wave nondestructive testing of rail bottom cracks based on this active method is shown in Figure 6.

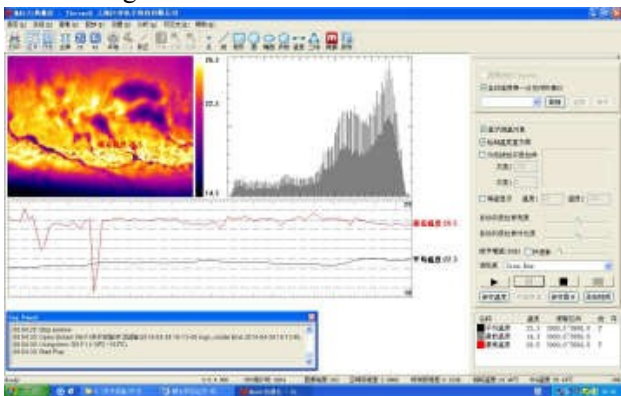
Fig.7 Interface screenshot of rail foot crack infrared image analysis software

The infrared image of the rail crack was analyzed online. ThermoX infrared image online analysis software was opened on the computer, the infrared image of the rail foot crack was input, and the temperature distribution in the image was analyzed. The interface screenshot of the online rail crack infrared image analysis software is shown in Figure 7.

The results of the on-line analysis of the rail foot crack infrared images are also shown in Figure 7. The upper left corner of the image shows the infrared image video and dynamic histogram. From this module, it can be seen that the highest temperature point is at the crack in the rail bottom. Over the whole image, the highest temperature point reached 26.7°C, and the lowest temperature point was 14.1°C. Looking at the temperature distribution information in the image, it is

easy to determine the position and shape of the internal crack in the rail foot. The upper right corner of the figure is the set-up control area for the thermal imager, where it is possible to choose the interface mode between the thermal imager and the computer. The lower-left corner of the image is the real-time temperature curve of the rail bottom crack image. The highest temperature value of the real-time curve shown in red is 26.7°C, and the average temperature value of the real-time curve shown in black is 22°C, The lower right corner of the image is the image saving control area. This module can set the brightness and contrast of the image and set the temperature curve to be displayed.
