# Improvements in long-term output energy performance of Nd:glass regenerative amplifiers

Peng Zhang, Youen Jiang, Jiangfeng Wang, Wei Fan, Xuechun Li, and Jianqiang Zhu

National Laboratory on High Power Laser and Physics, Shanghai Institute of Optics and Fine Mechanics, Chinese Academy of Sciences, Shanghai 201800, China

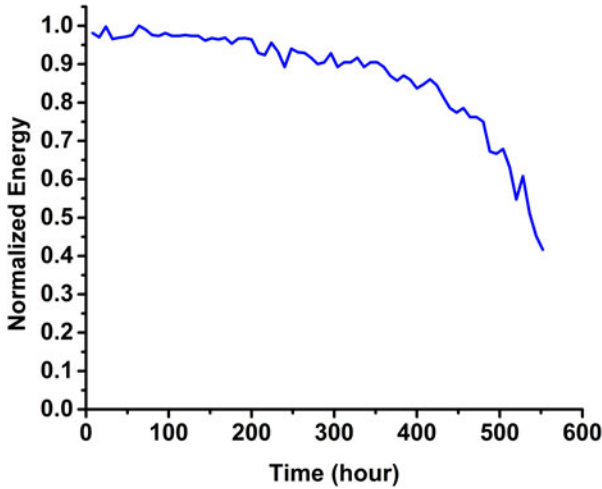
Although the regenerative amplifier has excellent energy stability, its output energy will gradually drop after a long-term operation. And the energy decreases faster as operation time grows. Figure 1 displays the output energy of the regenerative amplifier over a 3.5-month period, which has dropped by almost 60%. To our knowledge, this is a common problem for most high-power solid-state lasers and is the most severe challenge to apply them in large laser systems.

**Figure 1.** Normalized output energy of the regenerative amplifier as a function of time over a 3.5-month period.

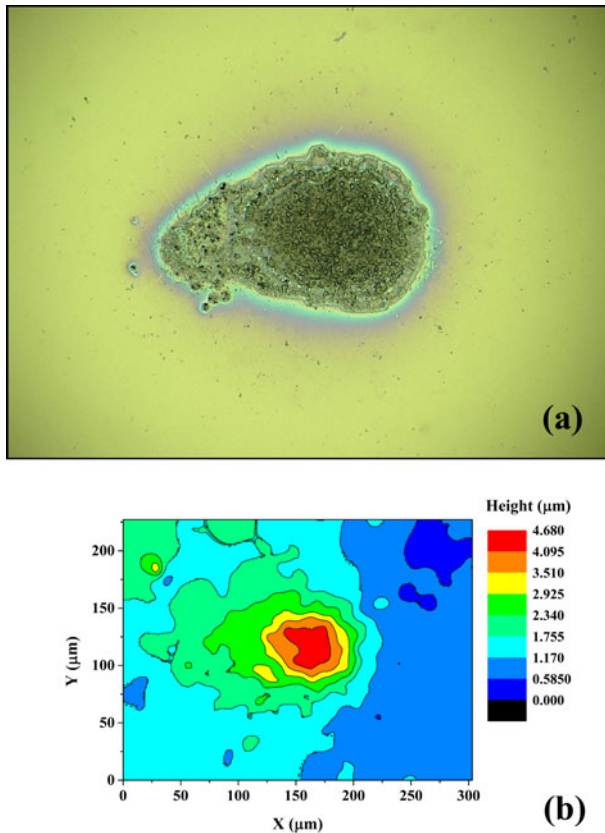
scanning with 0.05  $\mu\text{m}$  per pulse precision and 30 mm of automated travel distance, which makes 3D model imaging and 3D height measurement available. In Figures 2 and 3, the morphology of damage spots of a quarter waveplate (QWP) and a window glass (WG) of the Pockels cell (PC) in the Regen is shown with 1000 $\times$  and 350 $\times$  magnification, respectively. It can be seen from these figures that there are some deposits on damage sites compared to undamaged sites. And the thickness of deposited material on the QWP and WG is 4.67 and 6.16  $\mu\text{m}$ , respectively, which can be read from Figures 2(b) and 3(b). Figure 4 shows the morphology of the whole damage sites on the WG surface of PC in the Regen. From the figure, we can see that deposits only exist in the region on which the laser pulse irradiates, which is a typical characteristic of LIC<sup>[14]</sup>. There are less and smaller deposits on the central parts of this region. The reason for this may be that the spatial center of laser beam has the highest energy fluence, which has a clean effect for the deposits and results in removal of the center part of deposits where laser intensity is highest at the beginning of their growth. Moreover, as a comparison, the morphology of a damage spot on an Nd:glass rod surface caused by LID when laser energy fluence exceeds its damage threshold in the LID test experiment mentioned in Section 2.1 is shown in Figure 5. It is obvious that on the damage site the coating was peeled off and no deposits were observed, though after damage the surface shape of the Nd:glass rod had distorted severely.

**Figure 2.** Morphology of a damage site on a QWP surface in the Regen cavity. (a) Optical microscopy of the QWP damage site with 1000 $\times$  magnification; (b) contour map of the QWP damage site.

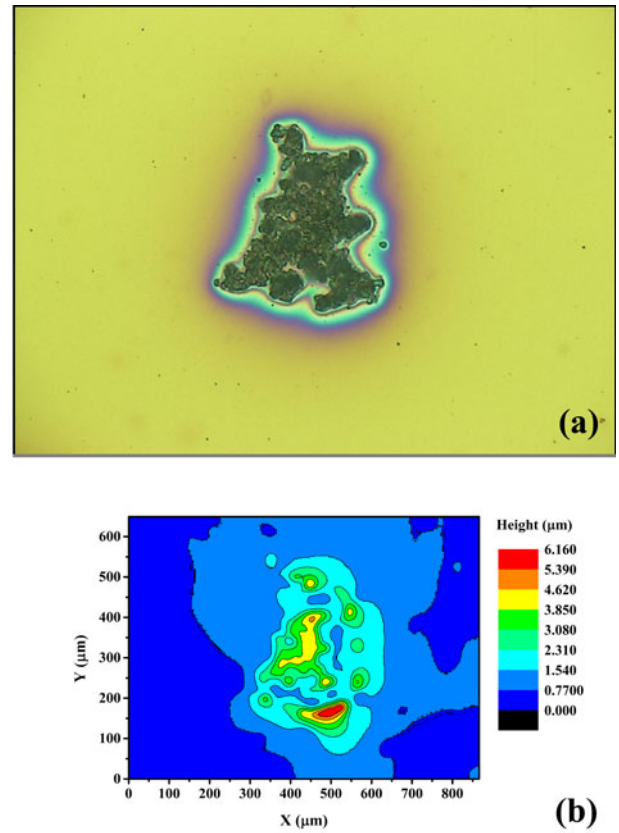
**Figure 3.** Morphology of a damage site on a WG surface of the PC. (a) Optical microscopy of the WG damage site with 350 $\times$  magnification; (b) contour map of the WG damage site.

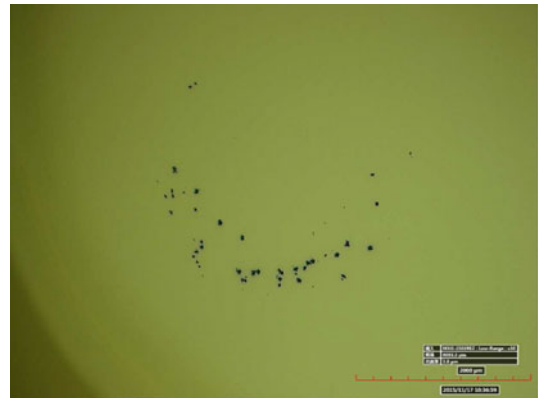
**Figure 4.** Morphology of the whole damage sites of WG surface of PC in the Regen.

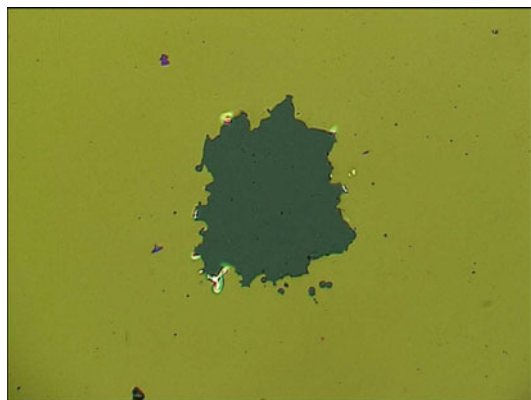
**Figure 5.** Morphology of a damage site on an Nd:glass rod surface caused by LID in the LID test experiment when laser energy fluence exceeds the damage threshold of the Nd:glass rod surface.

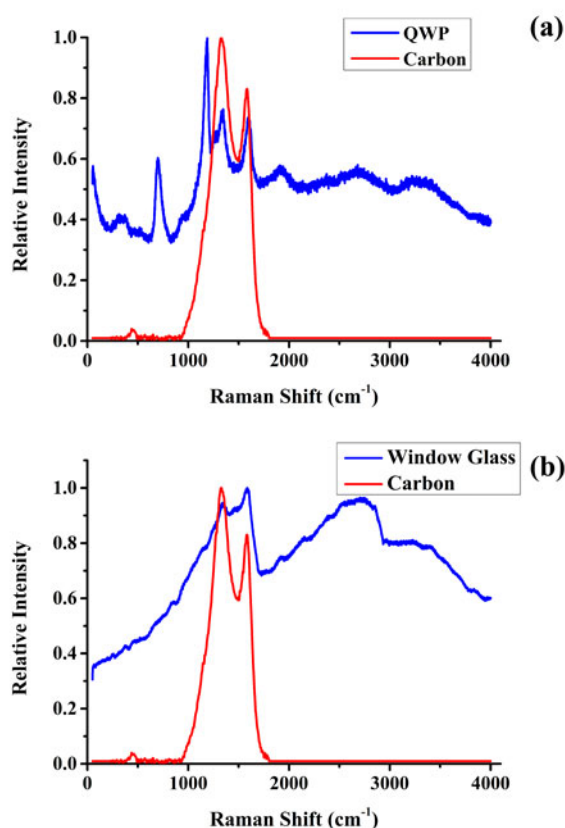
Chemical constituents of deposited material on damaged optical components surfaces were investigated by Raman spectroscopy. By comparison with the integrated database of Raman spectra, the Raman spectra of these deposits can be matched with Raman spectrum of carbon, which is a basic chemical element contained in organic compounds. This suggests that the deposited material on surfaces of damaged optical components may be organics. Figure 6(a) and 6(b) show the Raman spectra of deposits on the QWP surface and WG surface of the PC in the Regen, respectively.

**Figure 6.** (a) Raman spectra of deposits on the damaged QWP surface in comparison to that of carbon; (b) Raman spectra of deposits on the surface of damaged WG of PC in comparison to that of carbon.

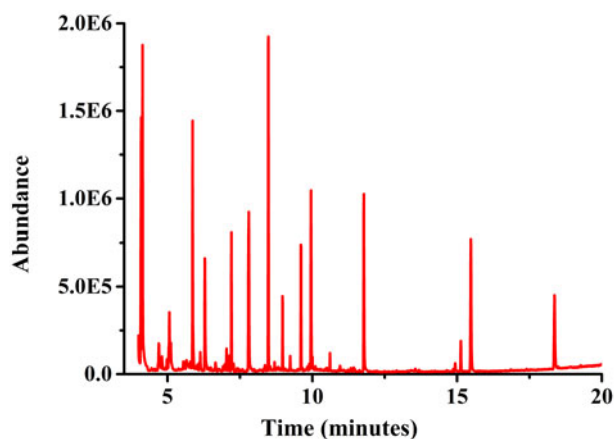
**Figure 7.** The TIC for the AMC sampling made in the Regen cavity.

The total ion current chromatogram (TIC) is shown in Figure 7. The top ten AMCs in the sample, whose concentrations were highest, are listed in Table 2. Concentration of each AMC is less than 10 ppbv, and the total AMC concentration in the sample is a mere 42 ppbv, almost in the same order of magnitude of that in a general air environment, which indicates that the outgassing of organic materials in the Regen is at a very low level.

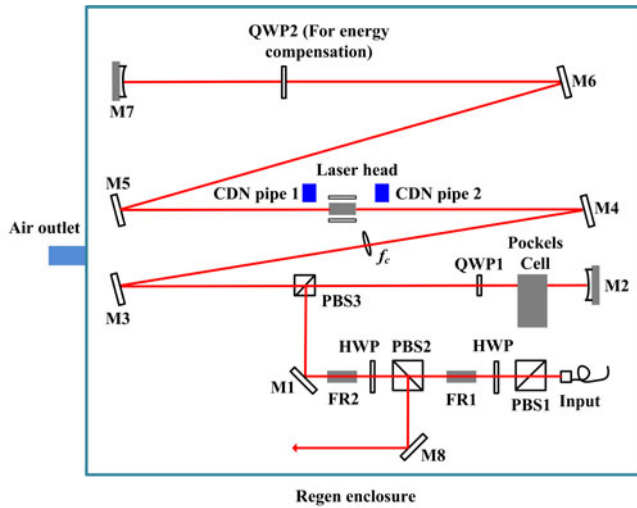
**Figure 8.** The regenerative amplifier with a CDN purge system, which is installed in the Regen cavity.

The layout of the regenerative amplifier with a CDN purge system is shown in Figure 8. Two clean stainless steel pipes are installed near both ends of the Nd:glass laser head, which suffers from LIC frequently. CDN with the cleanliness level less than Class 10 standard is purged into the Regen cavity by these two pipes. The flow rate of CDN purge system is 3 L/min. However, as is shown in Figure 9, when the Regen worked, its output energy declined more than 10% after 26 h of operation, much faster than it used to. Then the energy was compensated to its initial value by QWP2, which had preattenuated output energy of the Regen, but the energy decreasing rate still remained the same.

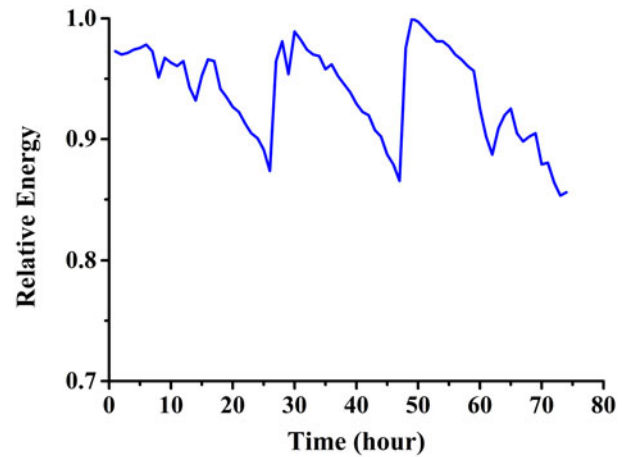
Then we turned off the Regen, and uncovered its enclosure. It was found that almost all the optical components with antireflective (AR) coatings were damaged on surfaces. All these damages had been proved to be organic deposits by the optical microscope and Raman spectrometer. It should be mentioned that no deposits have been discovered in reflecting mirrors. And the reason for this may be that the energy fluence on the surfaces of reflecting mirrors is almost twice as much as that on AR coatings, since energy fluence had been enhanced by incident beam and reflected beam, and the high fluence laser beam cleaned the deposits

**Figure 9.** The output energy of the Regen with a CDN purge system working versus time.

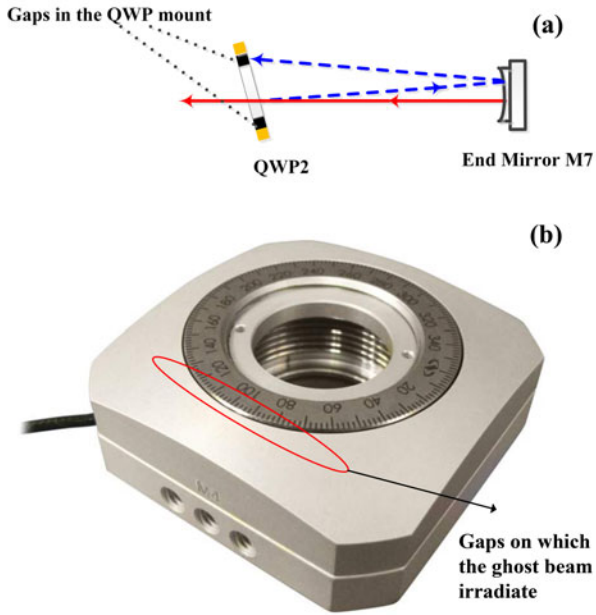
It was observed that a fraction of the laser beam (about 0.5%), which propagated from the second end mirror M7 to QWP2, was reflected by the second surface (S2 surface) of QWP2 with AR coatings, as shown in Figure 10(a). The reflective beam, which reflected from S2 surface of QWP2, is called ghost beam. This ghost beam was first transmitted to M7 and reflected by it. And finally, the ghost beam illuminated on the gap of the rotation stage, in which QWP2

**Figure 10.** (a) The diagram which describes that the ghost beam irradiates on the gap of the rotation stage of QWP2. The solid red line represents the propagation of the main laser beam, and the dashed blue line represents the propagation of the ghost beam generated by reflection of the main beam from a surface of QWP2. (b) A photo of rotation stage.

was mounted, as shown in Figure 10(b). There was a lot of vacuum compatible grease in the gap. Although the energy of the ghost beam was as low as  $50 \mu\text{J}$ , its energy fluence was almost on the same level as energy fluence of the main laser beam ( $1 \text{ J/cm}^2$ ), since it was focused twice by the concave end mirror M7. This fluence is high enough to generate aerosols.

To verify the conclusion of generation process of LIC in Regens, which was illustrated in Section 3.3, several improvements have been made in the regenerative amplifier: (1) all mechanical components in the Regen, including the ones supplied by manufacturers of optical components (PC supplied by Fastpulse Technology, Inc., for instance), were cleaned by ethanol in a supersonic tank; (2) all ghost beams generated by optical components with AR coatings were found, and blocked by beam traps; (3) all nonmetal materials were shielded by clean aluminum foil.

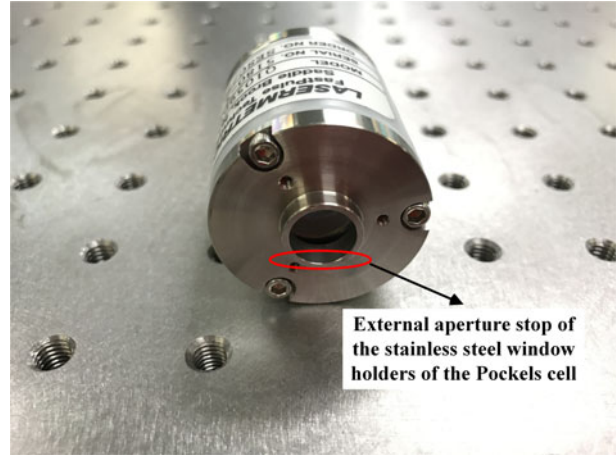
Subsequently, it was discovered that in the vicinity of each damaged optical component, ghost beams can be found illuminating on organic materials. For instance, we found that the external aperture stop of the stainless steel window holders (shown in Figure 11) of the damaged PC (Fastpulse Technology, Inc.) was not clean enough. There was a lot of residual lubricant on the aperture stop. The lubricant, which should have been cleaned away before the PC left the factory, might be introduced by the manufacturer when the PC was produced. And unfortunately, the aperture stop was illuminated by ghost beams from PBS3 and QWP1, which might produce aerosols near the PC which led to LIC on WG surface of PC. The same situation also existed in the Nd:glass laser head.

**Figure 11.** A photo of the PC used in the Regen. The external aperture stop of the stainless steel window holders was marked with a red circle.

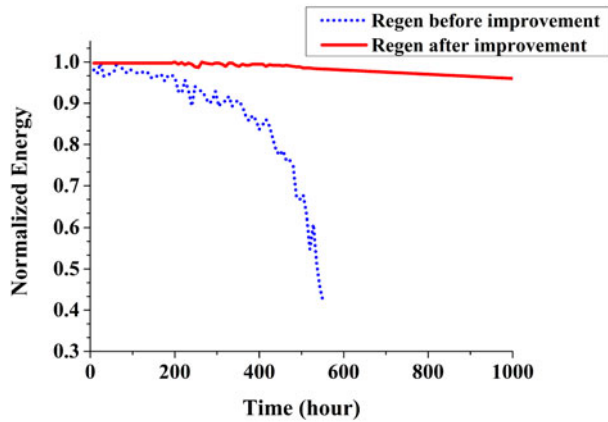
After the regenerative amplifier was modified, it operated for 6 months to examine its long-term output energy performance. The output energy of Regen as a function of time is shown in Figure 12, which illuminates that the decline of Regen output energy after 1000 h of operation is less than 4%, far lower than it used to be. This indicates that laser irradiation on organic materials by ghost beams is the primary cause of energy decrease of the regenerative amplifier in the long-term operation. This operation lifetime meets the requirement for the Nd:glass regenerative amplifier used in high-energy laser facilities.

**Figure 12.** Normalized output energy of the regenerative amplifier as a function of time before and after improvement.
