Application of Brillouin Optical Correlation Domain Analysis for Crack Identification in Concrete Structure

Michio IMAI* and Satoru MIURA

Kajima Technical Research Institute, Tokyo, 1820036, Japan

Citation: Michio IMAI and Satoru MIURA, "Application of Brillouin Optical Correlation Domain Analysis for Crack Identification in Concrete Structure," *Photonic Sensors*, DOI: 10.1007/s13320-013-0134-3.

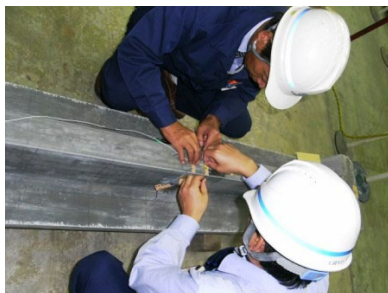
Fig. 6 Optical fiber sensor installation on the specimen.

concrete (FRC). The specimen was 3560 mm long, 250 mm high, and 404 mm wide. An optical fiber was mounted as the sensing medium on the bottom girder surface by means of a two-component epoxy adhesive (see Fig. 6).

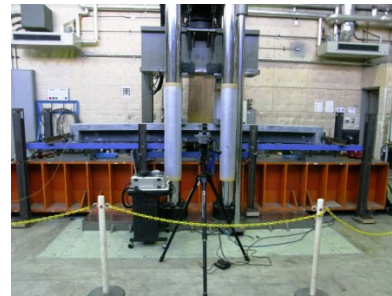
Figure 7 shows the experimental setup of the four-point bending test on the beam. The distances between the two supports and between the two loading points were 3490 mm and 500 mm, respectively. The measurement range for the optical fiber sensor was 3330 mm along the middle of the span. The longitudinal strain was measured statically by the BOCDA-based sensor at 19-mm measurement intervals while maintaining the load for a couple of minutes. In this case, the spatial resolution was 29 mm. Once a crack was detected by the sensor, it was observed under the microscope, primarily because there is no other alternative to investigating an imperceptible crack in the FRC.

Fig. 7 Four-point bending experiment.

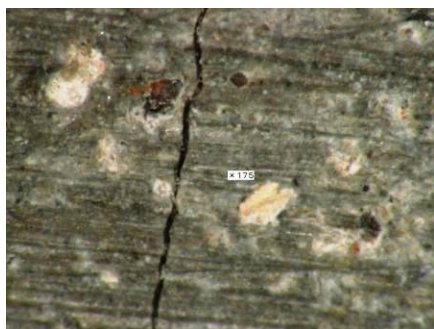
Fig. 9 Microscopic image of tiny crack.

The measured and analyzed results are shown in Figs. 8 (a) – 8 (d). The measurements are in good agreement with the analytical results, and the peak-shaped strain distributions appear at 70 kN, around the middle of the span. The location of the peak corresponds to the location of the crack observed under the microscope (see Fig. 9); hence, the three strain peaks in Fig. 8 (d) are confirmed to be derived from three discrete cracks on the bottom surface of the FRC specimen.

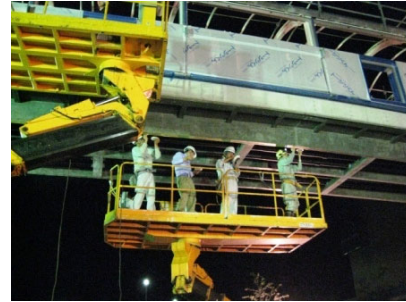
deck construction, an optical fiber was mounted as the sensing medium, as in the case of the beam-bending test, on the bottom surface of the girder at the mid-span using a two-component epoxy adhesive (see Fig. 13). The measurement region along the girder was approximately 24 m long.

Fig. 13 Optical fiber sensor installation on girder.

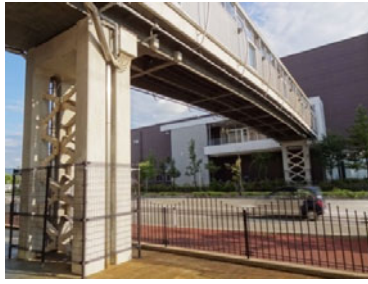
Using the BOCDA-based sensor, the longitudinal strain distribution along the girder was periodically measured, as shown in Fig. 14. Table 1 tabulates the lists of five measurements with the temperature on the surface of the girder. In the measurement setting used here, the spatial interval was approximately 40 mm, and the spatial resolution was 48 mm.

Fig. 14 Monitored pedestrian deck.

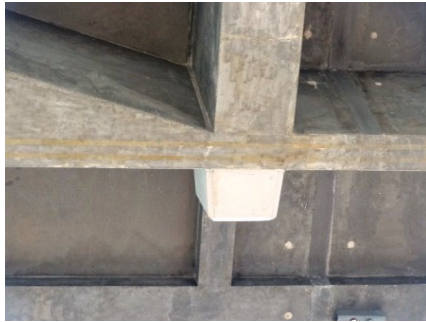
Fig. 16 Mounted five-year-old optical fiber.

The initial strain distribution in August 2007 was regarded as a baseline measurement, and the generated strain was calculated using the other four measurements, as shown in Figs. 15 (a) – 15 (d). These figures show 20- μm crack-induced strain distribution models, which were re-calculated by taking the 48-mm spatial resolution ($\Delta z = 24\text{ mm}$), into (1). Although the whole range of the fiber shows scattering owing to the measurement precision error, $50 \times 10^{-6} - 100 \times 10^{-6}$, the measurement region shows no consistent peak-shaped strain distribution like the 20- μm crack model; therefore, one can at least conclude that the girder has no cracks, which are more than 20 μm in width. Another important finding is that the surface mounted sensor can remain *in situ* and work for more than five years without any obvious deterioration (see Fig. 16).
