# Identification of subsurface damage of 4H-SiC wafers by combining photo-chemical etching and molten-alkali etching

**Abstract:** In this work, we propose to reveal the subsurface damage (SSD) of 4H-SiC wafers by photo-chemical etching and identify the nature of SSD by molten-alkali etching. Under UV illumination, SSD acts as a photoluminescence-black defect. The selective photo-chemical etching reveals SSD as the ridge-like defect. It is found that the ridge-like SSD is still crystalline 4H-SiC with lattice distortion. The molten-KOH etching of the 4H-SiC wafer with ridge-like SSD transforms the ridge-like SSD into groove lines, which are typical features of scratches. This means that the underlying scratches under mechanical stress give rise to the formation of SSD in 4H-SiC wafers. SSD is incorporated into 4H-SiC wafers during the lapping, rather than the chemical mechanical polishing (CMP).

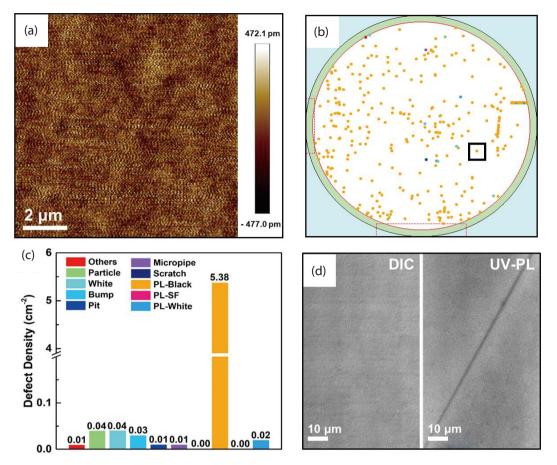
Fig. 1. (Color online) (a) AFM image of the CMP-treated 4H-SiC wafer, (b) distribution and (c) density of defects of the CMP-treated 4H-SiC wafer, and (d) DIC and UV-PL images of the same PL-Black defect site [the black box in (b)] of the Si-face of the CMP-treated 4H-SiC wafer.

As shown in Fig. 1(a), the CMP processing yields a flat and smooth 4H-SiC wafer. The surface roughness for the Siface of the 4H-SiC wafer is 0.11 nm, which meets the requirement of subsequent homoepitaxy. The distribution and density of defects at the Si-face of the CMP-treated 4H-SiC wafer are presented in Figs. 1(b) and 1(c), respectively. Although scratches, pits, bumps, particles and other defects are almost cleaned up after CMP, the UV-PL image shows that high density (5.38 cm<sup>-2</sup>) of PL-Black defects appear at the Si-face of the CMP-treated 4H-SiC wafer. As shown in Fig. 1(d), the PL-Black defects are invisible under optical microscopy but appear as straight lines in the UV-PL measurements. This indicates that the SSD appears at the CMP-treated 4H-SiC wafer.

Because the UV-generated electrons and holes would recombine at the defects of 4H-SiC<sup>[27, 28]</sup>, the PL-Black SSD on the Si-face of CMP-treated 4H-SiC are preserved as straight ridges during the photo-chemical etching [Fig. 3(a) and 3(b)], which are consistent with the UV-PL results [Fig. 1(d)]. After 20 min of photo-chemical etching, the width and height of the ridge-like defects are ~2  $\mu$ m and 82 nm, respectively [Figs. 3(c) and 3(d)].

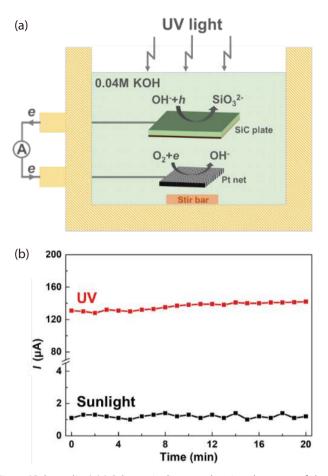
Fig. 2. (Color online) (a) Schematic diagram showing the setup of the photo-chemical etching of 4H-SiC. (b) The current of 4H-SiC during the photo-chemical etching under the UV and sunlight illumination.

To clarify the nature of the PL-Black SSD, the photo-chemical etching of the CMP-treated 4H-SiC was carried out in 0.04 M KOH solution. Fig. 2(a) schematically shows the setup for the photo-chemical etching. The 4H-SiC sample is connected to the Pt sheet by short circuiting. The onset potential of the oxygen reduction reaction at Pt is more positive than that of the photoanodic oxidation of 4H-SiC, which initiates the photo-etching reaction<sup>[30]</sup>. During photo-chemical etching of the perfect region of 4H-SiC, the UV-generated electron-hole pairs are separated by the electric field of the surficial spacecharge layer. The UV-generated electrons (e) transporting to the Pt net via the circuit are captured by the dissolved oxygen, and form OH<sup>-</sup> species by the reaction:  $O_2 + 2H_2O + 4e \rightarrow 4OH^-$ . The holes (h) are left at the Si-face of the 4H-SiC sample and participates in the oxidation and dissolution of the perfect region of 4H-SiC by the reaction: SiC + 10OH<sup>-</sup> + 8h  $\rightarrow$  SiO<sub>3</sub><sup>2-</sup> + CO<sub>2</sub>↑ + 5H<sub>2</sub>O<sup>[29]</sup>. As shown in Fig. 2(b), the etching current for the Si-face of 4H-SiC remains at 130  $\mu$ A under UV illumination, which is much higher than the current of that under natural sunlight illumination (1  $\mu$ A), indicating the strong etching of 4H-SiC.

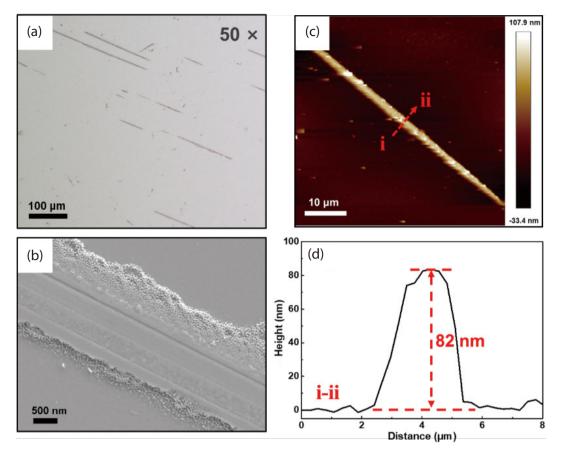
Fig. 3. (a) Differential interference contrast (DIC) optical microscopy image, (b) SEM image, (c) AFM image, and (d) height of the ridge-like defect in the photo-chemically etched Si-face of 4H-SiC.

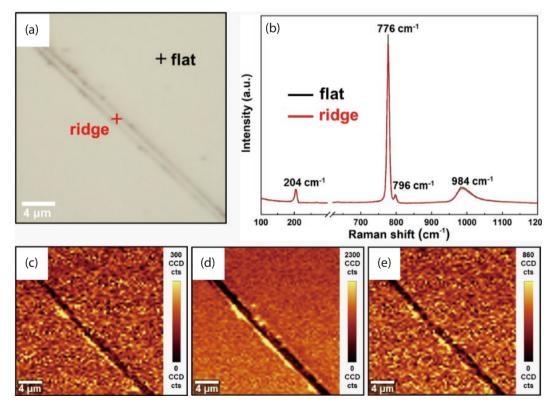
Fig. 4. (Color online) (a) Optical microscopy image, (b) Raman spectra, and Raman mappings based on the intensity of peaks located at (c) 204, (d) 776, and (e) 984 cm<sup>-1</sup> across the ridge-like defect in the photo-chemically etched Si-face of 4H-SiC.

Micro-Raman spectroscopy is then used to investigate the crystalline properties and lattice distortions of the exposed ridge-like defects. Fig. 4(a) illustrates the distribution of two tested points on photo-chemical etched Si-face. As shown in Fig. 4(b), the folded mode of the transverse acoustic branch (FTA) locating at 204 cm<sup>-1</sup>, as well as the folded modes of the transverse optical branches (FTO) locating at 776 and 796 cm<sup>-1</sup>, are observed in the ridge-like defect and the perfect 4H-SiC region. The folded mode of the longitudinal optical branches (FLO) shifts to 984 cm<sup>-1</sup>, as a result of Ndoping<sup>[31]</sup>. This indicates that the polytype of the ridge-like defect is still 4H-SiC<sup>[32]</sup>. As shown in Figs. 4(c)-4(e), the micro-Raman mapping across the ridge-like defect indicates that the intensities of the FTA peak, FLO peak, and FTO peak of the ridge-like defect are all lower than that of the perfect region, which indicates the atomic displacement of the ridge-like SSD.

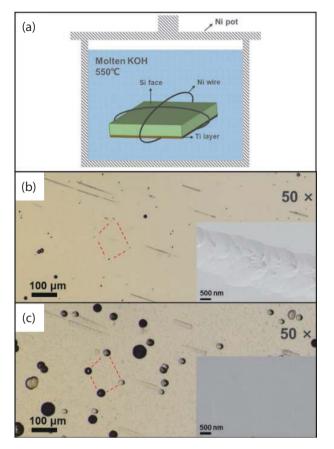
Fig. 5. (Color online) (a) Schematic diagram of molten-KOH etching of the photo-chemically etched Si-face of 4H-SiC. (b, c) DIC images obtained with the molten-KOH etching with 3 and 30 min, respectively. The insets show the local SEM images in the red dotted boxes.

To investigate the nature of the atomic displacement of the ridge-like SSD, molten-KOH etching is then carried out on the 4H-SiC that undergoes photo-chemical etching. After 3 min of molten-KOH etching at 550 °C, the ridge-like SSD changes into a groove line [Fig. 5(b), inset], which is due to the preferential etching along defects during the molten-KOH etching<sup>[33, 34]</sup>. As the etching duration increases to 30 min [Fig. 5(c)], the groove line gradually becomes wider and shallower. According to results obtained by Zhang et al., the groove line is attributed to the underlying scratches<sup>[8, 10]</sup>. In addition, some groove lines [in the red dotted box of Figs. 5(b) and 5(c)] gradually disappear due to the molten-KOH etching, which further demonstrates the characteristics of underlying scratches. This indicates that the underlying scratches induced by mechanical stresses give rise to the formation of SSD in 4H-SiC.

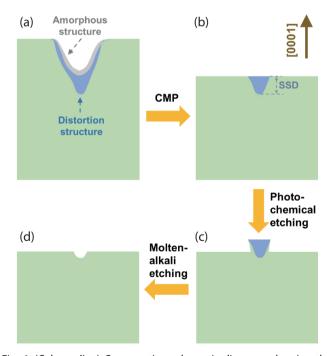
Fig. 6. (Color online) Cross-section schematic diagrams showing the Si-face of 4H-SiC after the (a) fine-lapping, (b) CMP, (c) photo-chemical etching and (d) molten-KOH etching.

stand the deformation of 4H-SiC<sup>[35]</sup>. Except for cracks, distortion structures and amorphous structures have also been identified as the mechanical-processing induced defects [Fig. 6(a)]. The CMP process is carried out to remove the fine-lapping-induced surface damages and create an atomically smooth surface that is ready for the epitaxy of 4H-SiC thin films, while the underlying scratches still exist below the smooth Si-face and form the SSD [Fig. 6(b)]. The photo-chemical etching [Fig. 6(c)] and molten-alkali etching [Fig. 6(d)] are successively carried out to reveal and identify the nature of the SSD. The average width of the SSD is about 2  $\mu$ m, which is in the range of the diameter of the diamond abrasives during the fine lapping. Therefore, we conclude that SSD is induced by the scratch of diamond abrasive particles during the lapping. Furthermore, the abrasives of Al<sub>2</sub>O<sub>3</sub> and SiO<sub>2</sub> during the CMP is softer than 4H-SiC, which confirms that the SSD is not likely to be induced during CMP. This indicates that efforts should be devoted to optimize the lapping process to avoid the formation of scratches during the lapping, or to prolong the duration of the CMP process to sufficiently remove of the lappinginduced SSD.
