## 脉冲激光清洗过程中振镜扫描速度对 TA15 钛合金表面氧化层的影响

**摘要** 采用脉冲激光清洗技术以不同的振镜扫描速度对 TA15 钛合金表面的氧化层和油污进行去除, 分析了激光清洗后 TA15 钛合金的表面形貌以及清洗表面的成分变化和硬度变化。结果表明: 随着振镜扫描速度从  $7000 \text{ mm} \cdot \text{s}^{-1}$  增大到  $10000 \text{ mm} \cdot \text{s}^{-1}$ , 清洗表面的钛元素含量呈现先增加再降低的趋势, 而氧元素含量则是先降低再升高; 当扫描速度为  $8000 \text{ mm} \cdot \text{s}^{-1}$  时, 清洗表面的钛元素含量达到最高值,  $w(\text{Ti})=79.47\%$ , 氧元素含量达到最低值,  $w(\text{O})=8.62\%$ ; 清洗表面的硬度随着扫描速度的减小而增大; 激光清洗去除 TA15 氧化层的机制主要为气化机制和相爆炸机制。

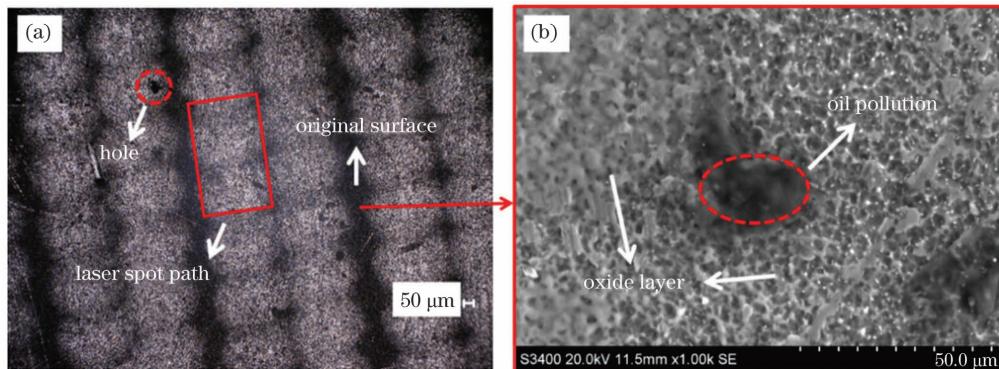
图 1 激光清洗前后 TA15 钛合金的表面形貌。(a) 清洗表面形貌和原始表面形貌;(b) 原始表面的电镜图

Fig. 1 Surface morphologies of TA15 titanium alloy before and after laser cleaning. (a) Cleaned surface morphology and original surface morphology; (b) SEM image of original surface

以厚度为 2 mm 的 TA15 钛合金板材为实验材料进行激光清洗实验。该板材试样表面存在着在自然放置状态下形成的一层多孔松散的氧化层以及生产过程中留下的油污,其表面形貌以及激光清洗后的表面形貌如图 1 所示。

TA15钛合金在不同激光工艺参数下清洗后的微观形貌如图5所示。对比图1(b)可以看到,在7000,8000,9000,10000  $\text{mm} \cdot \text{s}^{-1}$ 扫描速度下清洗的TA15钛合金表面与原始表面相比发生了明显变化;同时从图5(b)中可以看到一些剥落的氧化层碎渣,这也证明了激光清洗TA15钛合金表面氧化层

图4(a)~(d)分别是用7000~10000  $\text{mm} \cdot \text{s}^{-1}$ 的振镜扫描速度清洗后的TA15钛合金的表面形貌。对比图1(a)中黑色的原始表面可以看到,激光清洗后,清洗表面整体变亮,且出现了孔洞。这说明钛合金试样表面的污染物和氧化层被大量清除。当扫描速度为10000  $\text{mm} \cdot \text{s}^{-1}$ 时,清洗表面上可以看到激光光斑的扫描路径,且清洗表面上的黑白颜色分布不均匀,存在黑白色差,如图4(d)所示。从图4(d)中的区域(1)、(2)可以发现,由于振镜扫描速度过快,该区域表面呈现出与原始表面较为接近的暗黑色。这表明,在该扫描速度下部分油污和氧化层未被清洗掉。

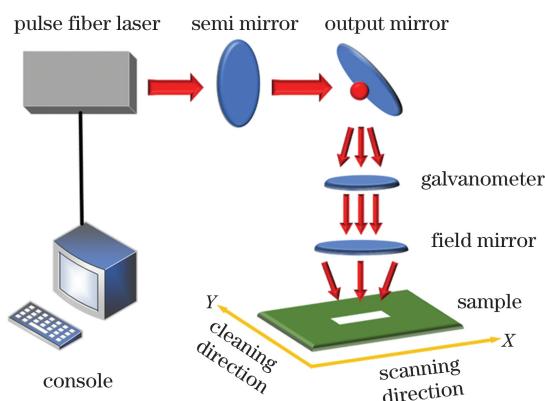
激光清洗系统以及激光清洗原理如图 2 所示。具体清洗操作步骤如下:1)将准备好的试样放置在 Y 轴移动平台上,通过控制移动平台使试样位于激光头的下方;2)打开激光清洗设备,将清洗参数设置为实验设计的参数;3)通过振镜的高速振荡来实现光斑在清洗表面沿 X 轴方向高速移动,从而在试样表面形成一条线状光斑,并通过 Y 轴移动平台实现试样在清洗方向的移动,通过振镜和移动平台的配合实现对 TA15 表面的清洗;4)清洗完成后,再次移动 Y 轴移动平台,取出试样,然后关闭激光器和主机电源。

图 2 激光清洗原理

Fig. 2 Laser cleaning schematic

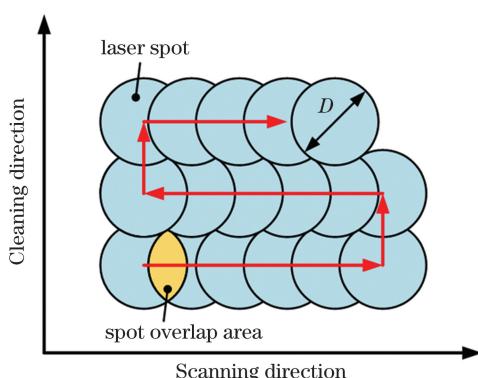
图3 激光光斑扫描路径

Fig. 3 Scanning path of laser spot

激光清洗实验所用工艺参数为:功率 200 W,重复频率 20 kHz,脉宽 60 ns,单脉冲能量 10 mJ,扫描速度 7000~10000  $\text{mm} \cdot \text{s}^{-1}$ 。实验中所使用的振镜扫描速度具体如表 1 所示,激光光斑扫描路径如图 3 所示。

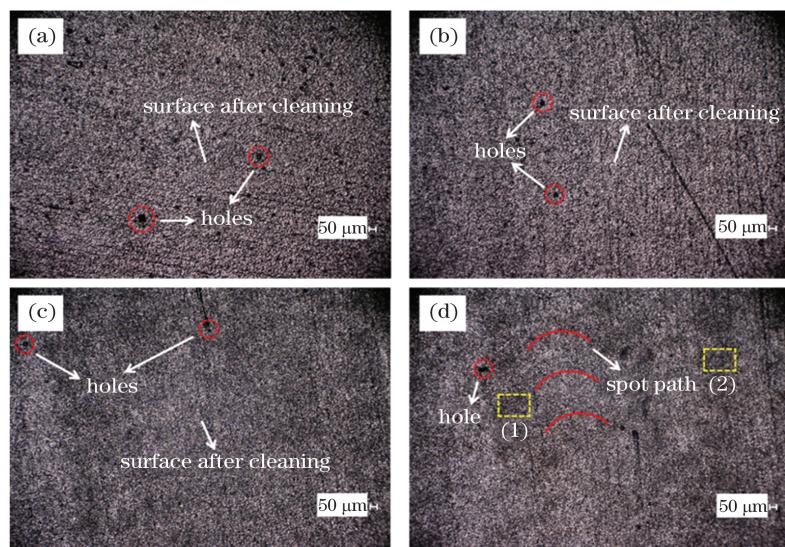
图4 激光清洗TA15钛合金的表面形貌。(a)  $V=7000 \text{ mm} \cdot \text{s}^{-1}$ ; (b)  $V=8000 \text{ mm} \cdot \text{s}^{-1}$ ; (c)  $V=9000 \text{ mm} \cdot \text{s}^{-1}$ ; (d)  $V=10000 \text{ mm} \cdot \text{s}^{-1}$ Fig. 4 Surface morphologies of TA15 after laser cleaning. (a)  $V=7000 \text{ mm} \cdot \text{s}^{-1}$ ; (b)  $V=8000 \text{ mm} \cdot \text{s}^{-1}$ ; (c)  $V=9000 \text{ mm} \cdot \text{s}^{-1}$ ; (d)  $V=10000 \text{ mm} \cdot \text{s}^{-1}$

**Results and Discussions** After pulsed laser cleaning, the original black surface of TA15 becomes white and bright. The scanning speed of the galvanometer has a certain influence on the cleaning effect [Fig. 1(a) and Fig. 4]. When other laser cleaning process parameters remain unchanged, the overlap ratio of galvanometer spot increases with the decrease of scanning speed. This leads to an increase in the laser energy absorbed by the cleaning surface so that the porous and loose oxide layer on the TA15 surface can be removed. Moreover, the surface cleaned with the small scanning speed of the galvanometer is smoother than the surface cleaned with the large scanning speed, and the removal effect of the oxide layer is also more obvious [Fig. 1(b) and Fig. 5]. Combined with the principle of laser cleaning and the oxide debris observed on the surface of the TA15 alloy, it can be inferred that gasification and phase-explosion mechanisms are followed during the laser cleaning process for the oxide layer and oil stain on the TA15 surface. Because the air and moisture contained in the porous structure of the original oxide layer explode under the irradiation of the laser, phase-explosion is caused in the cleaning surface. Additionally, some oil stain can be attached to the oxide layer debris generated by the phase-explosion and removed together (Fig. 6). Due to the element content changes on the cleaning surface, as the scanning speed of the galvanometer increases from  $7000 \text{ mm} \cdot \text{s}^{-1}$  to  $10000 \text{ mm} \cdot \text{s}^{-1}$ , the Ti-element content on the TA15 surface first increases and then decreases, while the O-element content first decreases and then increases (Fig. 7). The oil stain and oxide layer on the TA15 surface cannot be well cleaned when very high scanning speed is used. However, very low scanning speed can easily cause thermal oxidation of the cleaned surface and generate new  $\text{Al}_2\text{O}_3$  and  $\text{TiO}_2$  layers that adhere to the cleaned surface (Fig. 8). Through the analysis of the change of the hardness of the cleaned surface, it is concluded that the plasma and phase-explosions can cause the plastic deformation of the TA15 surface and the refinement of the grain, which can produce the effect of laser shock strengthening and improve the surface hardness of TA15. With the decrease of scanning speed, the effect of laser shock strengthening is also improved (Fig. 9).

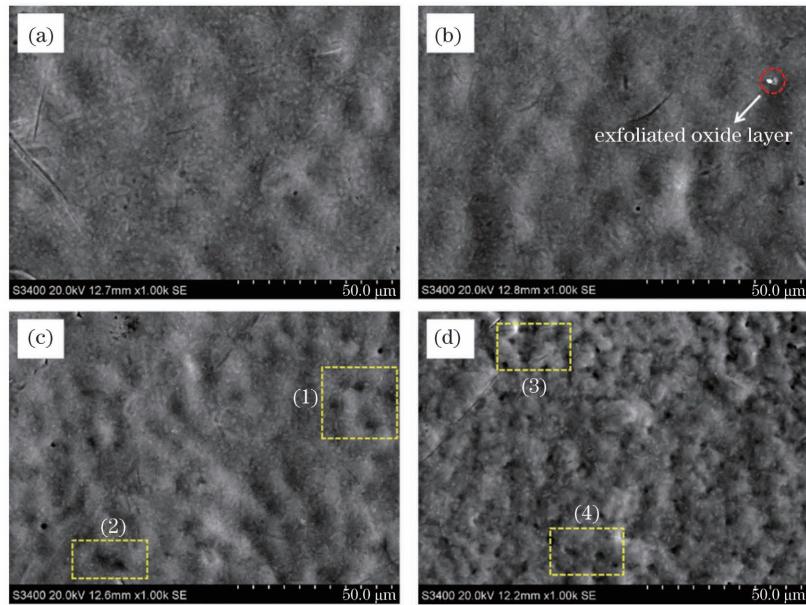
图 5 激光清洗 TA15 钛合金表面的 SEM 形貌。(a) $V=7000\text{ mm}\cdot\text{s}^{-1}$ ; (b) $V=8000\text{ mm}\cdot\text{s}^{-1}$ ; (c) $V=9000\text{ mm}\cdot\text{s}^{-1}$ ; (d) $V=10000\text{ mm}\cdot\text{s}^{-1}$

Fig. 5 SEM morphologies of TA15 surface after laser cleaning. (a)  $V=7000\text{ mm}\cdot\text{s}^{-1}$ ; (b)  $V=8000\text{ mm}\cdot\text{s}^{-1}$ ; (c)  $V=9000\text{ mm}\cdot\text{s}^{-1}$ ; (d)  $V=10000\text{ mm}\cdot\text{s}^{-1}$

从图5(a)~(d)中可以看出,在激光清洗过程中,当其他激光工艺参数保持不变时,不同的扫描速度对TA15钛合金表面氧化层的去除效果不同,但表面上大面积的油污可以被基本去除。图5(a)、(b)显示,采用7000  $\text{mm} \cdot \text{s}^{-1}$ 和8000  $\text{mm} \cdot \text{s}^{-1}$ 扫描速度清洗后,TA15钛合金表面相比其他较大扫描

速度下清洗的表面更加平滑。图 5(c)是采用 $9000\text{ mm}\cdot\text{s}^{-1}$ 扫描速度清洗后的 TA15 钛合金的表面形貌,从其中的区域(1)、(2)可以看到,随着扫描速度增大,振镜光斑搭接率减小,部分清洗区域吸收的激光能量不足以去除氧化层,从而使得被清洗表面开始变得不平滑。图 5(d)是采用 $10000\text{ mm}\cdot\text{s}^{-1}$ 扫描速度清洗后的 TA15 钛合金的表面形貌,同样,从其中的清洗区域(3)、(4)可以看到,由于扫描速度过大,振镜光斑搭接率较小,清洗后的表面比 $9000\text{ mm}\cdot\text{s}^{-1}$ 扫描速度下清洗后的表面更加凹凸不平。这表明,振镜扫描速度过快会导致清洗表面上残留一些氧化物。

由激光清洗原理可知<sup>[24]</sup>,在激光的辐照下,清洗表面吸收激光能量产生局部热效应,使得表面上的氧化层和油污发生迁移。当清洗表面的温度达到油污的燃点后,大量的油污便会气化或燃烧,从而被去除。结合图 5(b)中所示的剥落的氧化层碎片可知在激光清洗氧化层过程中发生了相爆炸,而且相爆炸是由氧化层多孔结构中夹杂的空气和水分在激光辐照下发生受热爆炸引起的。相爆炸导致大部分油污被气化去除,同时,一小部分油污会附着在氧化层爆炸后产生的氧化层碎渣上一起被去除。所以,依据本节的分析可知激光清洗过程主要基于气化机制和相爆炸机制去除 TA15 钛合金表面的氧化层和油污,去除原理如图 6 所示。

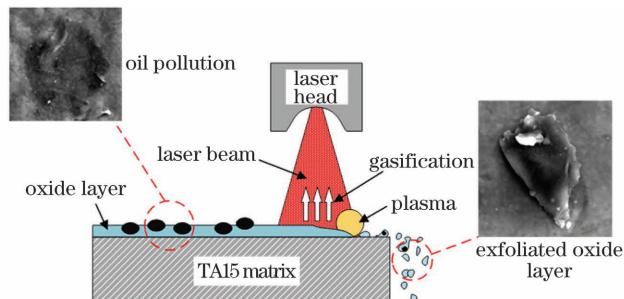
图 6 激光去除 TA15 钛合金表面氧化层和油污的原理图

Fig. 6 Schematic of laser removal of oxide layer and oil pollution on TA15 surface

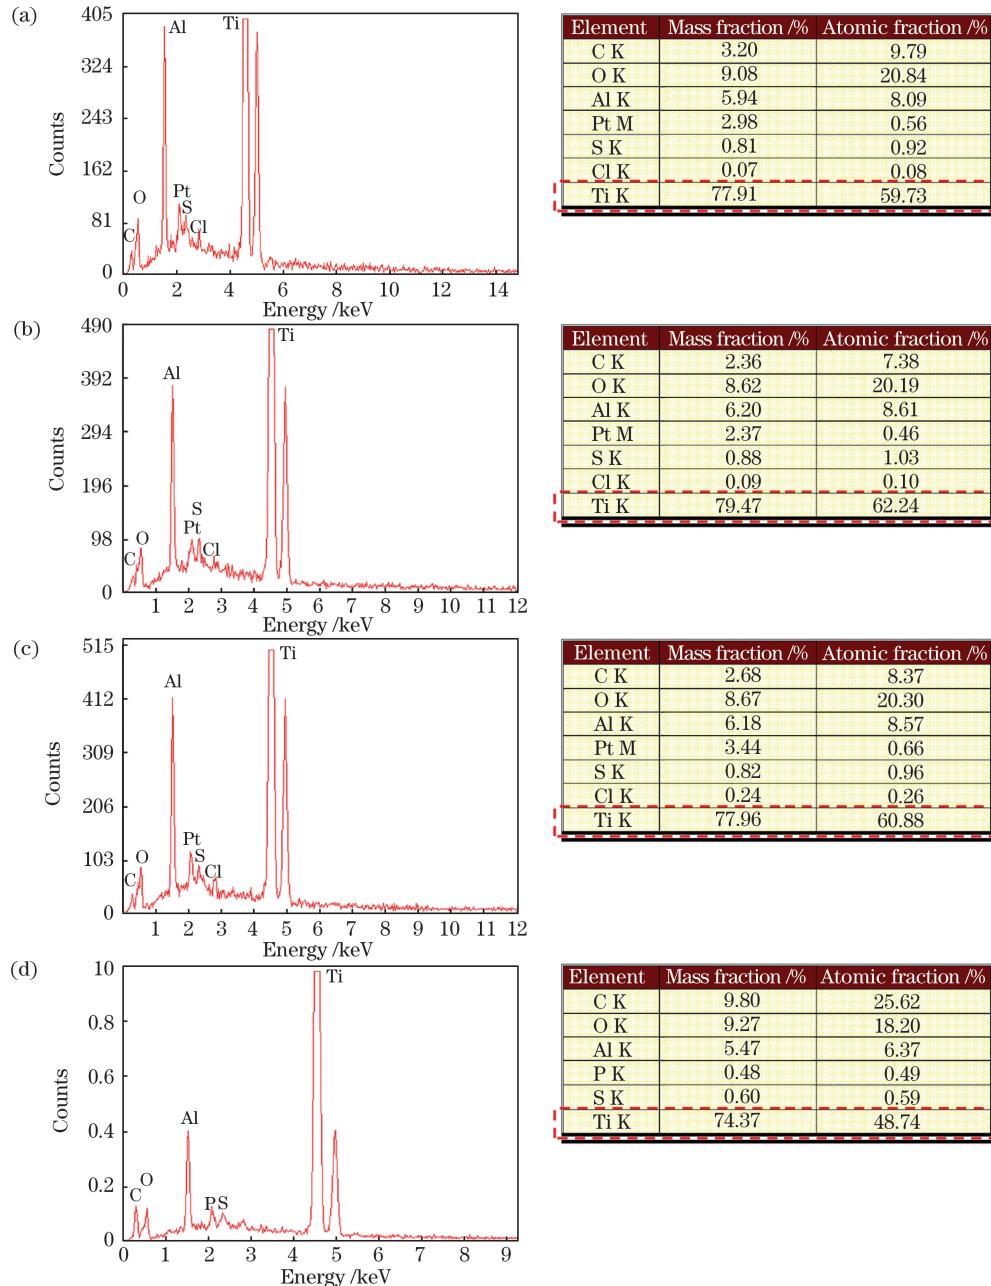
图7 激光清洗TA15钛合金表面的EDS谱及EDS分析结果。(a)V=7000 mm·s<sup>-1</sup>;(b)V=8000 mm·s<sup>-1</sup>;(c)V=9000 mm·s<sup>-1</sup>;(d)V=10000 mm·s<sup>-1</sup>

Fig. 7 EDS patterns and EDS analysis of TA15 surface after laser cleaning. (a) V=7000 mm·s<sup>-1</sup>; (b) V=8000 mm·s<sup>-1</sup>; (c) V=9000 mm·s<sup>-1</sup>; (d) V=10000 mm·s<sup>-1</sup>

图7(a)、(b)分别是扫描速度为7000 mm·s<sup>-1</sup>和8000 mm·s<sup>-1</sup>时激光清洗TA15钛合金表面的EDS谱及EDS分析结果,可见,氧元素的质量分数分别为9.08%和8.62%,钛元素的质量分数分别为77.91%和79.47%。这说明,在7000 mm·s<sup>-1</sup>的扫

描速度下,清洗表面出现了热氧化现象。这是因为随着扫描速度的降低,光斑搭接率增大,激光光斑扫描区域的热累积效应随之增强,原始表面的氧化层被气化去除;同时,空气中的氧原子又与热累积区的基体材料结合形成新的氧化层,并附着在清洗表面,从而导致TA15钛合金基体裸露面积减小。图7(c)是扫描速度为9000 mm·s<sup>-1</sup>时激光清洗TA15钛合金表面的EDS谱及EDS分析结果,可见,氧元素的质量分数为8.67%,钛元素的质量分

数为 77.96%。相对于  $8000 \text{ mm} \cdot \text{s}^{-1}$  扫描速度下的清洗表面,在  $9000 \text{ mm} \cdot \text{s}^{-1}$  扫描速度下清洗的 TA15 钛合金表面的钛元素含量有所下降,而氧元素的含量变化不大。前者表明在  $9000 \text{ mm} \cdot \text{s}^{-1}$  的扫描速度下清洗后裸露出的 TA15 基体有所减少,而后者则主要是由氧化层厚度不均匀导致较厚的氧化层不能被很好地去除引起的。所以可以认为在该扫描速度下,氧化层的清洗去除效果不如  $8000 \text{ mm} \cdot \text{s}^{-1}$  扫描速度下的清洗效果。由图 7(d)可以看出,当扫描速度为  $10000 \text{ mm} \cdot \text{s}^{-1}$  时,清洗表面碳元素的质量分数为 9.80%,氧元素的质量分数为 9.27%,钛元素的质量分数为 74.37%。这表明,过大的扫描速度会导致 TA15 钛合金表面存在较多氧化层和一些残留的油污。上述分析表明,7000, 9000,  $10000 \text{ mm} \cdot \text{s}^{-1}$  扫描速度下的清洗效果均没有  $8000 \text{ mm} \cdot \text{s}^{-1}$  扫描速度下的清洗效果好。

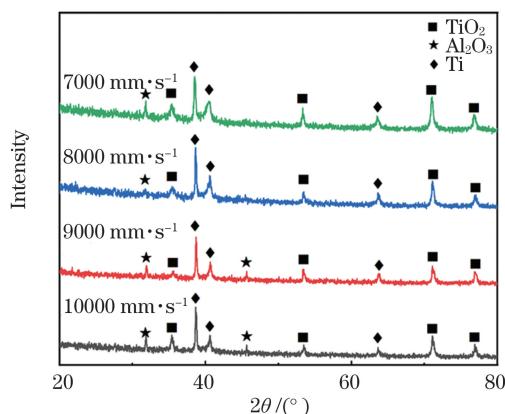
图 8 激光清洗 TA15 钛合金表面的 XRD 谱

Fig. 8 XRD spectra of TA15 surface after laser cleaning

图 8 为不同扫描速度下清洗的 TA15 钛合金表面的 XRD 谱。可以看到,当扫描速度为  $7000 \text{ mm} \cdot \text{s}^{-1}$  时,  $\text{Al}_2\text{O}_3$  峰和  $\text{TiO}_2$  峰的强度都有所增强。这表明在该扫描速度下,激光清洗表面发生了热氧化,清洗表面又生成了新的  $\text{Al}_2\text{O}_3$  和  $\text{TiO}_2$  层。当扫描速度为  $8000 \text{ mm} \cdot \text{s}^{-1}$  时,清洗表面的  $\text{Al}_2\text{O}_3$  峰基本消失,  $\text{TiO}_2$  峰的强度相比其他扫描速度下的更弱,  $\text{Ti}$  峰的强度更强。这更加有力地证明了激光清洗可以去除 TA15 钛合金表面的氧化层,且  $8000 \text{ mm} \cdot \text{s}^{-1}$  的扫描速度能获得较好的清洗效果。过小的扫描速度易使清洗表面发生热氧化,而过大的扫描速度又无法获得较好的清洗效果。

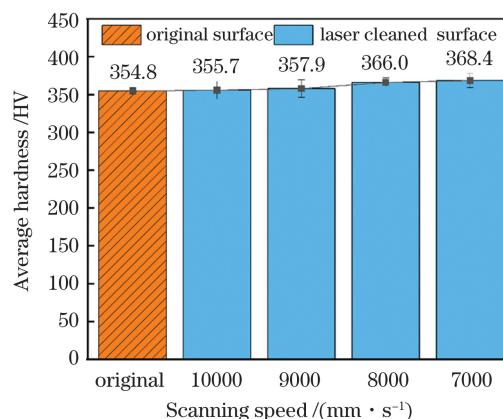
图 9 激光清洗 TA15 钛合金表面的硬度

Fig. 9 Hardness chart of TA15 surface after laser cleaning

产生激光强化作用,对激光清洗后的 TA15 表面的维氏硬度进行了分析。从图 9 可以看出,经过激光清洗后,TA15 清洗表面的硬度相比原始表面有所提高。造成该现象的主要原因是 TA15 表面的氧化层较薄,在激光的辐照下,TA15 基体表面也会吸收部分激光能量,从而产生高温高压的等离子体,这些等离子体会被表层未清洗掉的氧化层束缚,被束缚的等离子体继续吸收激光能量后发生热膨胀,随后爆炸,爆炸产生的冲击波对 TA15 表面产生了压应力。同时,结合 3.2 节的分析可以知道,在清洗过程中,多孔结构的氧化层中夹杂的空气和水分在激光辐照下发生爆炸,也产生了冲击波。在这两种冲击波引起的压力的作用下,清洗表面发生塑性变形,导致表面晶粒细化<sup>[25]</sup>,从而产生了激光冲击强化作用,提高了 TA15 钛合金的表面硬度。从不同扫描速度下清洗的表面的硬度变化可以看出,随着扫描速度减小,表面硬度缓慢提高。这是由于扫描速度越小,单位面积的氧化层和基体吸收的激光能量越多,因此激光冲击强化作用越明显。
