车轴激光清洗表面质量分析及在线评估

摘要 基于高铁转向架轮对的高级检修过程中的漆层去除需求, 采用激光清洗技术对高强钢表面漆层进行去除, 研究不同功率下漆膜的去除状况, 分析不同清洗状态下工件表面的宏观、微观形貌及成分变化; 之后, 采用机器视觉技术提取工件表面状态图像并进行处理, 提取出黑、白像素点的差异并将其作为特征值对工件表面的清洗状态进行判定, 为高强钢表面漆层的去除提供了实用的工艺参数及检测方法。

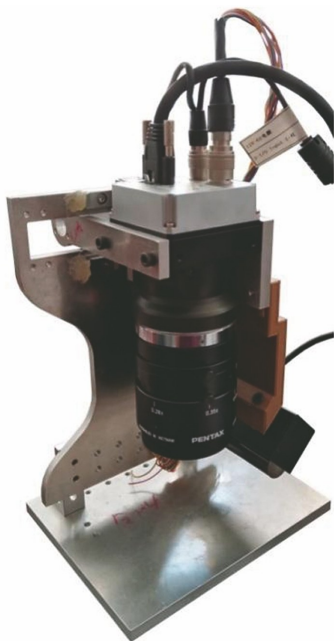
为了结合工件的宏观、微观形貌对激光清洗质量进行在线评估,设计了如图 4 所示的激光清洗工

件表面检测设备:采用 Y 向精密运动模块带动 Basler 公司的 raL6144-16gm 线阵相机在工件表面进行覆盖式扫查,采集工件的表面信息。

图 4 激光清洗表面在线检测设备
Fig. 4 Online detection mechanism of laser cleaning surface

An online detection device shown in Fig. 4 was used to scan and detect the surface of the cleaned workpiece. The online detection device uses a precision motion module to drive a camera to scan the workpiece for collecting surface information. The analysis results of the collected images using double thresholds (Fig. 12) show that the difference in cleaning effects has evident characteristics in the number of black/white pixels. When cleaning is insufficient (laser power of 150 W), the number of white pixels in the image is much higher than that of black pixels. Meanwhile, when cleaning is moderate (laser power of 180 W), the number of black and white pixels in the image is almost the same. Furthermore, for excessive cleaning (laser power of 200 W), the number of white pixels in the image is substantially lower than that of black pixels. Therefore, the difference between the number of black and white pixels in the image can be considered as the characteristic value, reflecting the cleaning residue status of the coating.

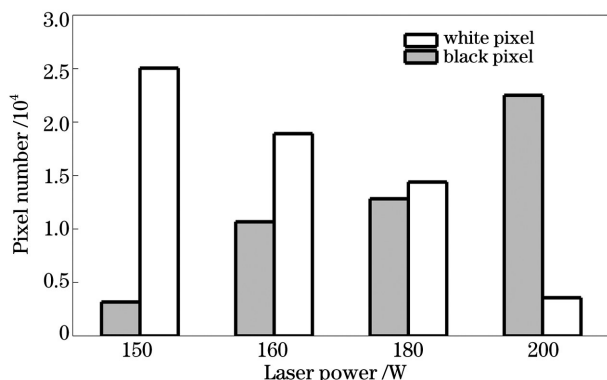
图 12 各清洗状态下黑白像素点数量的变化情况

从图 12 中可以看出,不同激光功率下清洗效果的不同反映在黑白像素点的数量上。当清洗不足时(激光功率 150 W),图像中的白色像素点数量远多于黑色像素点数量;当清洗适度时(激光功率 180 W),图像中的黑白像素点数量基本一致;当清洗过度时(激光功率 200 W),图像中白色像素点数量明显少于黑色像素点。因此,将图像中黑白像素点数量的差异作为特征值,能够直接反映漆层清洗后的残留状况。
