中国激光

碳纤维复合材料飞机蒙皮表面漆层激光清洗工艺研究

摘要 激光清洗碳纤维增强树脂基复合材料(CFRP)表面涂层一直面临着形貌破坏与基体过热的风险。为了明晰工艺参数对激光清洗 CFRP 飞机蒙皮表面油漆的影响规律, 探究 CFRP 表面油漆的激光清洗机理, 进行了红外纳秒激光清洗 CFRP 表面油漆的实验。首先利用田口正交阵列开展了不同参数下的清洗实验。随后采用信噪比(S/N)与方差分析(ANOVA)探讨了激光功率、扫描速度、搭接率与重复频率等工艺参数对油漆清洗深度、表面粗糙度和清洗温度的影响。最后借助红外热成像与高速摄像技术, 对激光清洗过程中的温度响应、羽流形成与消逝及漆层动态行为进行了观测。研究结果表明: 搭接率是影响清洗深度、表面粗糙度和清洗温度的主要参数, 扫描速度与激光功率的影响同样显著, 而重复频率的影响不显著。CFRP 表面油漆的激光去除机制主要以激光热效应造成的热烧蚀、气化为主。

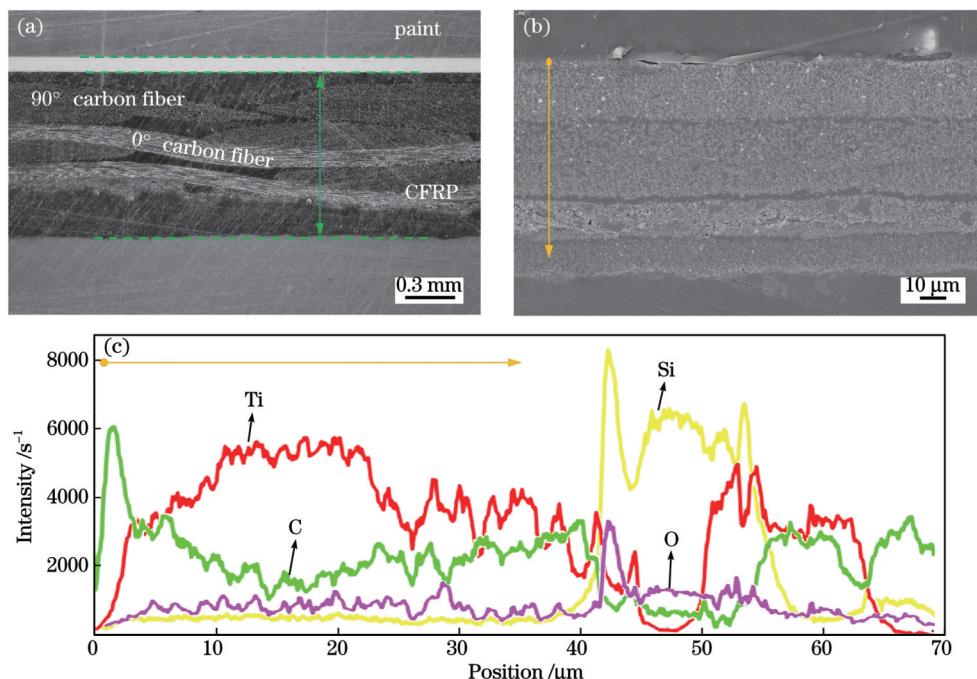
图 1 CFRP 样品形貌及漆层元素组成。(a)CFRP 样品宏观形貌;(b)CFRP 样品微观形貌;(c)漆层元素组成

Fig. 1 Morphologies of CFRP sample and composition of paint layer elements. (a) Macroscopic morphology of CFRP sample; (b) microscopic morphology of CFRP sample; (c) composition of paint layer elements

实验中 CFRP 基体取自某型号飞机的蒙皮, 厚度约为 1.1 mm, 由环氧树脂与碳纤维两部分异质材料组成。其中碳纤维的质量分数约为 70%, 为平纹编织结构。CFRP 表面涂覆有环氧-聚氨酯油漆, 漆层总厚度约为 75 μm , 呈灰白色。**图 1(a)、(b)** 分别为实验材料

横截面的宏观与微观形貌。可以看出, CFRP 表面漆层大致可以分为四层, 是多次喷涂而成的。**图 1(c)** 显示了漆层厚度方向上元素的变化。漆层成分以 C、O、Ti、Si 元素为主, 不同区域的元素含量波动较大。

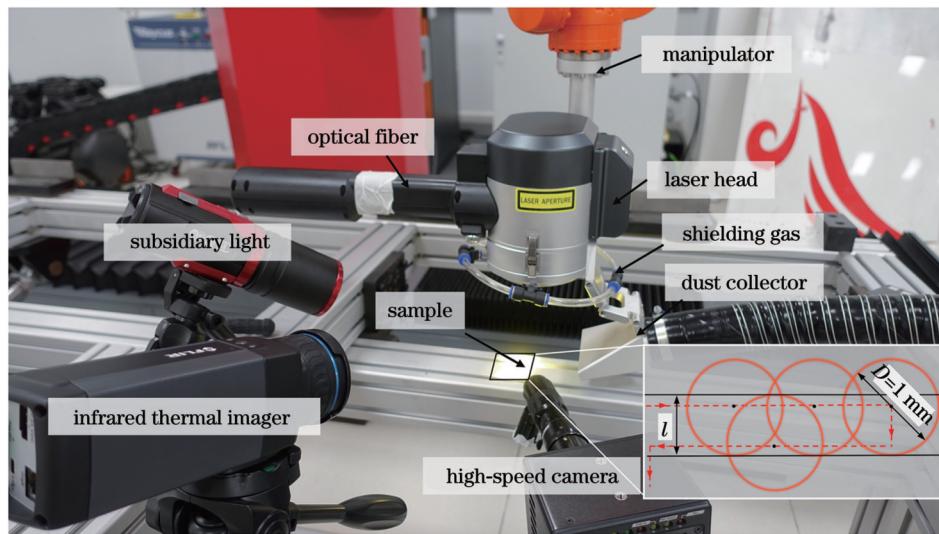
图 2 激光清洗系统
Fig. 2 Laser cleaning system

漆层清洗由激光清洗系统执行。整个系统如**图 2** 所示, 包含激光器、二维振镜、机器人、水冷装置、除尘器以及计算机系统等。清洗系统所用激光器为波长(λ)为 1064 nm 的光纤脉冲激光器, 激光直径(D)约为 1 mm。机器人可以将激光头移至样品上方, 并通过 Z 轴调节焦距。在控制系统中设定光束移动路径, 并由二维振镜实现。本实验将扫描路径设置为“弓”字形, 并在每一行光束扫描路径之间设置一定的搭接率, 以实现 10 mm \times 10 mm 矩形区域的清洗。搭接率(η)的计算公式为

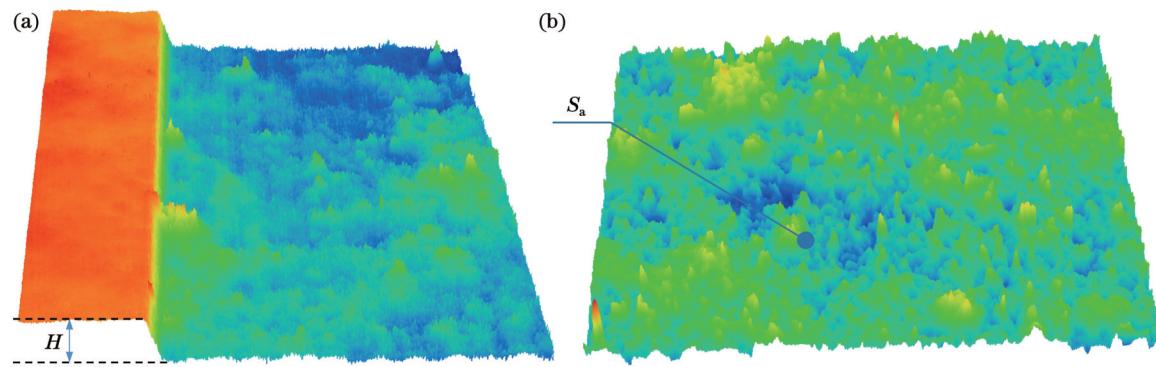
图 3 激光共聚焦显微镜测量内容。(a)激光清洗深度;(b)激光清洗区域的面粗糙度

Fig. 3 Measurement items of laser confocal microscope. (a) Laser cleaning depth; (b) surface roughness of laser cleaning area

形貌与微观形貌进行观察。同时,如图 3 所示,利用激光共聚焦显微镜对油漆清洗深度与样品表面粗糙度进行测量。最后,分别采用方差分析(ANOVA)和信噪

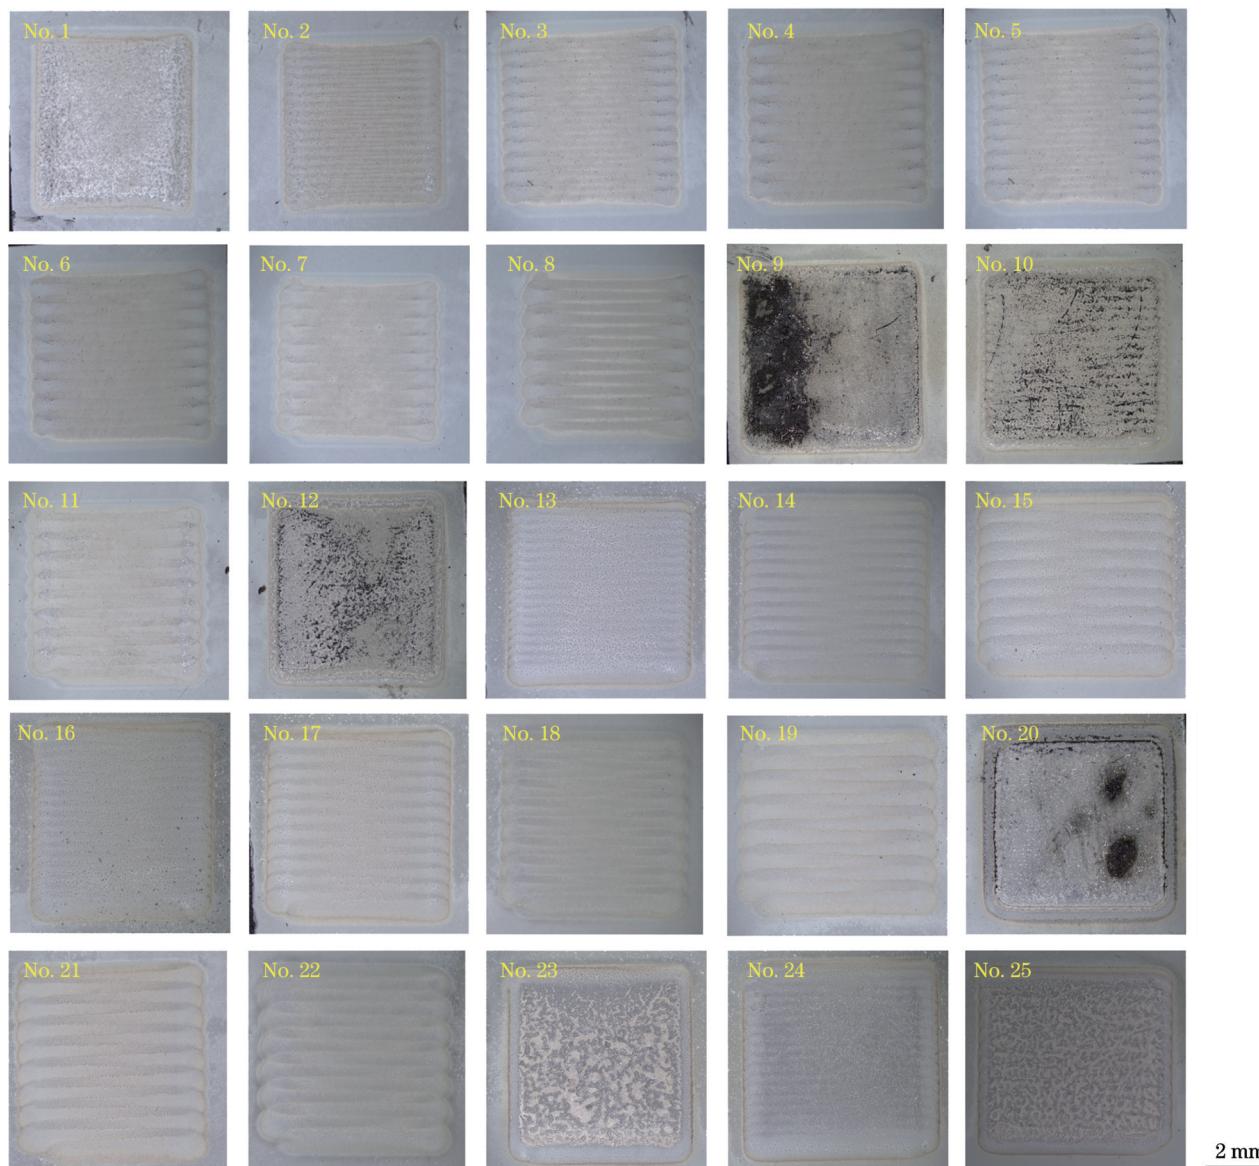
图 4 CFRP 样品激光清洗后宏观形貌

Fig. 4 Macroscopic morphologies of CFRP sample after laser cleaning

图 4 展示了激光清洗后样品表面的宏观形态。由

于实验对参数进行了控制,所有样品均未出现基体的严重烧损现象,因此比较能真实地反映出激光与漆层的作用规律。总体来看,所有样品表现出两种形态:一种是样品表面部分区域显露出黑色基体,如 No. 9、

No.9、No.12、No.20。这四组样品是在较高的搭接率或较低的激光扫描速度下进行激光清洗的,共同点在于激光对油漆存在较高的能量输入。另一种是油漆表层部分被去除,样品表面残留完整的漆层。此外,部分样品的表面粗糙度也有显著变化,如 No.23、No.25。相比于激光作用之前,剩余漆层具有显著的凹凸表面。观察样品 No.8、No.11、No.14、No.15、No.17、No.19、No.21、No.22 可以发现,相比于其他样品,表面遗留有显著的激光搭接痕迹。这类样品的共同点是在较低的搭接率或较高的扫描速度下进行激光清洗的。

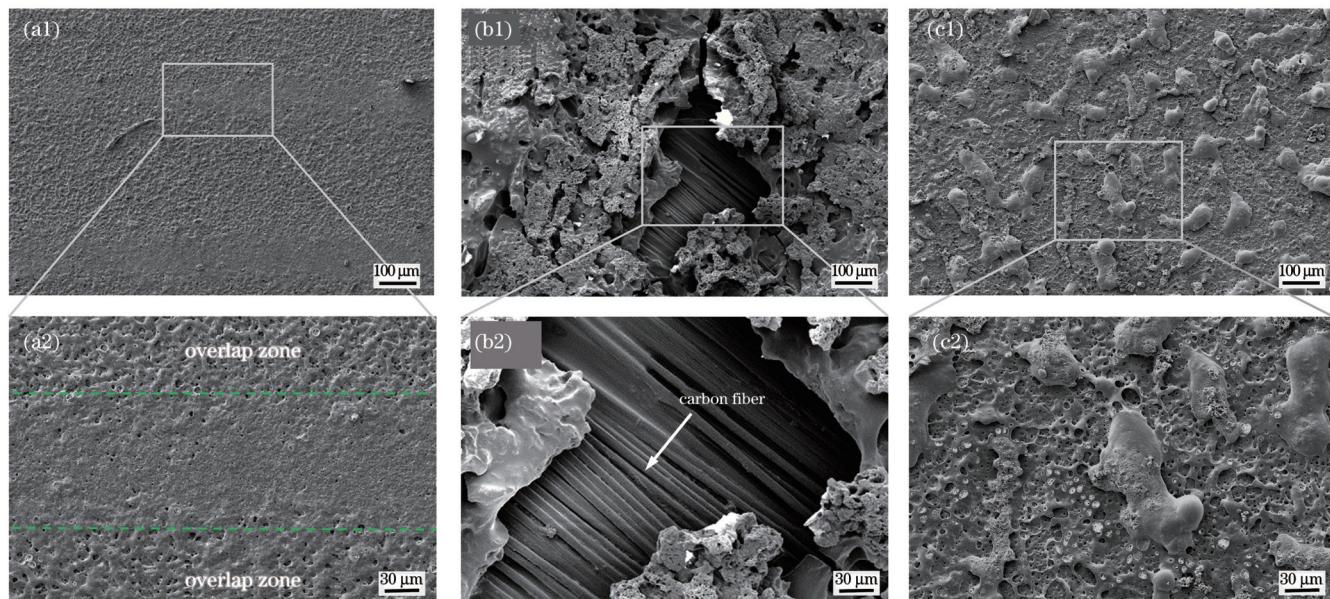
图 5 CFRP 样品在激光清洗后的 SEM 图。(a1)(a2) 样品 No. 22; (b1)(b2) 样品 No. 20; (c1)(c2) 样品 No. 25

Fig. 5 SEM images of CFRP samples after laser cleaning. (a1)(a2) Sample No. 22; (b1)(b2) sample No. 20; (c1)(c2) sample No. 25

图 5(a1)、(a2) 是样品 No.22 的 SEM 图,其更详细展示了低搭接率下的典型样品形貌。相比于非搭接区,光斑搭接区内由于激光的重复扫描,油漆烧蚀痕迹更为明显。同时由于搭接率仅为 50%,光斑之间的重叠较少,搭接区与非搭接区之间的界限较为明显。这意味着较低的光斑搭接率不利于提高油漆清洗的均匀性。

图 5(b1)、(b2) 为样品 No.20 中基体暴露区域(即图 4 中 No.20 的黑色区域)的 SEM 图,其更详细展示了高激光能量输入下的典型样品形貌。样品 No.20 是在 90% 搭接率、1000 mm/s 扫描速度、250 W 激光功率下进行激光清洗的,最高的搭接率、最低的扫描速度与较高的激光功率共同导致了较大的激光热输入。因此,部分油漆被完全清洗,基体顶部树脂也被一并去除,碳纤维暴露。如前文所述,由于参数控制,激光主要作用于油漆,碳纤维仍保持完整的形态。

图 5(c1)、(c2) 为样品 No.25 的 SEM 图,其更详细展示了具有凹凸表面结构的典型样品的形貌。可以看出,残留漆层的凹凸表面上分布着斑点状凸起。根据能谱分析(EDS)检测结果可知,这些凸起物主要由 C、O、Ti 等元素组成,与油漆本身成分相近。此外,相比于平整漆层,这些凸起更为光滑,具有熔化、重凝特征,可以判断这是油漆中的固化剂受热熔化继而凝固形成的。

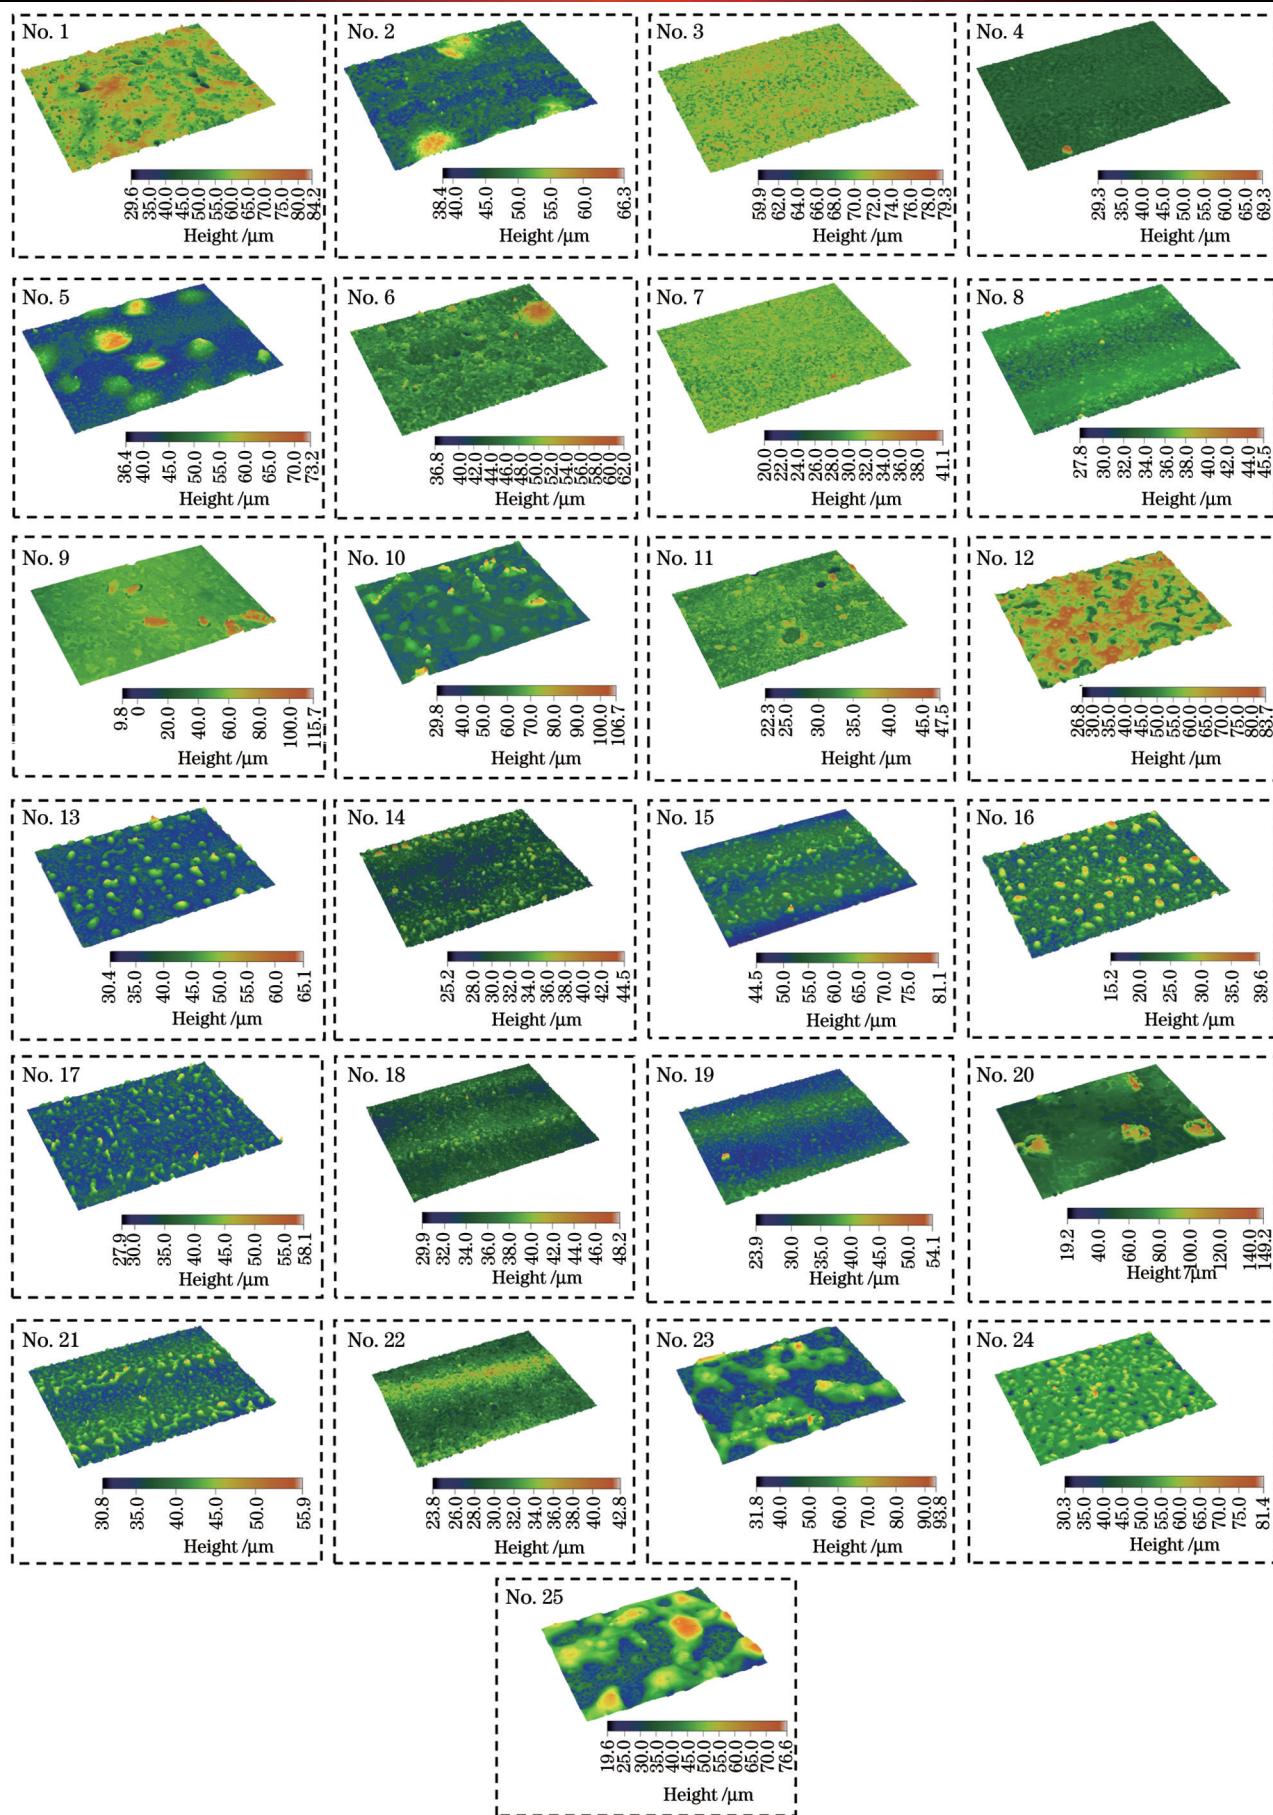
图 6 CFRP 样品激光清洗区域的三维轮廓
Fig. 6 3D profiles of laser cleaning areas of CFRP samples

通过激光共聚焦显微镜对激光清洗后的样品表面的三维轮廓进行观察。图 6 为各组样品激光清洗区域的三维形貌图。可以发现,不同激光清洗参数下的样品表面粗糙度存在较大差异。由于搭接率(50% 与 60%)较低,样品 No.15、No.18、No.19、No.21、No.22 表面的搭接痕迹十分突出,并形成谷脊结构。

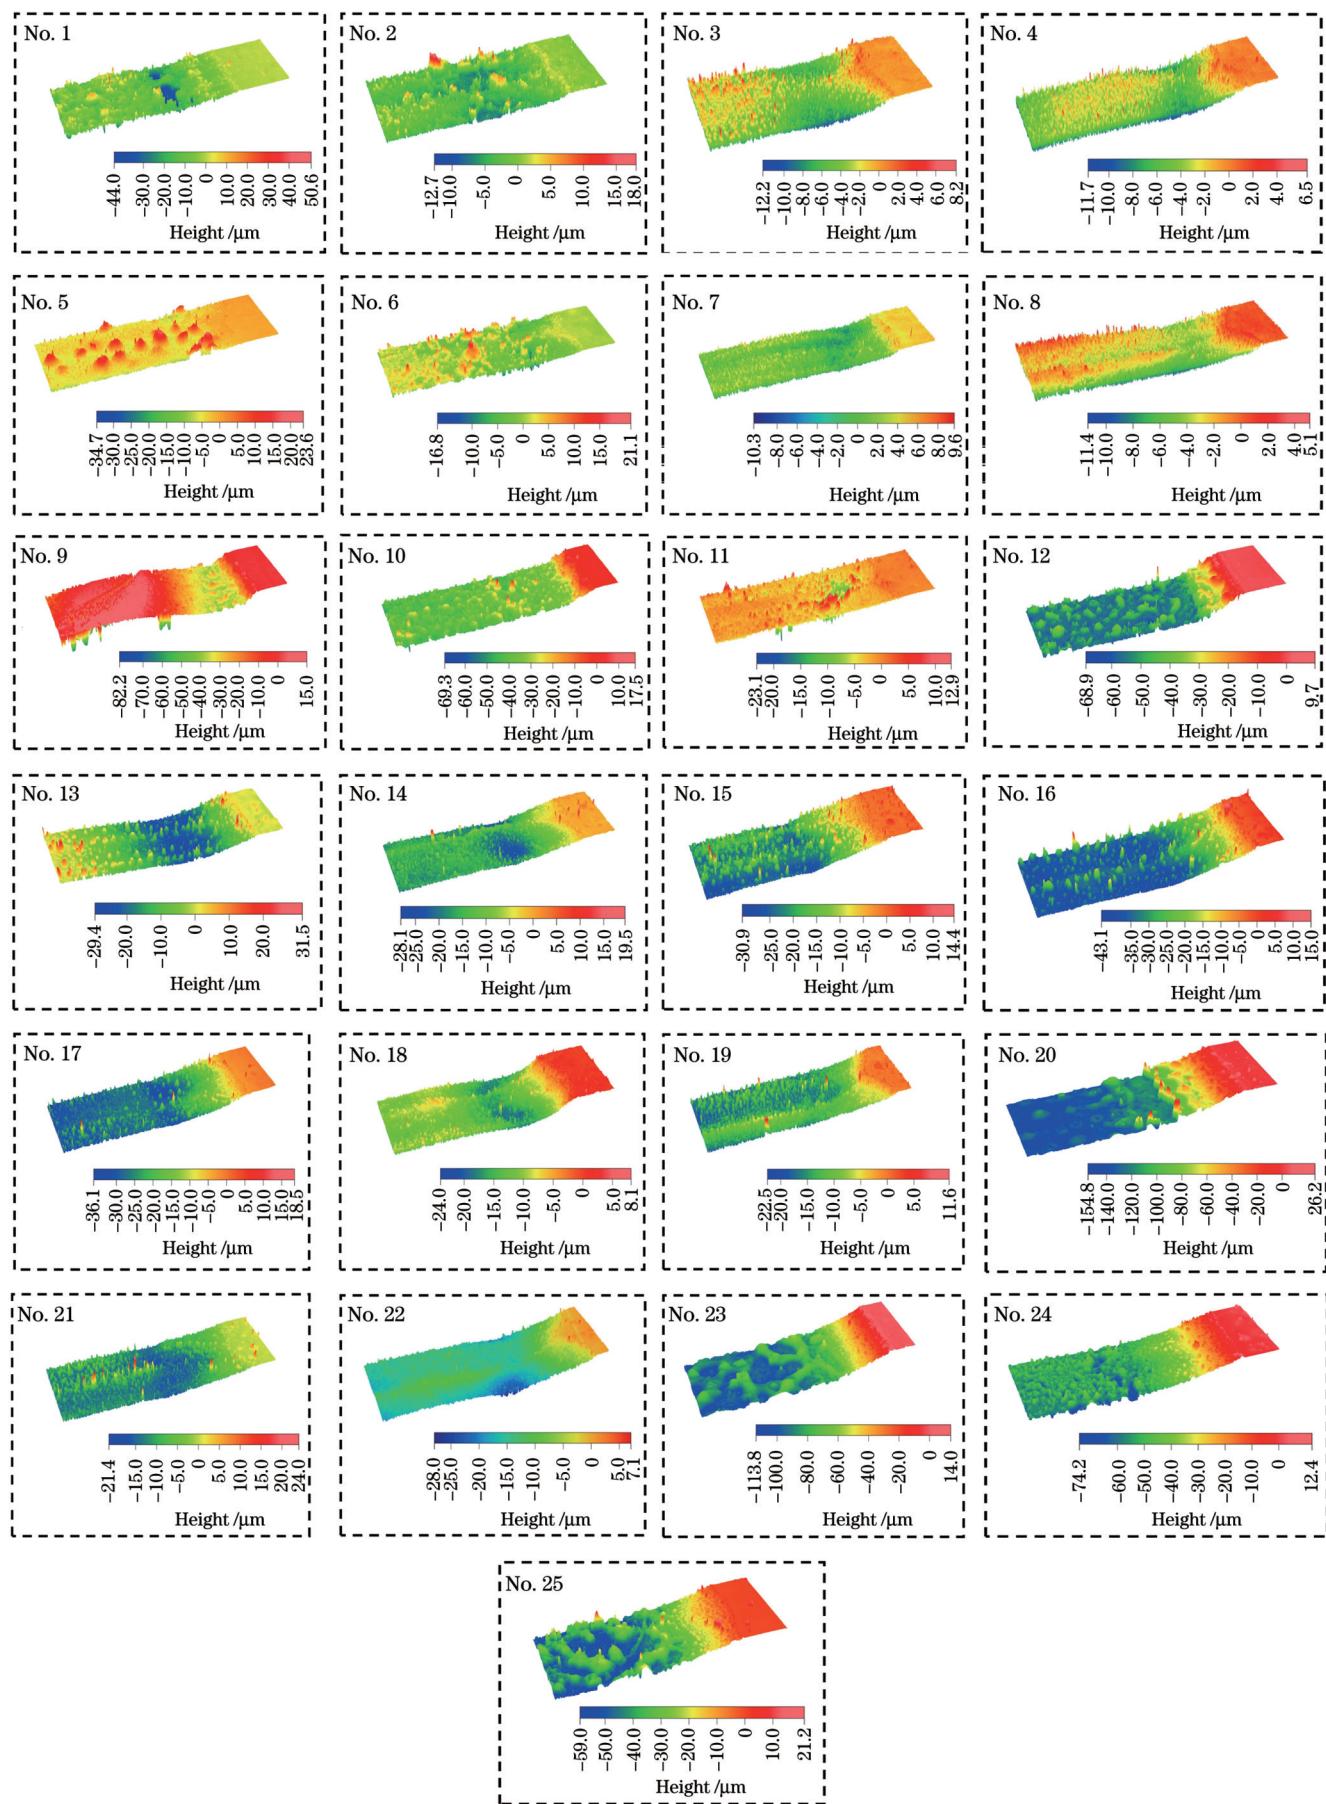
图 7 清洗-未清洗分界区域的三维轮廓
Fig. 7 3D profiles of cleaned-uncleaned boundary areas

图 7 为清洗-未清洗分界区域的三维轮廓图,显然清洗深度具有显著的参数依赖性。同样,对各组样品的清洗深度进行了测量。

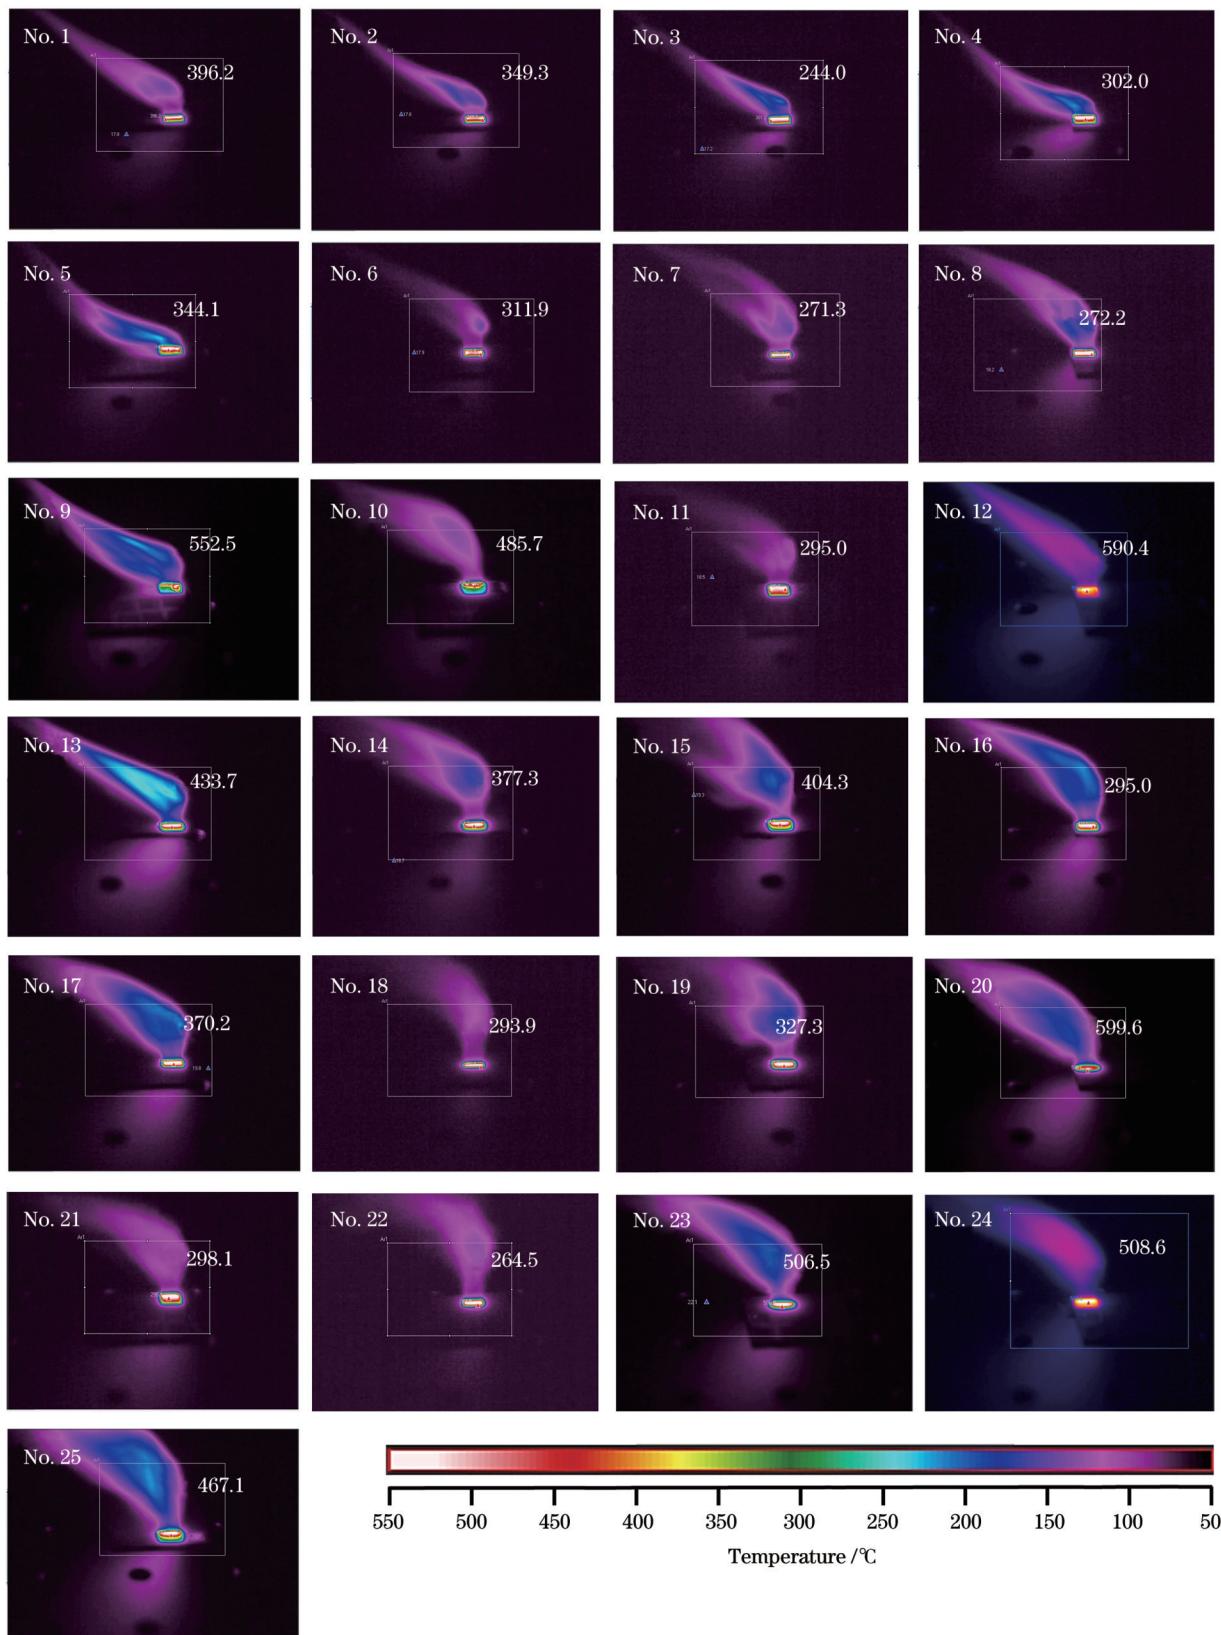
图 8 样品在温度峰值处的红外热成像图

Fig. 8 Infrared thermal imaging patterns of samples at peak temperature

图 8 展示了不同清洗参数下拍摄的红外热成像图。需要指出,图 8 展示的是清洗温度达到峰值时的

图像。值得注意的是,由于激光的脉冲频率较大,现有的光电测温技术无法精确捕捉每个激光脉冲下的样品表面温度,但能较为准确地测得样品在红外热成像图像相邻帧之间的常态温度,因此为温度测量提供了较好的参考依据。

由图 8 可以看出,激光清洗过程将在实验样品处及其附近引起两个高温区域。其一是激光作用在基体上的区域。虽然所有样品的漆层均有一程度的去除,但清洗温度有较大的差异。根据温度监测结果可知,该区域的最低清洗温度为 244 °C,最高清洗温度为 590.4 °C。另外一个高温区域是样品上方的高温羽流区。羽流包括四种物质状态,即固体、液体、气体和等离子体^[21]。根据 Yu 等^[22]的研究可知,

激光脱漆过程中的羽流主要由 CO_2 、 CO 、 H_2O 与有机微颗粒等构成。由于羽流的发射率并不稳定^[23]，因此未对高温羽流温度进行测量，但根据羽流颜色可以判断其温度的相对大小。羽流体积也反映出激光

清洗的剧烈程度，因此羽流大小与清洗温度也表现出了一致性。如样品 No.23、No.24、No.25、No.9、No.12、No.13 具有较高的清洗温度与较大的羽流体积。

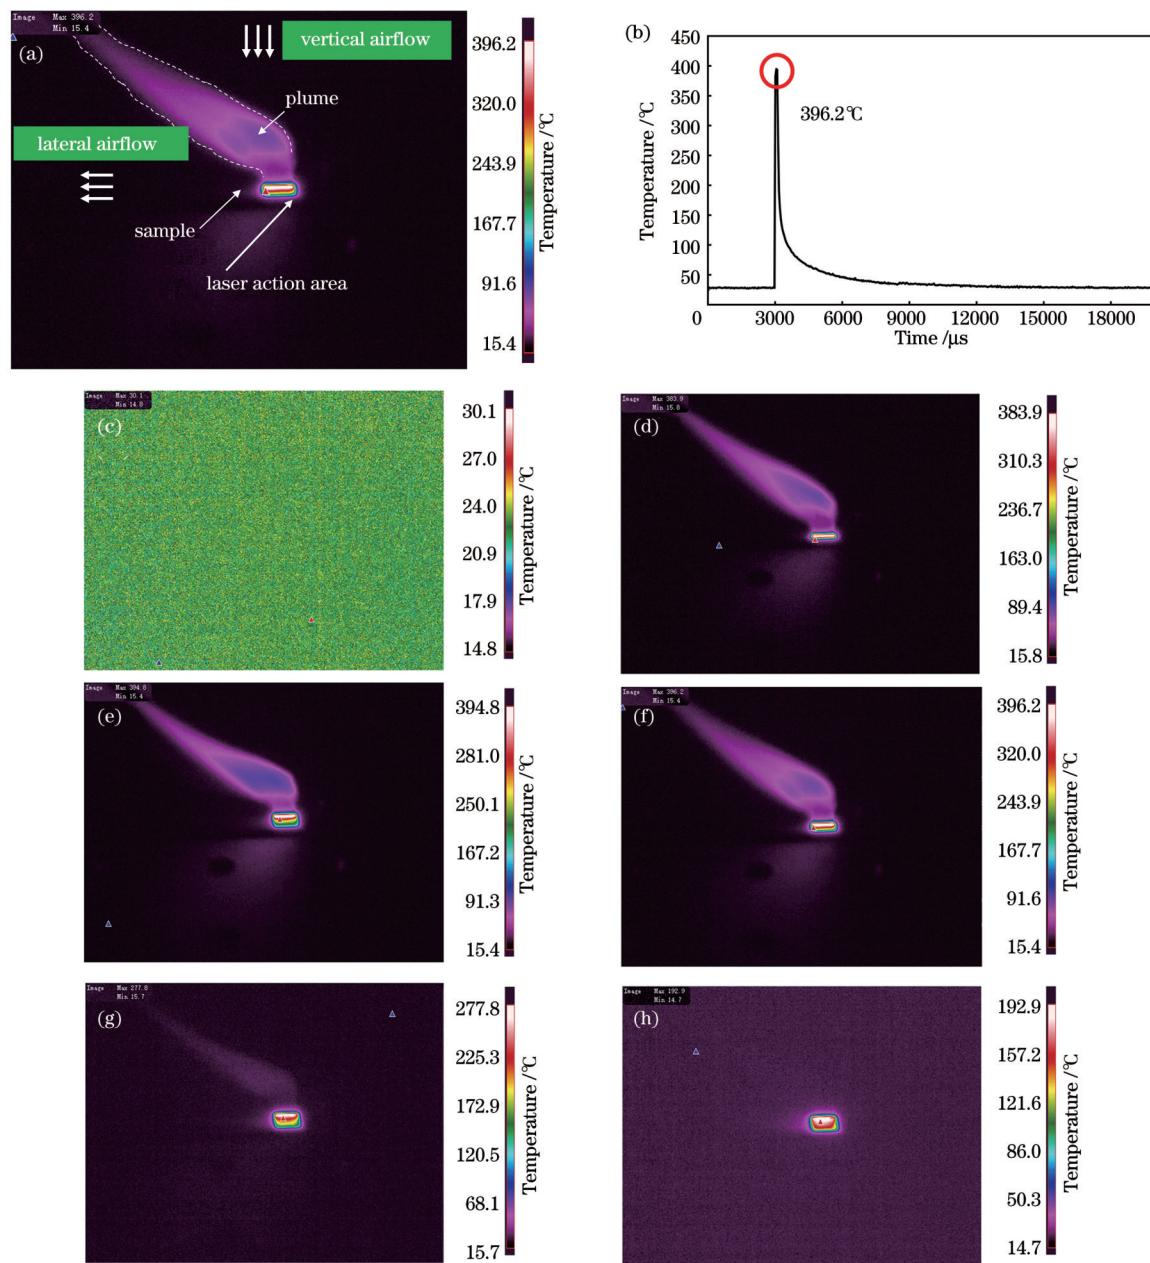
图9 红外热成像图。(a) 清洗区域的典型红外热成像特征;(b) 激光清洗期间的温度响应曲线;(c)~(h) 样品在清洗过程中不同时刻的红外热成像特征 (间隔 1/25 s)

Fig. 9 Infrared thermal imaging images. (a) Typical infrared thermal imaging feature of cleaning area; (b) temperature response curve during laser cleaning; (c)–(h) infrared thermal imaging characteristics of samples at different moments during cleaning process (interval of 1/25 s)

对红外热成像拍摄结果进行更深入的详细分析。图 9(a)是清洗区域的典型红外热成像特征(以样品 No.20 为例)。由于切向与垂直气流的存在,羽流挥

发轨迹发生了偏移。图 9(b)是样品在激光清洗期间的温度响应曲线。可以发现,当激光开始辐照漆层时,漆层表面温度瞬间上升至峰值温度。待清洗完成后,清洗区域温度缓慢降至室温。图 9(c)~(h)展示了样品在清洗过程中的红外热成像图片。图 9(c)~(f)更为详细地记录了温度上升过程。激光辐照至样品表面后,油漆温度骤升,达到 383 °C,随着激光辐照

的进行,最高温依次攀升至 394.8 °C 与 396.2 °C。这种清洗过程中的温度攀升是激光热积累所致。在激光清洗完成后,样品通过热传导、对流和辐射形式降温,样品表面温度依次降至 277.8 °C 和 192.9 °C。同时,羽流体积也迅速减小,如图 9(h)所示。如上文所述,羽流是油漆分解产物的聚集,由固体、气体或等离子体组成。

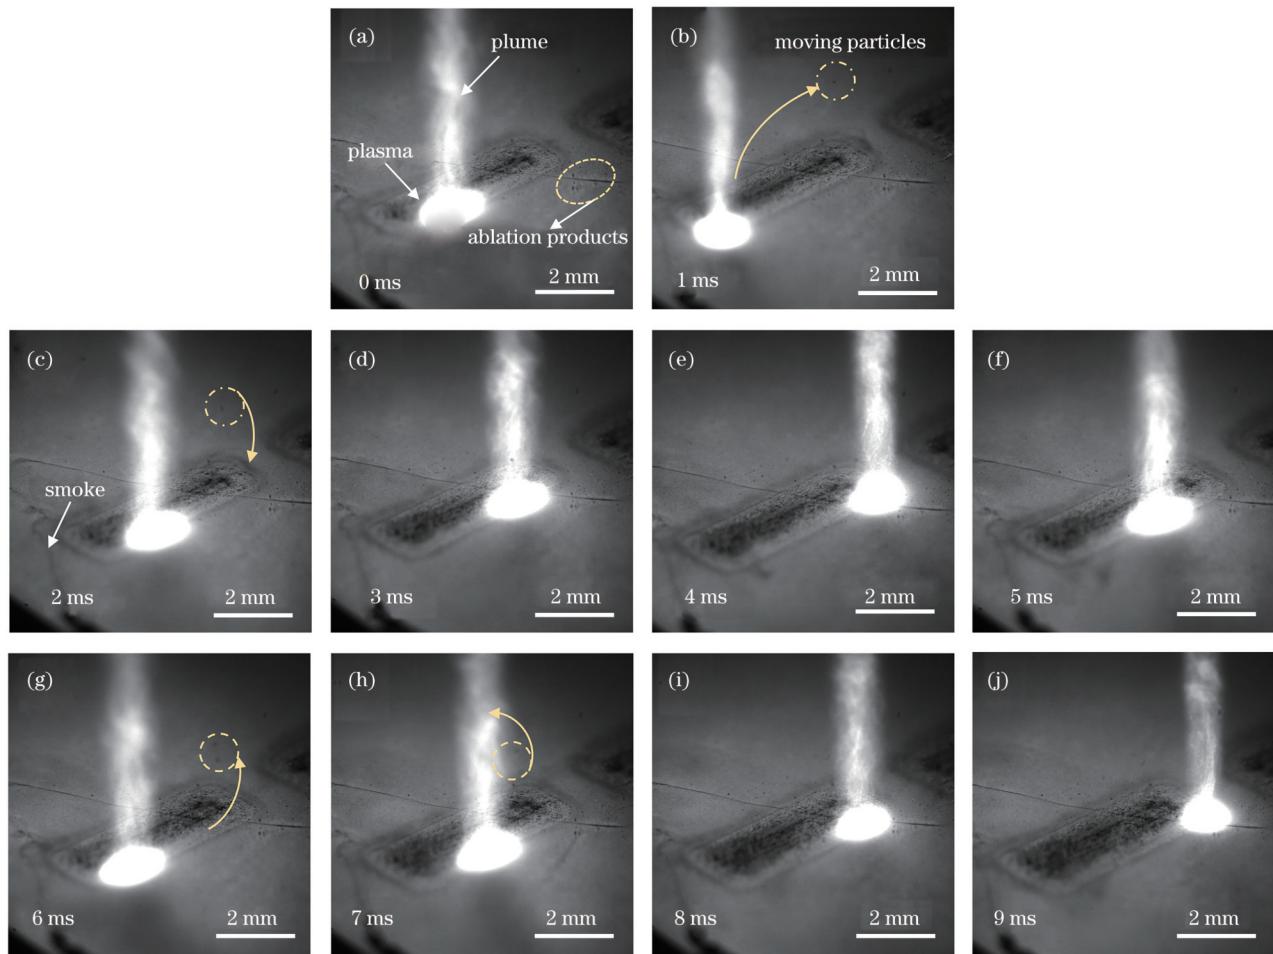
图 10 激光清洗过程中的动态行为
Fig. 10 Dynamic behavior during laser cleaning

接下来利用高速摄像技术观测激光除漆过程中的动态行为。图 10 展示了高速摄像机在与样品平面成 45° 左右夹角时拍摄到的图片(样品 No.20)。

图 10 共展示了总时长为 8 ms 的激光清洗过程,时间间隔为 1 ms。可以清晰看到,由于激光的作用,漆层发生了剧烈的变化。最明显的现象是产生了高亮等

离子体并形成了与样品垂直的羽流。在羽流内部可以看到大量混浊态颗粒。此外,从图 10(a)虚线圈标记区可以看到,有大量清洗产物在激光清洗区域边缘处沉积。在图 10(c)中的箭头指示区,可以看到烟尘产生。进一步观察图 10(b)、(c)与图 10(g)、(h)中的虚线圈标记区,可以看到呈漂浮态的微小的颗粒物。这些微颗粒存在时间为 2~3 ms,随后漂移出视野。与以往文献报道^[24-25]不同,没有在高速摄像中观察到飞溅态颗粒与块状物。这表明在此激光清洗过程中,应力作用的油漆剥离现象并不显著。结合红外热成像,可以判断油漆的去除机理主要是热烧蚀。详细地说,油漆吸收激光能量,温度迅速攀升。在温度超过自身分解温度后,油漆转化为细小颗粒与气体,从而实现油漆的清洗。
