高功率固体激光装置负载问题研究进展*

摘要: 高功率固体激光装置的负载问题是制约装置建设与运行的瓶颈问题。在高通量紫外纳秒激光辐照下, 熔石英后表面的损伤不断产生和增长, 严重限制了装置的负载能力。在提升熔石英抗损伤性能的基础上修复既有损伤, 循环使用光学元件, 是现阶段提升装置负载能力的主要手段。主要介绍了国内外近年来在熔石英损伤的规律与机制、光学元件循环处理的支撑技术以及提升负载能力的新材料与新技术方面所取得的重要进展。

Research progress on loading capability of high-power solid-state laser facilities

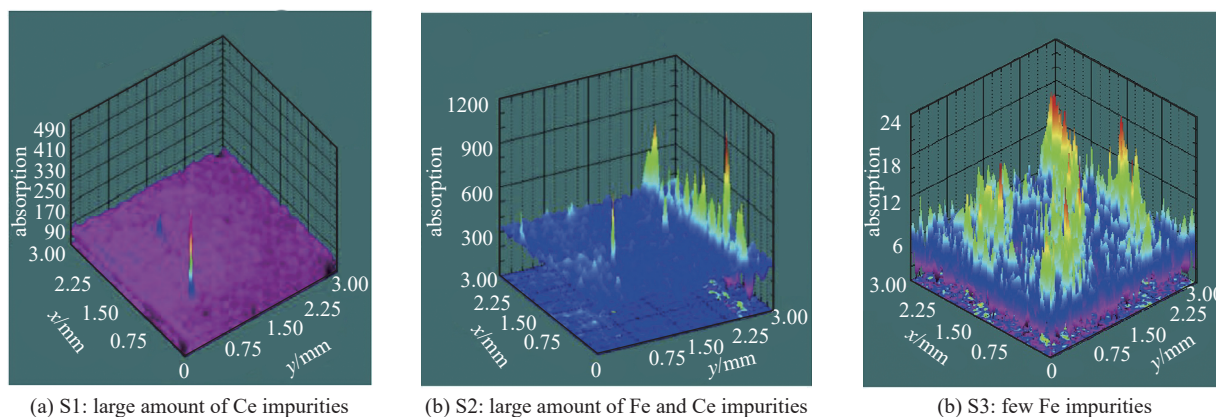
Fig. 4 Absorption mapping images of three kinds of samples^[27]

图4 三种金属元素污染的样品的吸收分布(扫描区域不同位置的相对吸收强度)^[27]

高的纯度,体内的杂质离子含量仅有 ppm 甚至 ppb 量级,同样难以引起熔石英表面损伤。另一方面,元件研磨、抛光和精修等加工过程会在亚表面引入大量抛光颗粒与裂纹,均具有较强的吸收特性,容易导致熔石英表面损伤性能下降。例如,刘红婕等通过光热弱吸收检测揭示了表面加工富集的铁、铈元素导致表面吸收增强,如图 4 所示;黄进等进一步建立了这种强吸收与熔石英表面损伤性能的关联关系^[27-28]。针对此类缺陷,除改进前级加工工艺外,现阶段主要对熔石英表面进行氢氟酸刻蚀,以达到去除杂质、钝化裂纹的效果,有望将熔石英损伤阈值提升至 30 J/cm^2 附近^[29-30]。然而,刻蚀过程中的氟硅酸盐反应产物如不及时去除,也将成为新的吸收前驱,诱导熔石英发生损伤^[29]。近期, Cross 等通过测试发现即使低通量辐照也会在附近表面产生不可见的污染,其损伤阈值在 20 J/cm^2 附近,同样造成熔石英损伤性能下降^[31]。

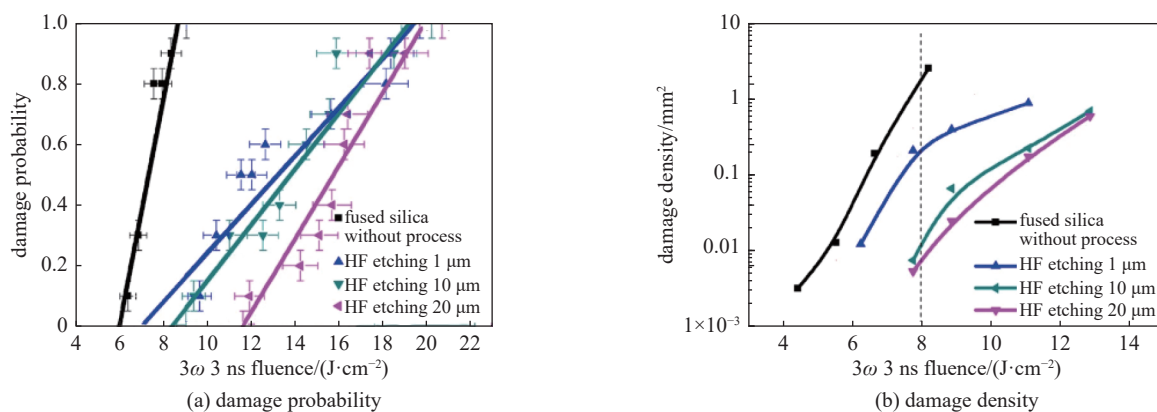
Fig. 6 Damage probability and damage density of fused silica etched different times^[48]

图 6 不同刻蚀次数下的熔石英损伤概率与损伤密度^[48]

先进延缓处理技术(Advanced Mitigation Processing, AMP)主要基于氢氟酸刻蚀清洗熔石英光学元件,即利用含氢氟酸的溶液和熔石英进行反应,以移除其表面的物质,提高熔石英的损伤性能。在之前的研究中,熔石英表面的抛光层被刻蚀去除之后,可以提高元件的损伤阈值,刻蚀深度约 200 nm,进一步刻蚀反而会起负面作用,刻蚀后出现熔石英表面的紫外损伤阈值下降、损伤密度增大现象。出现这种差异的原因可能在于对再沉积物的控制。氢氟酸溶液和熔石英反应后产生 SiF_6^{2-} 离子,极易和溶液中的阳离子(如 Na^+ 、 K^+ 等)产生沉淀。尽管 $(\text{NH}_4)_2\text{SiF}_6$ 具有较高的溶解度,但如果 NH_4^+ 离子浓度过高,也容易产生沉淀。NIF 研究人员发展了一种高频超声波辅助刻蚀的技术,将划痕整体的损伤统计概率从约 100/mm 降低到约 0.001/mm^[30]。与传统的氢氟酸刻蚀工艺相比,该工艺的“先进”之处主要有:通过减少阳离子浓度增加了反应产物的溶解度,以防止产生再沉积物;在刻蚀和漂洗过程中提高了反应产物的质量输运,防止产生再沉积物;刻蚀足够的深度,消除了抛光层和表面破裂层,使侧向裂纹贯通,最大程度提高质量输运速率^[30]。

激光聚变研究中心从 2005 年就开始了利用湿法刻蚀技术提升熔石英抗激光损伤性能的研究,经历了静态刻蚀-动态刻蚀-多次静态刻蚀-动态刻蚀的研究历程。在此基础上,叶鑫等研究了不同刻蚀深度对熔石英损伤性能的影响,如图 6 所示^[48]。

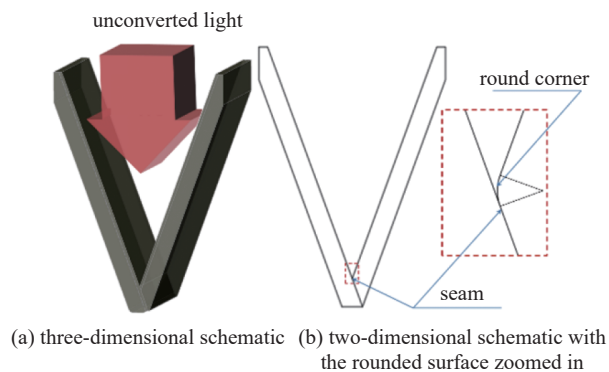
Fig. 8 Basic structure of a V-type beam dump^[57]

图8 V形结构的光收集器^[57]

随着高功率固体激光装置输出能量的持续提升,杂散光通量也随之大幅提升,设计并研制一种能够实现通量超 $30\ \text{J}/\text{cm}^2$ 基频杂散光吸收的超高通量激光光束陷阱是保证高功率固体激光装置安全运行的迫切需求。郑天然等基于有限元分析,设计了“V型”结构形式作为超高通量激光光束陷阱的结构形式,通过增大辐照面积使得吸收玻璃表面及体内实际通量不超过入射光通量的35%,并在“接缝”位置采用“倒边自然过渡”设计,避免尖角处加工杂质富集与较强的激光调制引起激光损伤,如图8所示^[57]。激光聚变研究中心牵引中国建筑材料科学研究总院有限公司基于CVD熔石英掺杂工艺,完成了基频损伤阈值超过 $20\ \text{J}/\text{cm}^2$ 的高阈值吸收玻璃的研发。

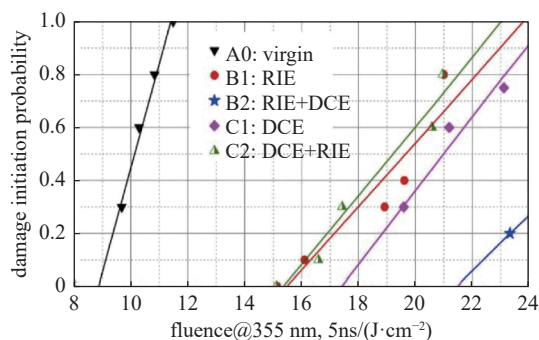
Fig. 9 Damage initiation probability versus laser fluence at 355 nm, 5 ns for the virgin sample and the samples treated with different processes^[60]

图9 不同表面处理工艺下的熔石英初始损伤概率^[60]

氢氟酸刻蚀技术可以极大程度地提升熔石英元件的紫外损伤性能,但较深的刻蚀量会导致元件表面粗糙度增加和面形劣化。将两种乃至多种熔石英表面处理手段相结合已成为制备高品质熔石英元件的重要发展方向。由于反应离子束刻蚀可以有效去除熔石英亚表面的物理结构缺陷,而动态化学刻蚀一般不存在化学结构缺陷的次生问题,因此提出将两者相复合的思想,先利用反应离子束刻蚀去除熔石英亚表面的物理结构缺陷,再利用动态化学刻蚀去除次生的化学结构缺陷。邵婷、孙来喜等通过改变不同刻蚀深度配比,系统研究了复合刻蚀过程中各个环节对熔石英元件损伤性能及表面质量的影响规律,有效复合反应离子刻蚀和动态化学刻蚀技术,在较浅刻蚀深度下获得了高阈值、低粗糙度的熔石英光学元件表面,实现了熔石英损伤阈值的显著提升,如图9所示^[59-60]。
