Laser-induced damage tests based on a marker-based watershed algorithm with gray control

Abstract

Keywords: damage growth; laser-induced damage; marker-based watershed algorithm with gray control

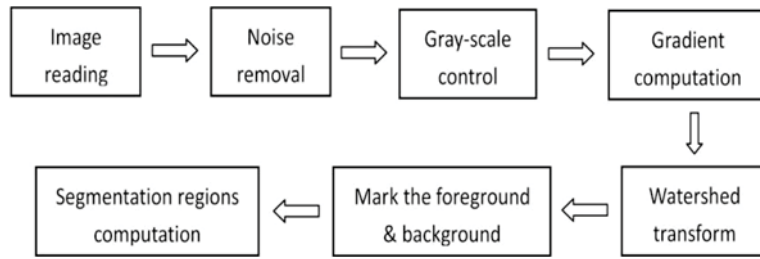
Figure 1. Flow chart of the imaging process using the MWGC.

The gray control is realized by setting a threshold that directly affects the image processing results. The threshold is determined by the gray level histogram of pixels in the damage image. For a damage image obtained by dark-field imaging technology, the image background has a low pixel gray value and maximum probability in the pixel gray histogram statistic. When the probability drops to the minimum from the peak, the gray value corresponding to the minimum probability is defined as the threshold of gray control. Figure 1 shows the flow chart of the improved algorithm.

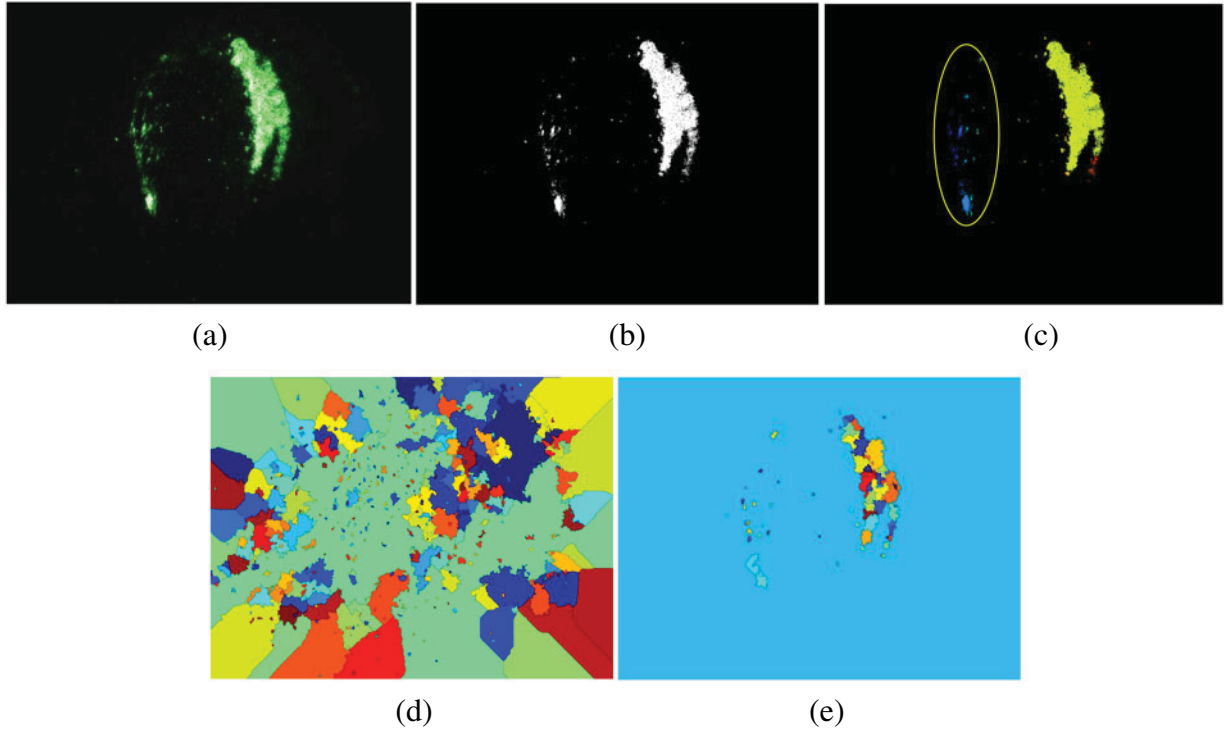
Figure 2. Results of image segmentation. (a) Original damage image; (b) by image binarization; (c) by threshold segmentation; (d) by marker-based watershed algorithm without gray control; (e) by MWGC.

Figure 2 shows the damage images extracted by different segmentation techniques. Figure 2(a) is the original damage image obtained by a microscope with CCD. The image binarization (Figure 2(b)) is merely an image denoising process for the gray information and cannot divide the damage sites. Since the selected threshold values in the threshold segmentation algorithm are generally determined by the gray scale for different regions, region segmentation based on this will be over-sensitive, which makes the damage pits inside one site divided into multiple sites unfavorably. This can be seen from damage regions with low gray contrast between the object and background in Figure 2(c). Over-segmentation can be observed in Figure 2(d) using marker-based watershed algorithms without gray control. In contrast, the MWGC clearly marks the different damage sites, which facilitates obtaining the damage growth and damage site size distribution. The different colors in Figures 2(c)–(e) represent different segmented damaged regions.

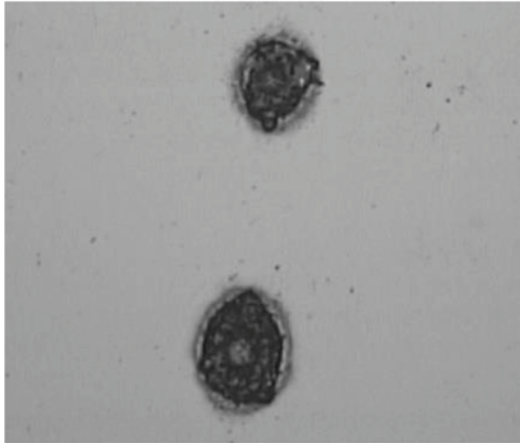
Figure 3. Damage site morphology captured by OM.

Table 1 shows a comparison between the diameters d_1 of damage site areas extracted using the MWGC and the diameters d_2 measured using an optical microscope (OM) with $200\times$ magnification. The morphology of damage sites obtained by the OM is shown in Figure 3. The average absolute error $\langle d_1 - d_2 \rangle$ is $0.93 \mu\text{m}$, which is much less than the pixel size (as shown in Table 2). Also, the average relative error $\langle \frac{d_1}{d_2} - 1 \rangle$ is 2.8%, indicating that the sizes of damage sites extracted by the MWGC are believable. It is clear that the segmentation algorithm incorporating gray control is effective in processing the damage image produced by a large-aperture laser.

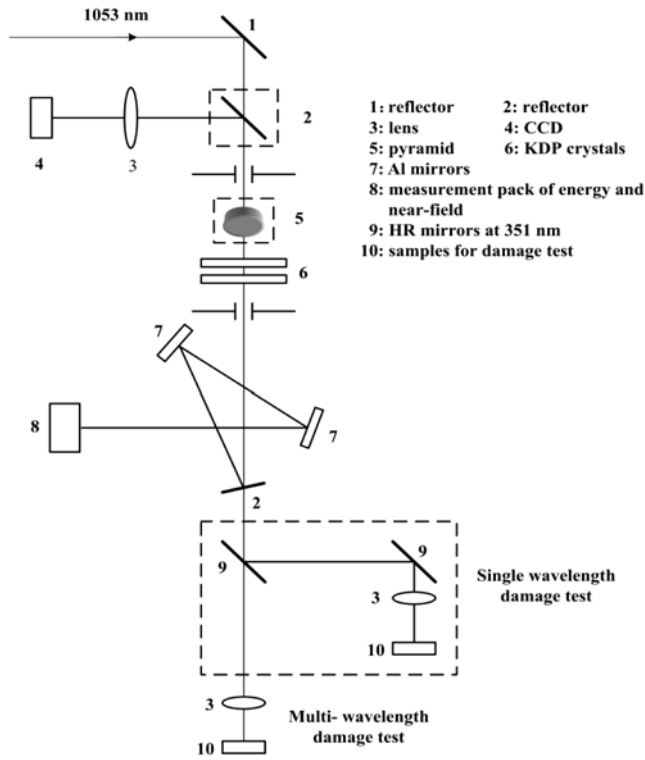
Figure 4. Experimental set-up for laser-induced damage testing.

The experimental set-up is shown schematically in Figure 4, and consists of modules for third-harmonic generation, laser

parameter measurements, damage initiation, and image capture. A 1053 nm laser with a beam aperture of $1.8 \times 1.8 \text{ cm}^2$ exits from a four-pass amplifier, the pulse width of which is 3 ns, as shown in Figure 5. The 351 nm laser is generated through frequency conversion of 1053 nm laser using two KDP crystals. By sampling the laser output from KDP crystals, the laser parameters are measured. Next, fused silica samples are exposed to the laser transmitted through a focusing lens. The beam sizes on the damage samples are 0.56–0.86 cm and are achieved by adjusting the distance between the samples and the lens (1 and 1.5 m in focal lengths for Corning-7980 and Heraeus-Suprasil 312 samples, respectively). The laser energies and near-field energy density distribution are measured by the measurement set of laser parameters. Figure 6 shows the near-field energy density distribution at 351 nm with a beam contrast (peak to average) of 1.75. The damage images after each shot are observed by a microscope with a CCD. The microscope magnification is calibrated using Group 0-4 of a 1951USAF resolution test chart with 1.41 line pairs per millimeter. Subsequently, the pixel size of the damage image is calibrated as shown in Table 2.

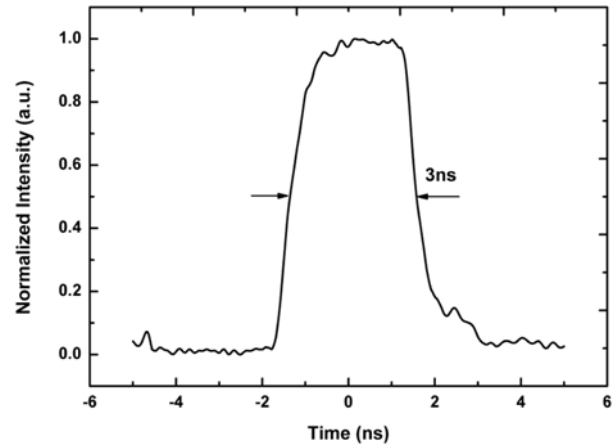
Figure 5. Temporal profile of a 3 ns pulse at 1053 nm.

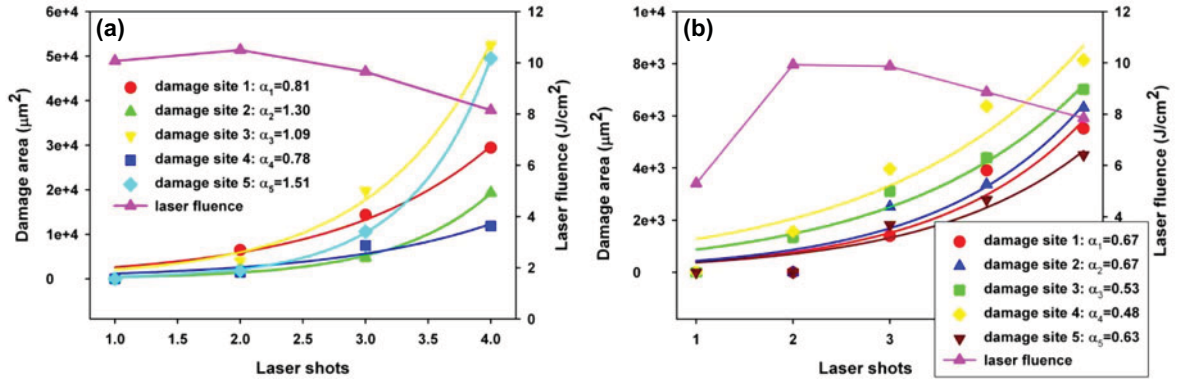
Figure 7. Damage growth of (a) Corning-7980 and (b) Heraeus-Suprasil 312 samples at 351 nm.

Damage tests at 351 nm are carried out to analyze the damage growth and damage site distributions on Corning-7980 and Heraeus-Suprasil 312 (secondary cleanliness) samples. For successive laser shots, five damage sites are selected to calculate the damage growth coefficients for the two samples. The damage growths for different damage sites are exponential, as shown in Figure 7, which is in good agreement with the reported results^[8, 12]. Table 3 shows

As seen from Figure 7, the damage growth coefficients are distinctly different for the five tested sites in the same sample. The difference possibly results from the site morphologies tested and the local fluence. Numerous researchers^[9, 13, 18, 19] have demonstrated that the complex damage growth process is affected not only by the various laser parameters but also the intrinsic structural features of the optical components. In general, there are various precursors on the optical surface that induce damage sites with different morphologies. Damage sites with different

morphologies grow differently. Therefore, damage sites grow with different coefficients after subsequent laser shots.

Note that the standard deviation of the growth coefficient for the Heraeus-Suprasil 312 sample is smaller than that for the Corning-7980 sample. This can be explained by the cleanliness of the optical surface. Most fragile precursors are removed from the Heraeus-Suprasil 312 sample surface with secondary cleanliness treatment. The damage sites induced by residual precursors are possibly similar. It can be inferred that the error bar of the growth coefficient (± 0.09) of Heraeus-Suprasil 312 is less than that of Corning-7980 (± 0.31).

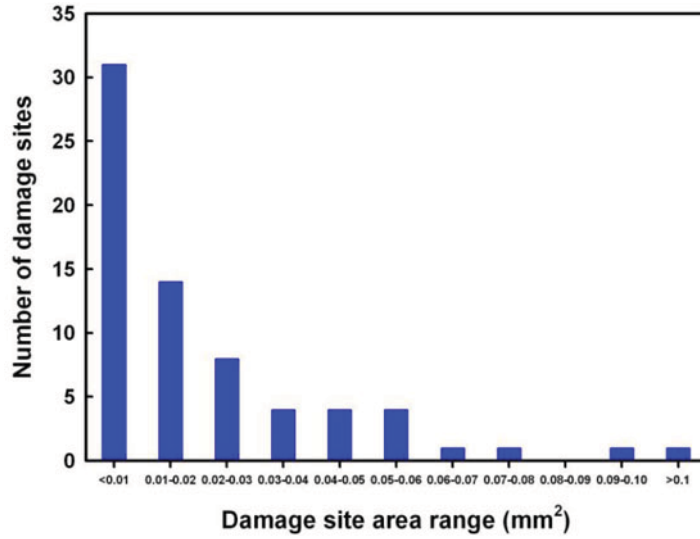
Figure 8. Damage site size distribution for the Corning-7980 sample at 351 nm.

Next, the damage site distributions are obtained after one laser shot, as shown in Figures 8 and 9. The number of damage sites decreased sharply with lateral damage site size. The average fluence of the 351 nm laser on Heraeus-Suprasil 312 sample is 22.60 J cm^{-2} , larger than that for the

Corning-7980 sample ($\sim 11 \text{ J cm}^{-2}$). Therefore, the number of large-size damage sites (area $> 0.1 \text{ mm}^2$) for Corning-7980 sample is less than that for the Heraeus-Suprasil 312 sample.

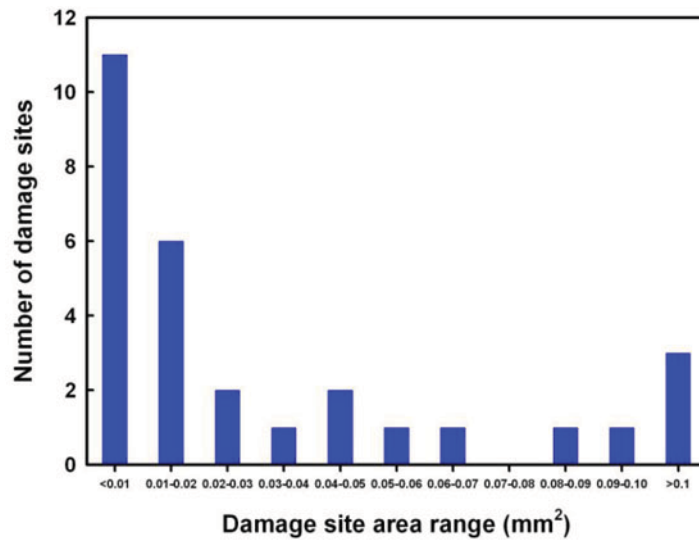
Figure 9. Damage site size distribution for the Heraeus-Suprasil 312 sample at 351 nm.
